# On Damage of Oil Storage Tanks due to the 2011 off the Pacific Coast of Tohoku Earthquake (Mw9.0), Japan

S. Zama, H. Nishi, K. Hatayama, M. Yamada, H. Yoshihara & Y. Ogawa

National Research Institute of Fire and Disaster, Japan

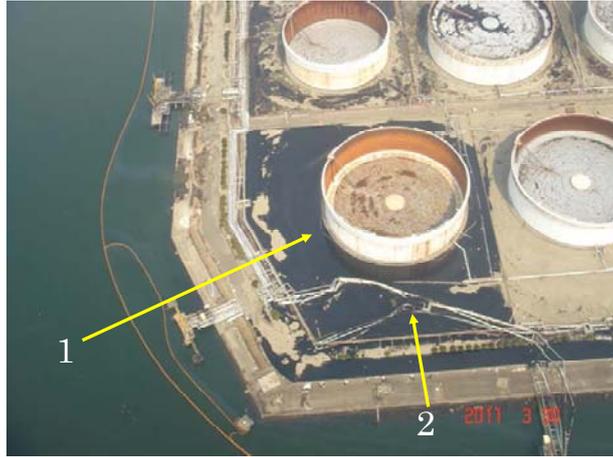
Fig.2 shows the heavy oil spill in the dike. The tank indicated as #1 in Fig.2 is empty when the tsunami attacked, and submerged into the sea water up to 3.5m high from the bottom plate. The tank did not uplift nor displace even though it was empty. Many pipelines have been bent at the #2 in Fig.2 and the large amount of oil leaked from the pipelines spilled all over the dike and the road beside. These pipelines presumably washed away by the tsunami. The largest fracture was found at an elbow in one of the heavy oil pipelines. Its length is approximately 10cm and its width is approximately 3cm.

**Figure 2.** Heavy oil spilled in the dike

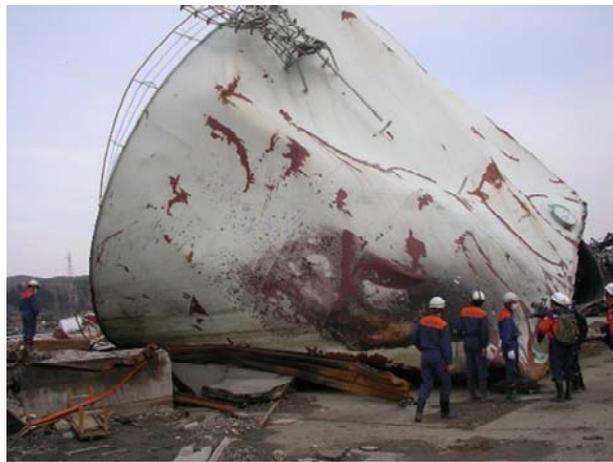
In Kesen’numa city, 22 out of 23 above ground oil storage tanks were washed away by the tsunami. The local fire authority announced that the total amount of oil flowed out of the oil storage tanks were assumed to be 11,721 kL and oil types are heavy oil, kerosene, diesel fuel and gasoline. Fig.3 shows an oil storage tank which was drifted and collapsed by the tsunami. It is reported that the large fires occurred in Kesen’numa city. It is not clear whether oil spill from destroyed tanks related to these fires or not.

**Figure 3.** Oil storage tank drifted and collapsed by the tsunami

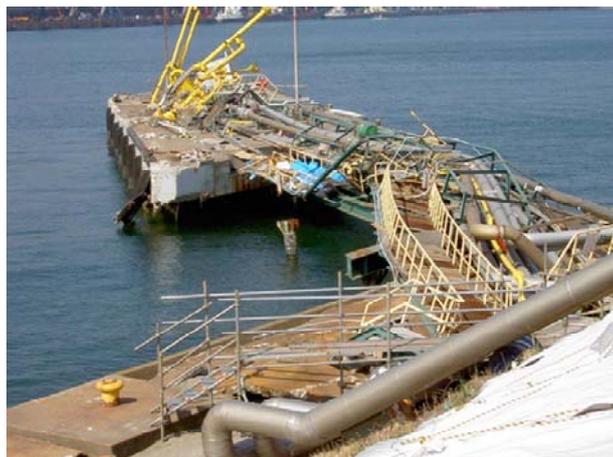
In Kashima area, a sea bank and berths were damaged by the tsunami of more than 6m high. The berth shown in Fig.4 was struck and collapsed by a drifted ship.

**Figure 4.** Berth collapsed by a ship strike

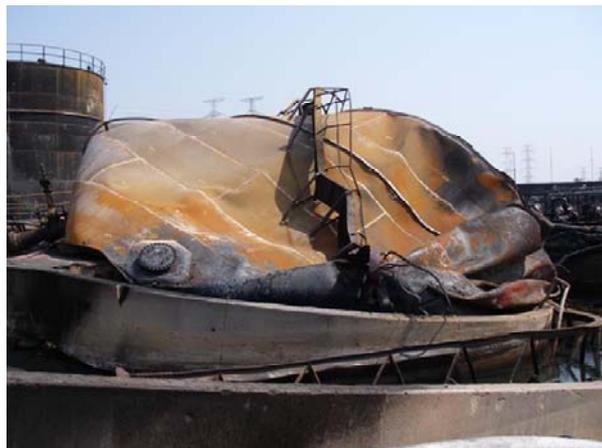
Fires occurred at a refinery in a petrochemical complex in Sendai area. Fig.5 shows a section of the refinery that was burnt out completely by the fires. There were a gasoline tank, asphalt tanks, molten sulfur tanks and oil handling facilities in the burned-out section. Fig.6 shows a burned-out gasoline tank. It seems that the tank inclined to the Pacific Ocean after the tsunami strike and it collapsed due to the fire. The soil of the dike and the foundation were washed away by the tsunami. The welded part of the gasoline tank between the shell plate and the bottom plate fractured along approximately 2.4m.

**Figure 6.** Burned-out gasoline tank

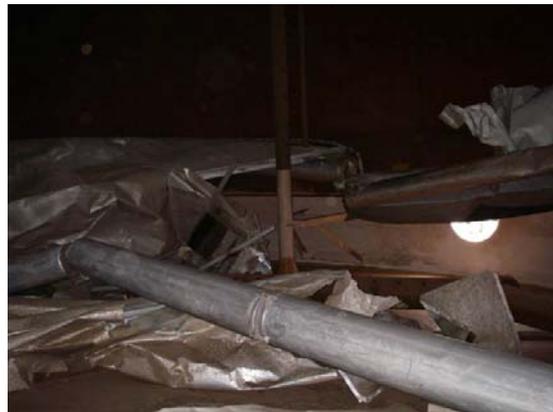
In Sakata city which locates on the thick sediment layers more than several km, the aluminum inner floating roof of gasoline tank was broken completely as shown in Fig.10. The length of broken float tube is about 6.7m and its diameter is 25.4cm. The velocity response at the site is about 200cm/s at the natural sloshing period of 4.19sec for the tank. The maximum sloshing height is calculated as 202cm by the 2-D response analysis. In addition, the frequency of more than 50% of maximum response, that is, sloshing height of 1m, is 73 from the sloshing response analysis using the one hour ground motion record. The cause of failure of the roof is considered as the large and frequent liquid sloshing, and also the situation of the inner floating roof fulfills the unsafe conditions proposed by FDMA (2011b), that is, (a) Sv is more than 100cm/s, (b) diameter is less than 30m, and (c) length of float tube is more than 6m.

**Figure 10.** Aluminum inner floating roof of gasoline tank completely broken in Sakata area

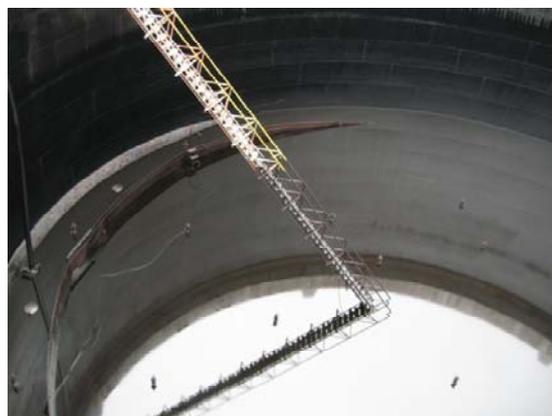
In Kawasaki city, floating roof of heavy oil tank completely sank three days after the earthquake as shown in Fig.11. According to the regulation, this tank's roof should be reinforced by 2029, but not conducted yet. The cause of sinking is considered as the inadequate buoyancy by failure of the pontoons due to the liquid sloshing. According to our observation near the tank, Sv is, however, 75cm/s at the natural sloshing period of 7.8s of the tank as shown in Fig.12, and the estimated sloshing wave height is no more than 1.0m. As the liquid sloshing of the tank is seemed to be too small to explain the failure of the pontoons based on the technical standard of the Fire Service Law, a rational explanation is required.

**Figure 11.** Sinking of floating roof

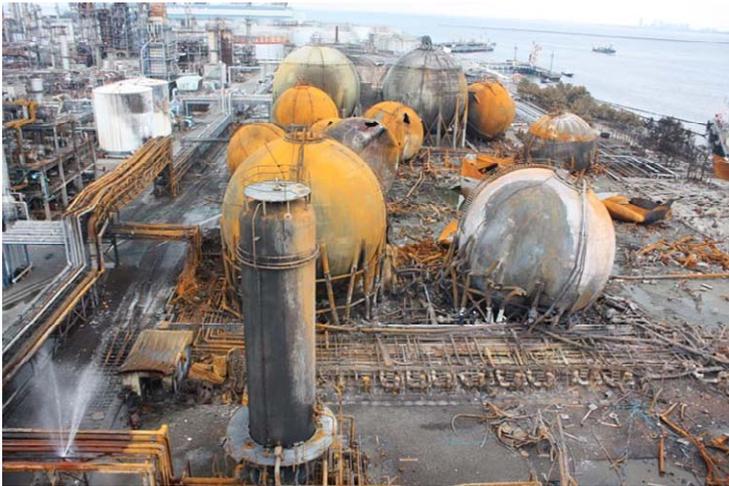
On the other hand, an LPG spherical tank collapsed due to the strong ground motions and fires and explosions with fire balls occurred at the LPG tank site as shown in Fig.14 in Ichihara city which locates on the eastern shore along the Tokyo bay. It took ten days to extinguish fires. The diameter of

the largest fire ball in the explosions is about 600m judging from the height of the plant extractor stack pipe. Many fragments of the LPG tanks scattered in the explosions, therefore the fire spread to the asphalt tanks, the control room and the neighboring factory. Furthermore, sheet metals flew several km to the adjacent inhabited areas, and the evacuation order to inhabitants near the tank site was issued by the mayor of Ichihara city.

According to the accident analysis report (Cosmo Oil Group, 2011), the processes to the outbreak of the fires and explosions in LPG tanks are considered that (1) braces of the tank filled with water for the inspection were cut off by the main shock, (2) the tank fell down onto and destroyed the gas pipes by the largest aftershock (M7.7), (3) the leaked LPG diffused and ignited for any reasons, and (4) BLEVE (Boiling Liquid Expanding Vapor Explosion) broke out finally.

**Figure 14.** Burned and exploded LPG tanks at Ichihara

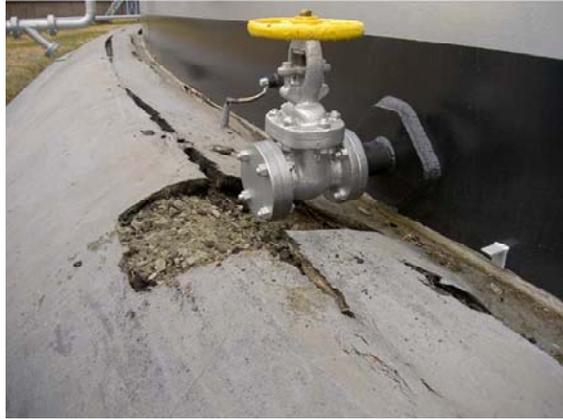
In Iwaki city along the Pacific coast, there was damage due to liquefaction caused by strong ground motions as shown in Fig.15, which was recorded at the Onahama Port observatory near the tank site operated by Port and Airport Research Institute. PGA is  $1533.8\text{cm/s}^2$  and the cyclic mobility can be seen as phenomenon of strong non-linearity. Fig.16 indicates the situation of settlement of oil storage tank. The valve of the tank slightly contact to the ground, therefore the asphalt of the scarcement was removed in order to avoid the failure of the neck of the nozzle in the further settlement due to the future earthquakes. Furthermore, the center part of bottom plate was relatively uplifted about 50cm high owing to the lateral flow of neighboring soil of the tank, and the welding area of the bottom plate cracked and oil leaked.

**Figure 16.** Tank settlement due to the liquefaction around the foundation

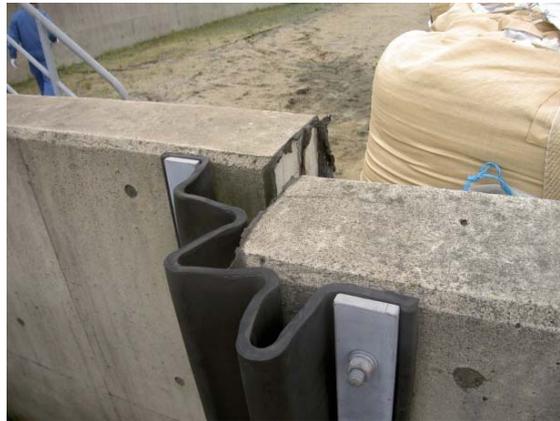
In Kashima area, the wall of the dike settled and inclined because of liquefaction. As shown in Fig.17, fractures of joints of the dikes were found in some walls. Some of them have rubber sheets protection in order to maintain its function in case of joint fracture. Some rubber sheets were torn and lost its function of retaining oil inside the dike.

**Figure 17.** Fracture of wall joint of the dike with rubber sheet protection
