# URBAN EARTHQUAKE DAMAGE ASSESSMENT AND RECONSTRUCTION: 2010 HAITI EARTHQUAKE

**H. Kit Miyamoto and Amir SJ Gilani**

*Miyamoto International, Sacramento, CA, USA*

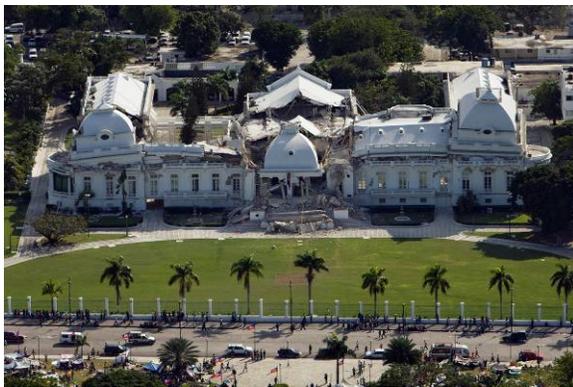
The 2010 earthquake caused significant damage to Port-au-Prince and other cities in the region. More than 200,000 structures were damaged or had collapsed, including many essential buildings, such as the Presidential Palace (see Figure 1), and the headquarters of the United Nations Stabilization Mission in Haiti (MINUSTAH) also collapsed (see Figure 2), killing many, including the mission's chief.

**Figure 1.** Damaged Presidential Palace in Port-au-Prince (UNDP Global 2010).

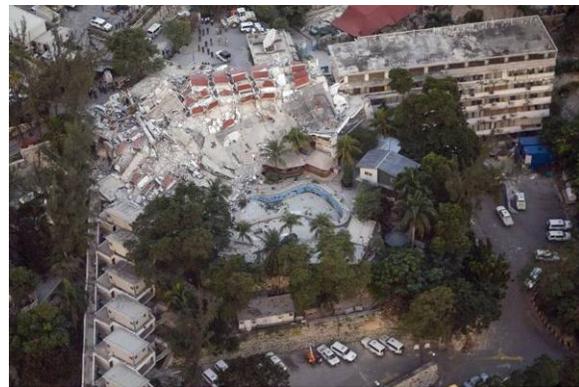
**Figure 2.** Collapsed UN building in Port-au-Prince (UNDP Global 2010).

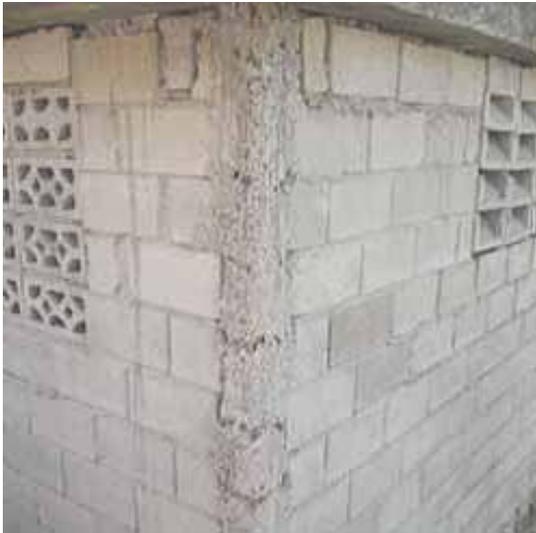
Concrete gravity frames display numerous design and construction practices that would be considered defective. Figure 3 shows some of the common seismic deficiencies. Design defects include the following: a) inadequate column size, b) insufficient amount of longitudinal reinforcement, c) use of smooth reinforcing bars, d) lack of column confinement reinforcing, and e) inadequate lap splices and rebar development length. Construction defects consist of the following: a) segregation, voids, and rock pockets evident in finished concrete, particularly in columns and at construction joints, b) exposed rebar and poor aggregate shape and grading, c) poorly located construction joints, and paper and other debris left in joints; formwork embedded in finished concrete, and d) out-of-plumb columns

poor concrete consolidation

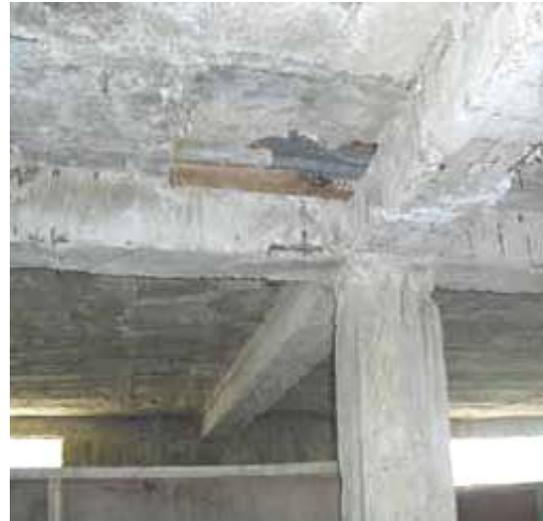
embedded formwork and exposed reinforcing

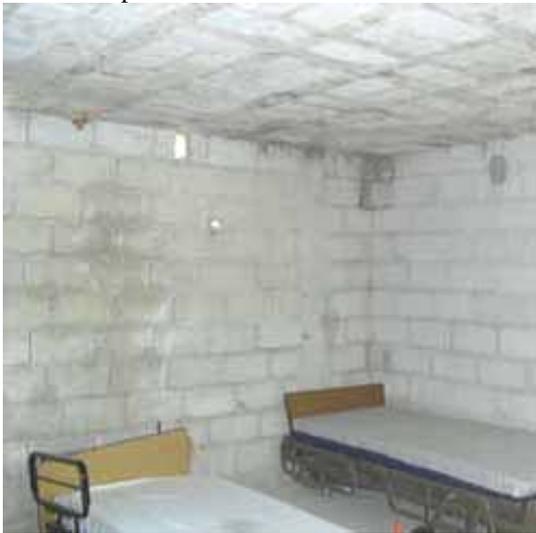
Typical masonry construction also has numerous defects, including irregular coursing, missing or inadequate vertical mortar joints, inadequate horizontal joints, poor material quality, and extensive use of broken block. These conditions were commonly found in nearly all the buildings, regardless of age, size, or number of stories. These design and construction practices led to a combination of heavy buildings with little lateral strength and essentially no post-yielding capacity, and were key factors in the vast majority of failures observed.

poor workmanship in unreinforced HCB wall

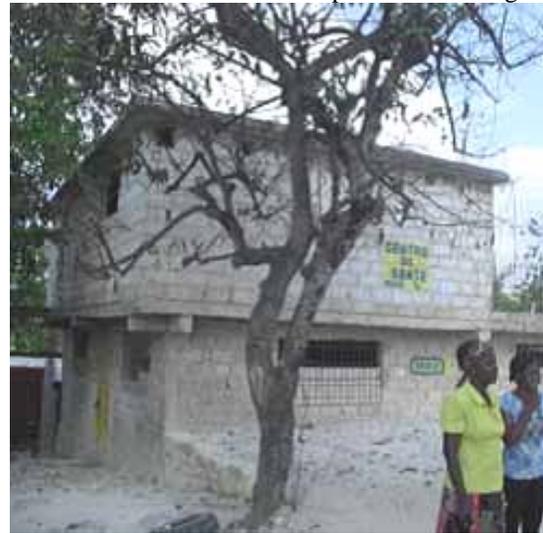
building with overhanging upper floor.

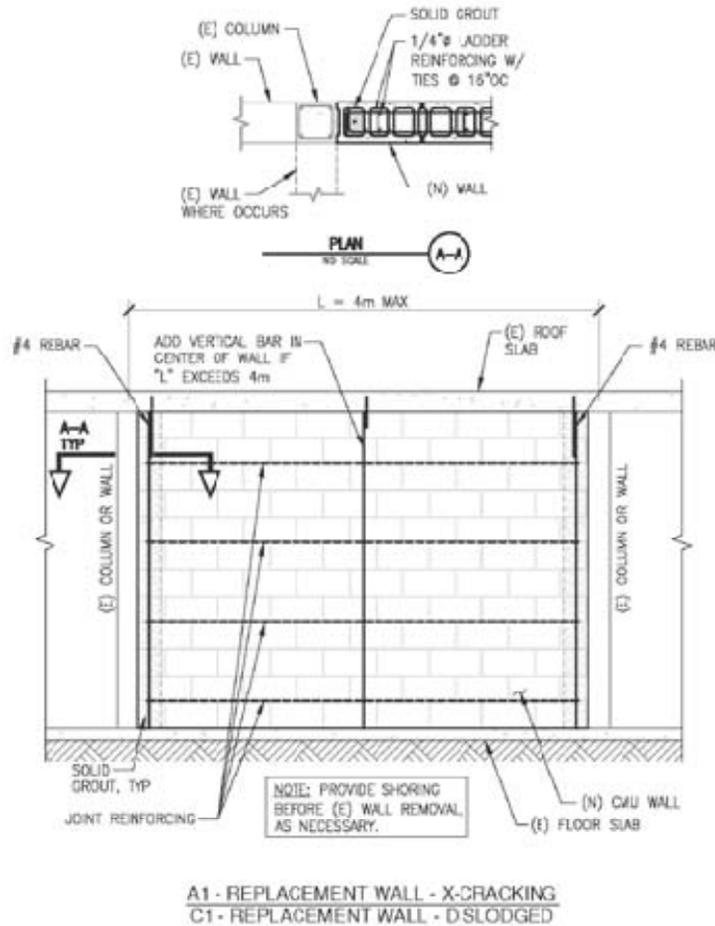
of paper through or see light from outside) cracks, which occur through the plaster and the entire width of the concrete block. The walls with major diagonal cracks require complete replacement of the wall because they have lost much of their lateral load carrying capacity. Their repair falls into three categories: Repair A1 (see Figure 6) for walls without windows. For walls with window opening a slightly different repair is used.

**Figure 6.** Repair A1, Replace Solid Wall
