Msila Algeria Earthquake Of May 14, 2010: Main Features And Building Damage Analysis

Belazougui Mohamed

*Director of the Centre National de Recherche Appliquée en Génie Parasismique,
CGS, Algiers, Algeria*

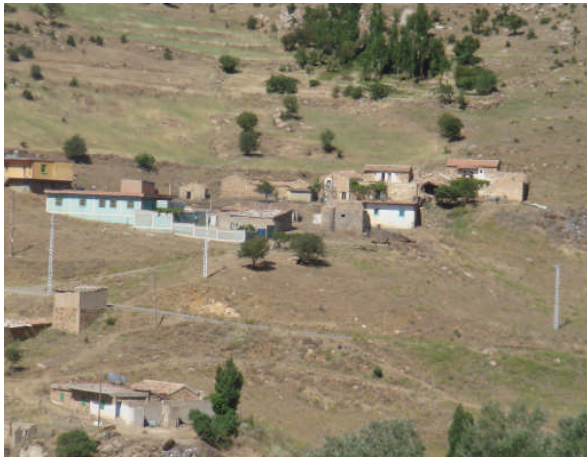
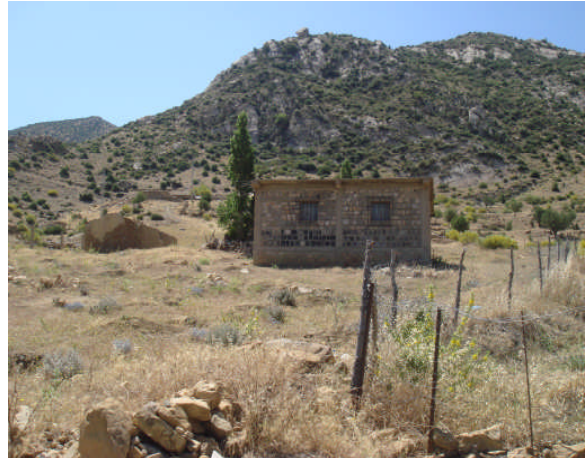
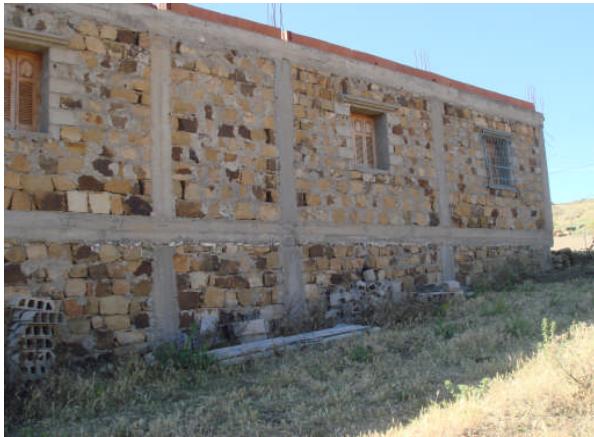
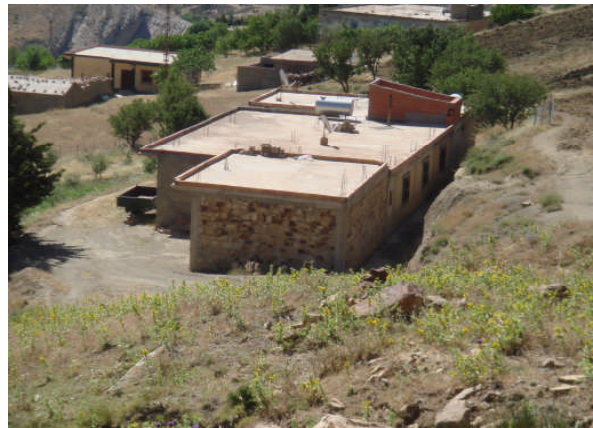
- Traditional non confined (or non tied) bearing masonry structures (in rural and urban areas) (Figure 4.2)
- Short columns in « vides sanitaires » (crawl spaces under the first story) and between upper windows of classrooms or, sometimes, in other configurations (Figure 4.3)

Figure 4.2. Confined bearing masonry structures (one school and three houses) that behave very well.

- Apply more strictly the Algerian earthquake resistant regulations (“RPA 99/2003”) and the other building codes in force
- Promote at maximum possible use of confined stone bearing masonry that showed a very good behavior during this event.
- Perform and promote more training and better organization of the building staff and professions to improve quality in design and execution.

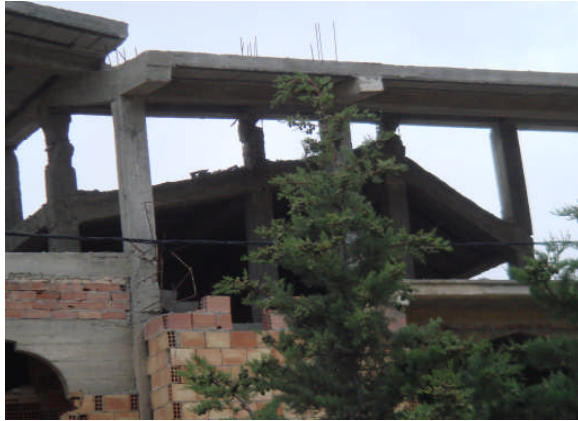
Figure 4.3. Short columns

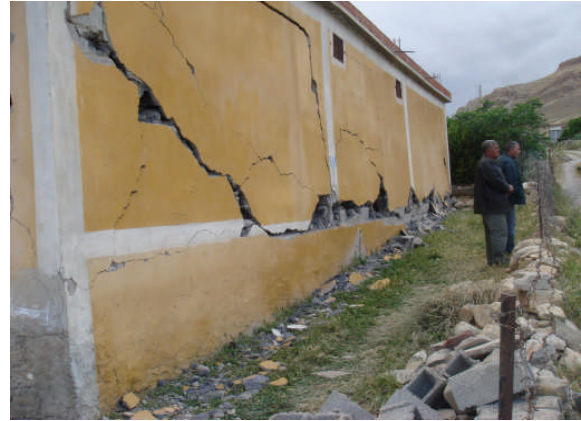
- Use of irregular building configurations with severe discontinuities in mass, stiffness, strength, and ductility resulting in torsional effects and stress concentration (Figure 4.4)

Figure 4.4. Vertical dissymmetry and poor quality of execution

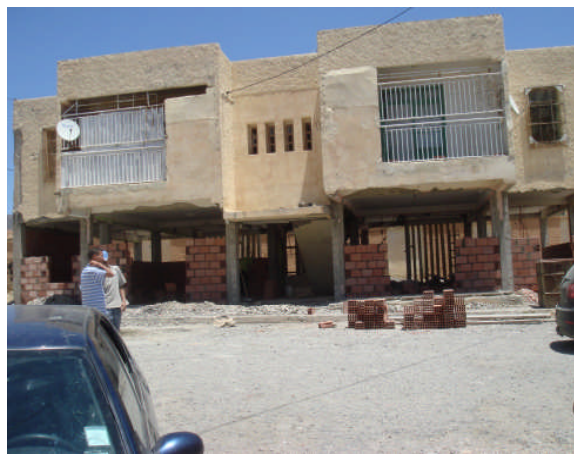
- Presence of soft stories, generally at the ground zero (first story) used as car parking or stores, with lack of infill and/or height greater than for upper stories (Figure 4.5)

Figure 4.5. Soft story (Classroom at the 1st story under rigid apartment 2nd story)

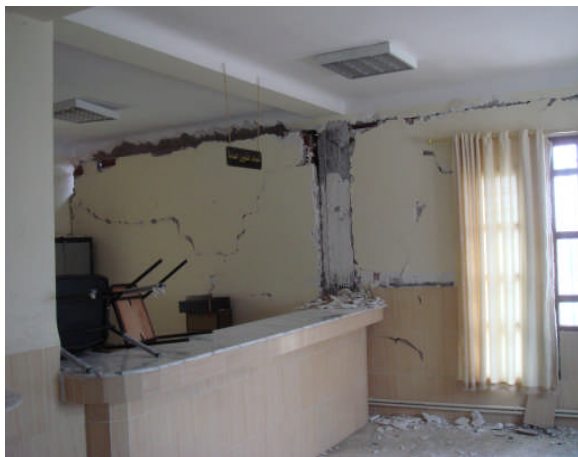
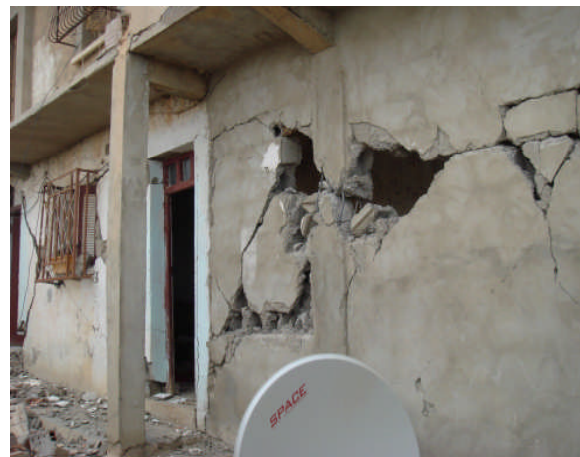
- Use of very heavy roofs
- Use of "strong girders / weak columns" and masonry-structure interaction (Figure 4.6)
- Use of important and heavy cantilevers

Figure 4.6. Masonry-structure interaction and bad quality of design and execution

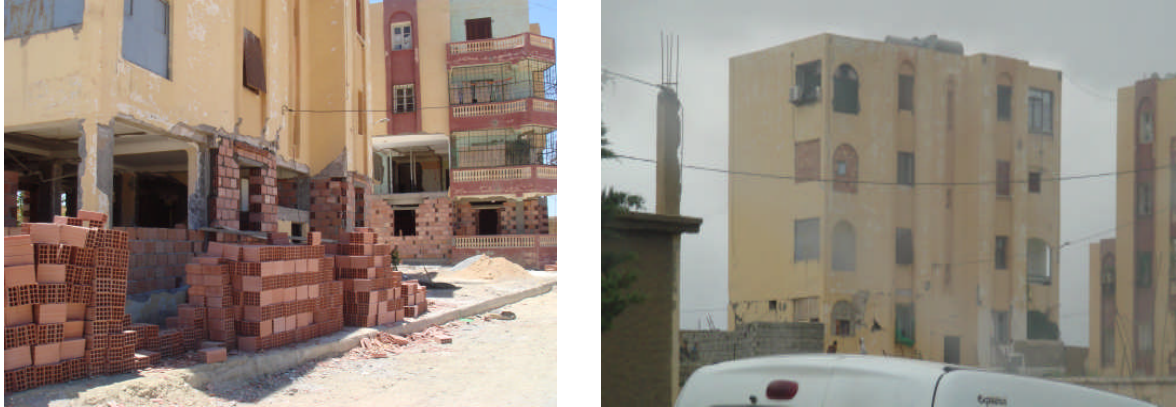
This is the case of all the buildings aged before 1981 or the great majority of individual or private houses built after 1980 (more than 60% of the new built environment) (Figure 4.7).

Figure 4.7. Under-dimensioning

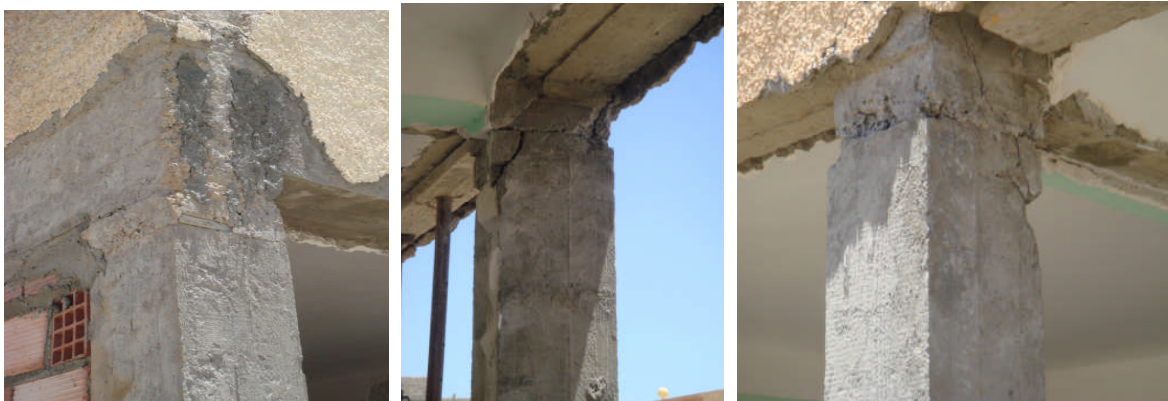
In this framework we can note the very low strength of concrete checked in the field (generally less than 20 MPA instead of 25 MPA required by the standards for current buildings) and the very inadequate recastings of concrete in columns at the beam-column joints (Figure 4.8).

Figure 4.8. Poor quality of execution and inadequate concrete recasting

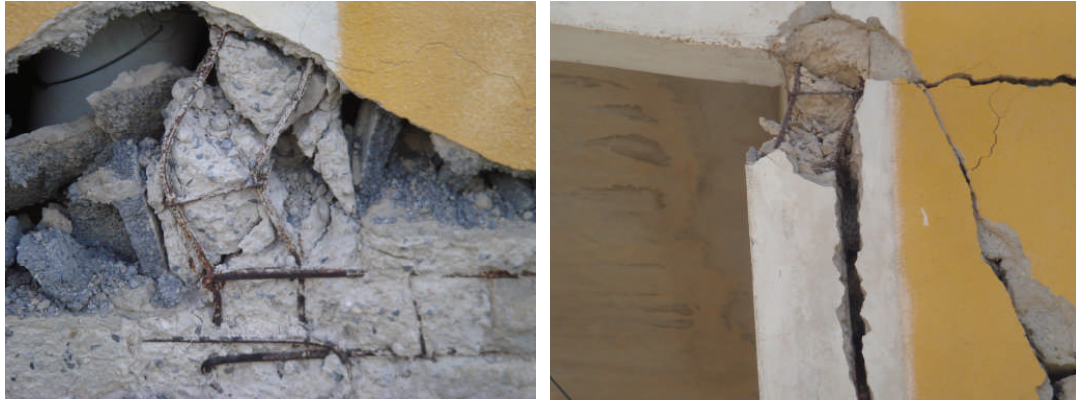
In this framework, we can mention the lack of transverse reinforcement in the core of reinforced concrete beam-column joints (no confinement) or great distance between these transverse reinforcement (insufficient confinement in the remaining of joint area).

Figure 4.9. Inadequate proportioning and detailing of structural elements
