# Performance of RC Buildings along Hill Slopes of Himalayas during 2011 Sikkim Earthquake

**A.R. Vijaya Narayanan, Rupen Goswami and C.V.R. Murty**

*Indian Institute of Technology Madras, Chennai, India*

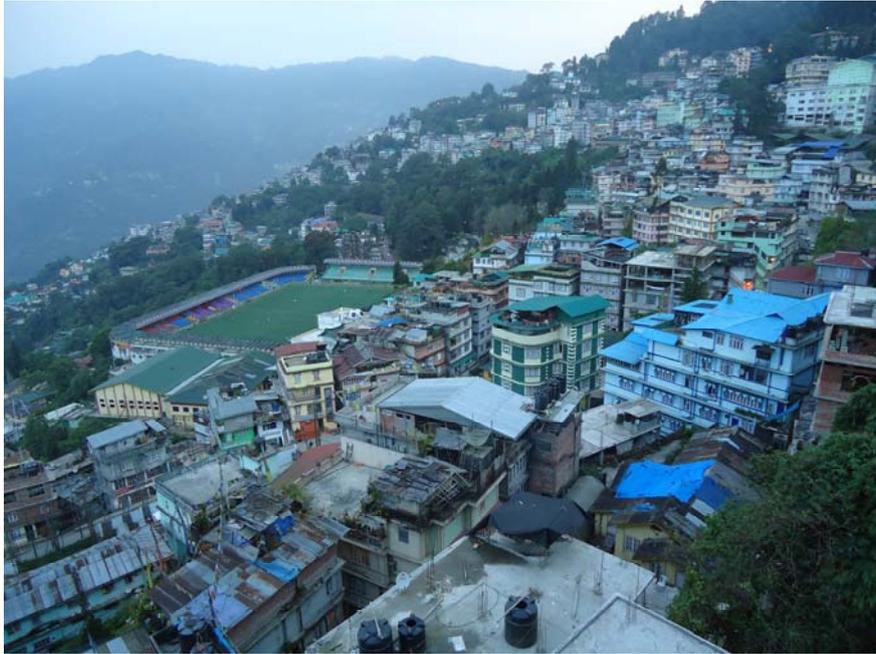
**Figure 1.1** Skyline of Gangtok city covered with RC frame buildings in hill slopes built in last 10-15 years with no techno-legal regime in place

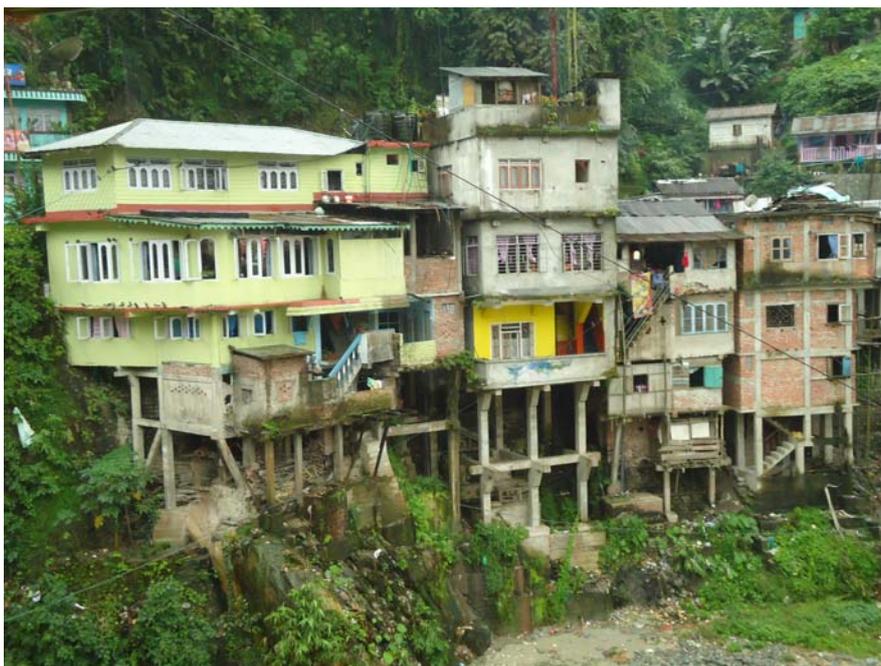
**Figure 1.2** Housing sprawl along the Teesta river side made of reinforced concrete frames, that lack many desirable features necessary to be called earthquake resistant

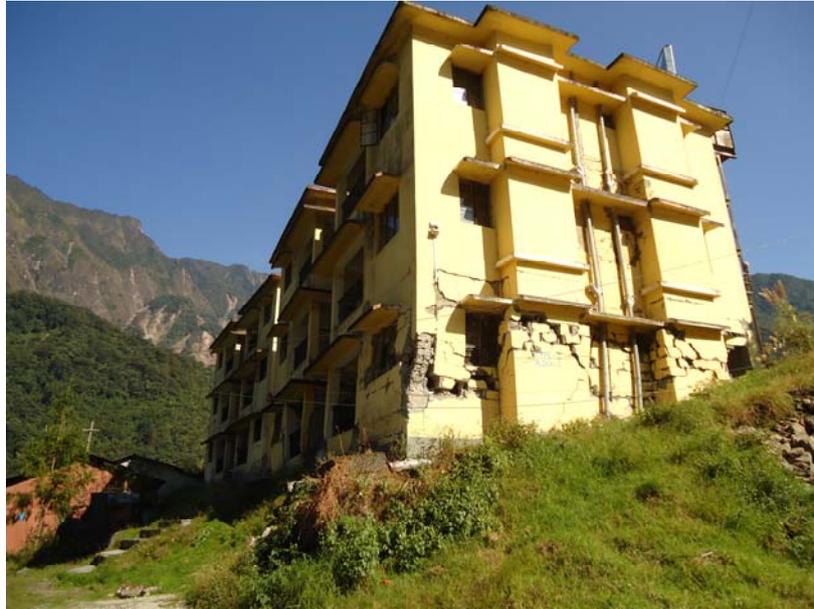
During the 2011 Sikkim earthquake, many buildings were shaken severely and some even collapsed. For instance, the government owned ITBP campus building near Chungthang sustained large inelastic deformations in the lowest storey, even though the hill slope was shallow (Figure 2.1). Typical individual homes are small and are of single storey, with frame columns spreading along the hill slope

**Figure 2.1** Building by government on shallow slope constructed near Chungthang, North Sikkim, was severely shaking in the first storey during 2011 Sikkim Earthquake. RC corner column is well confined and severely distorted

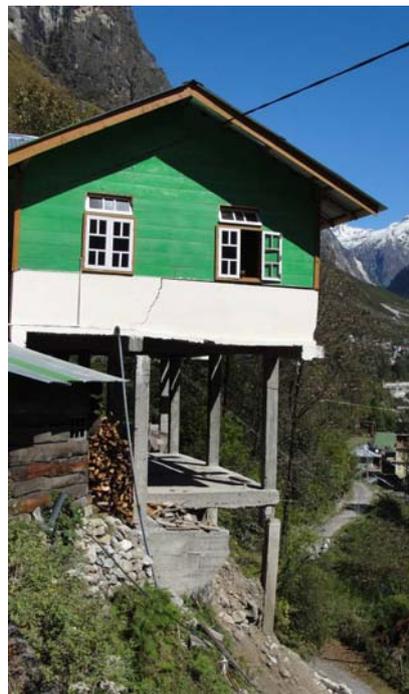
(Figure 2.2); even in these small building, severe damage was noticed, but this is largely attributed to poor quality of construction. In large RC buildings of 7-9 storeys along hill slopes, the common practice of completely removing masonry infill walls between the columns and providing half-brick infills on the cantilever slabs have caused significant damage. In one instance in Gangtok, there was severe damage, but no collapse (Figure 2.3). But, in another instance, three intermediate storeys collapsed (Figure 2.4a). One three storey building on hill slopes of Gangtok collapsed again due to insufficient lateral capacity to resist ground shaking (Figure 2.4b); the recorded PGA value in Gangtok was only around 0.15g [Murty *et al*, 2012].

**Figure 2.2** RC frame supports of RC frame buildings on hill slopes are not designed with the basic effects to withstand even small as was noted during the 18September 2011 earthquake

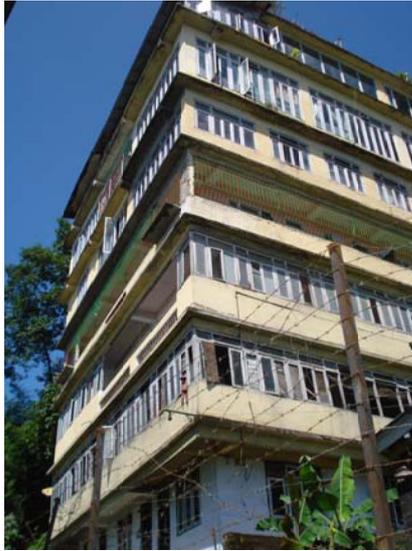
**Figure 2.3** (a) 7-storey Himachuli Building at Zero Point in Gangtok, and (b) It sustained compression failure of columns in intermediate open storey of the building at level 3 from the base

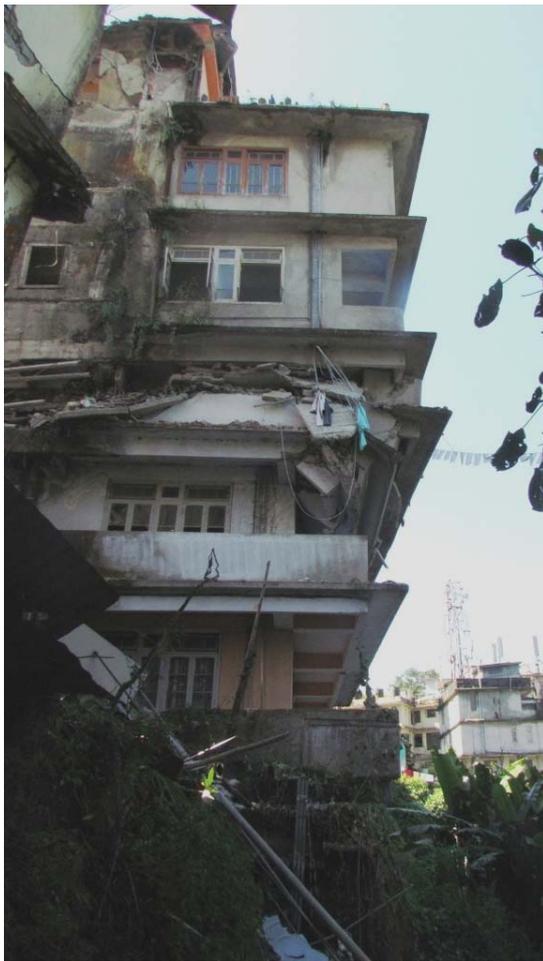
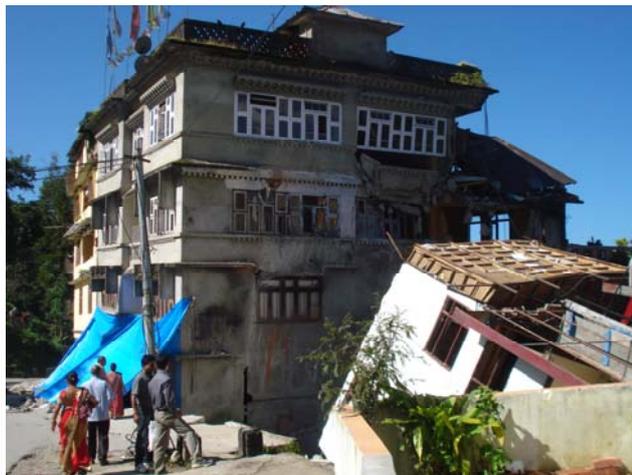
**Figure 2.4** Buildings on slope collapsed during 2011 Sikkim Earthquake: (a) Collapse of intermediate storeys of Dzongpo House in Gangtok, and (b) Adjoining 3-storey building also collapsed

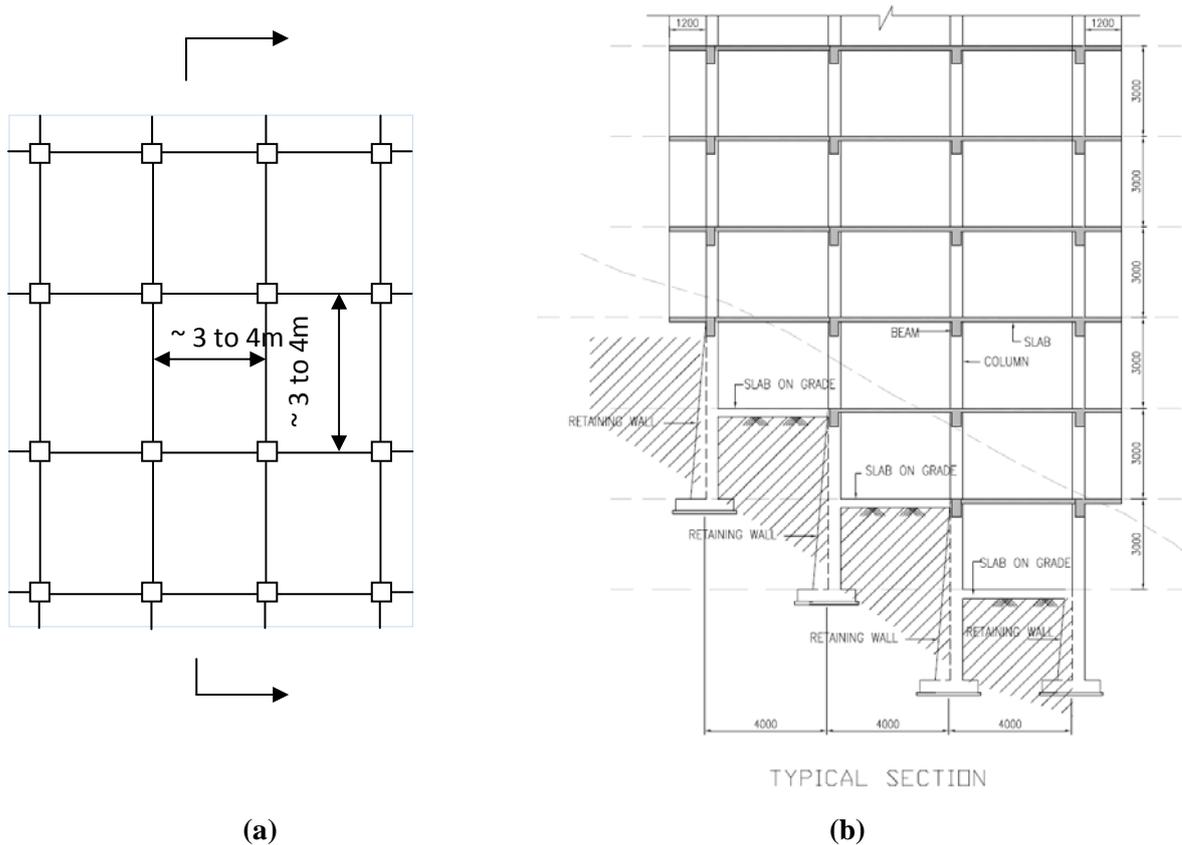
Majority of the buildings, in and around Gangtok (India), are observed to be constructed on slopes. Typical features of these buildings (Figure 3.1) include *columns of unequal lengths along the slope*, and *lack of proper foundation well embedded into the soil underneath* to provide adequate translational fixity under lateral earthquake shaking. Two basic types of fixity conditions are achieved depending on construction type and local soil/rock strata – one that provides *full translational and rotational restraints*, and the other does not. Lack of translational and rotational fixity occurs due to creep or subsidence of flexible soil along hill slope. Actual degree of fixity (translational and rotational) varies.

**Figure 3.1** Typical RC frame building along hill slopes (a) building plan, and (b) and sectional elevation [Courtesy: Alpa Sheth, Mumbai]

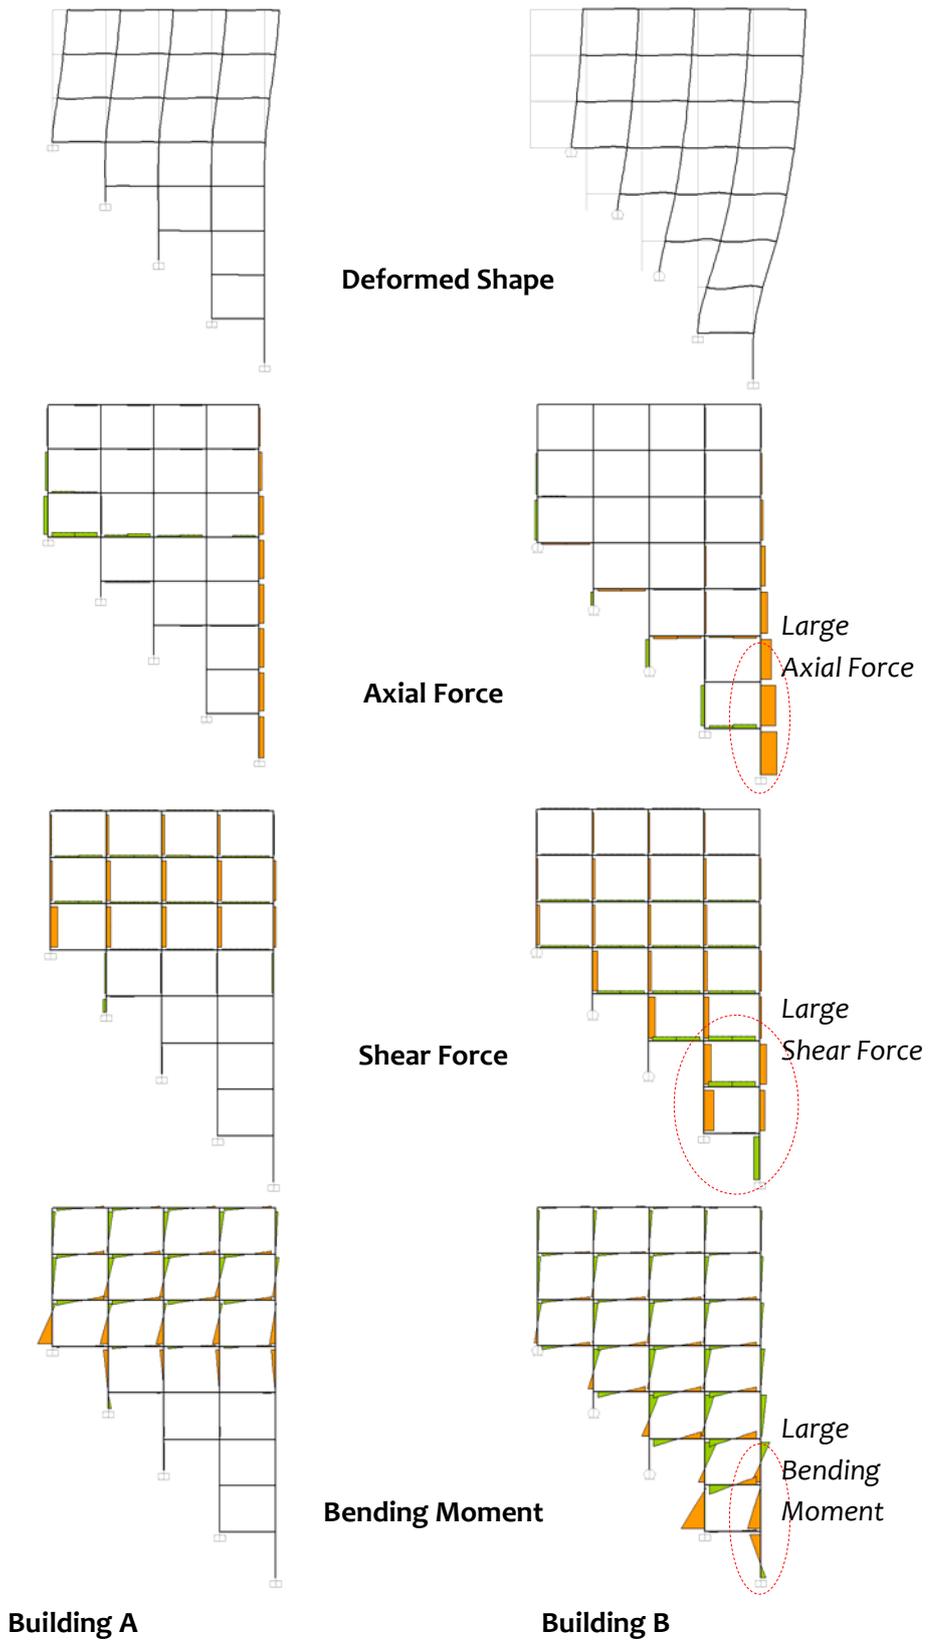
Comparison of deformed shapes, and axial forces, shear forces and bending moments in members of these two possible buildings A and B under strong lateral force (Figure 3.3) suggests revealing information along VALLEY direction. Under small intensity of shaking, the lateral deformation is concentrated only in the portion of the building *ABOVE the uppermost support* (as in Building A), and cause predominantly large axial force in the valley-side columns below the ground level. This additional axial force, along with the existing gravity load, can cause compression failure of these columns, as observed during the 2011 Sikkim Earthquake (Figure 2.3). Under strong shaking, most column bases loose contact with the soil and cause large axial force, shear force and bending moment in columns, particularly in those *BELOW the uppermost support* (as in Building B), and is likely to cause catastrophic collapse of buildings under combined action of axial force, shear force and bending moment. Further, stability of such buildings is jeopardized by slope instability that can be triggered by ground shaking of strong intensity. The situation is slightly different in the outer frames along the ROAD direction. Amplification is seen only in axial force, but not in shear forces and bending moments (Figure 3.4).

**Figure 3.3** Deformed Shape, Axial Force, Shear Force and Bending Moment Diagram for Building A and Building B subjected to lateral load; the frames shown are along VALLEY direction

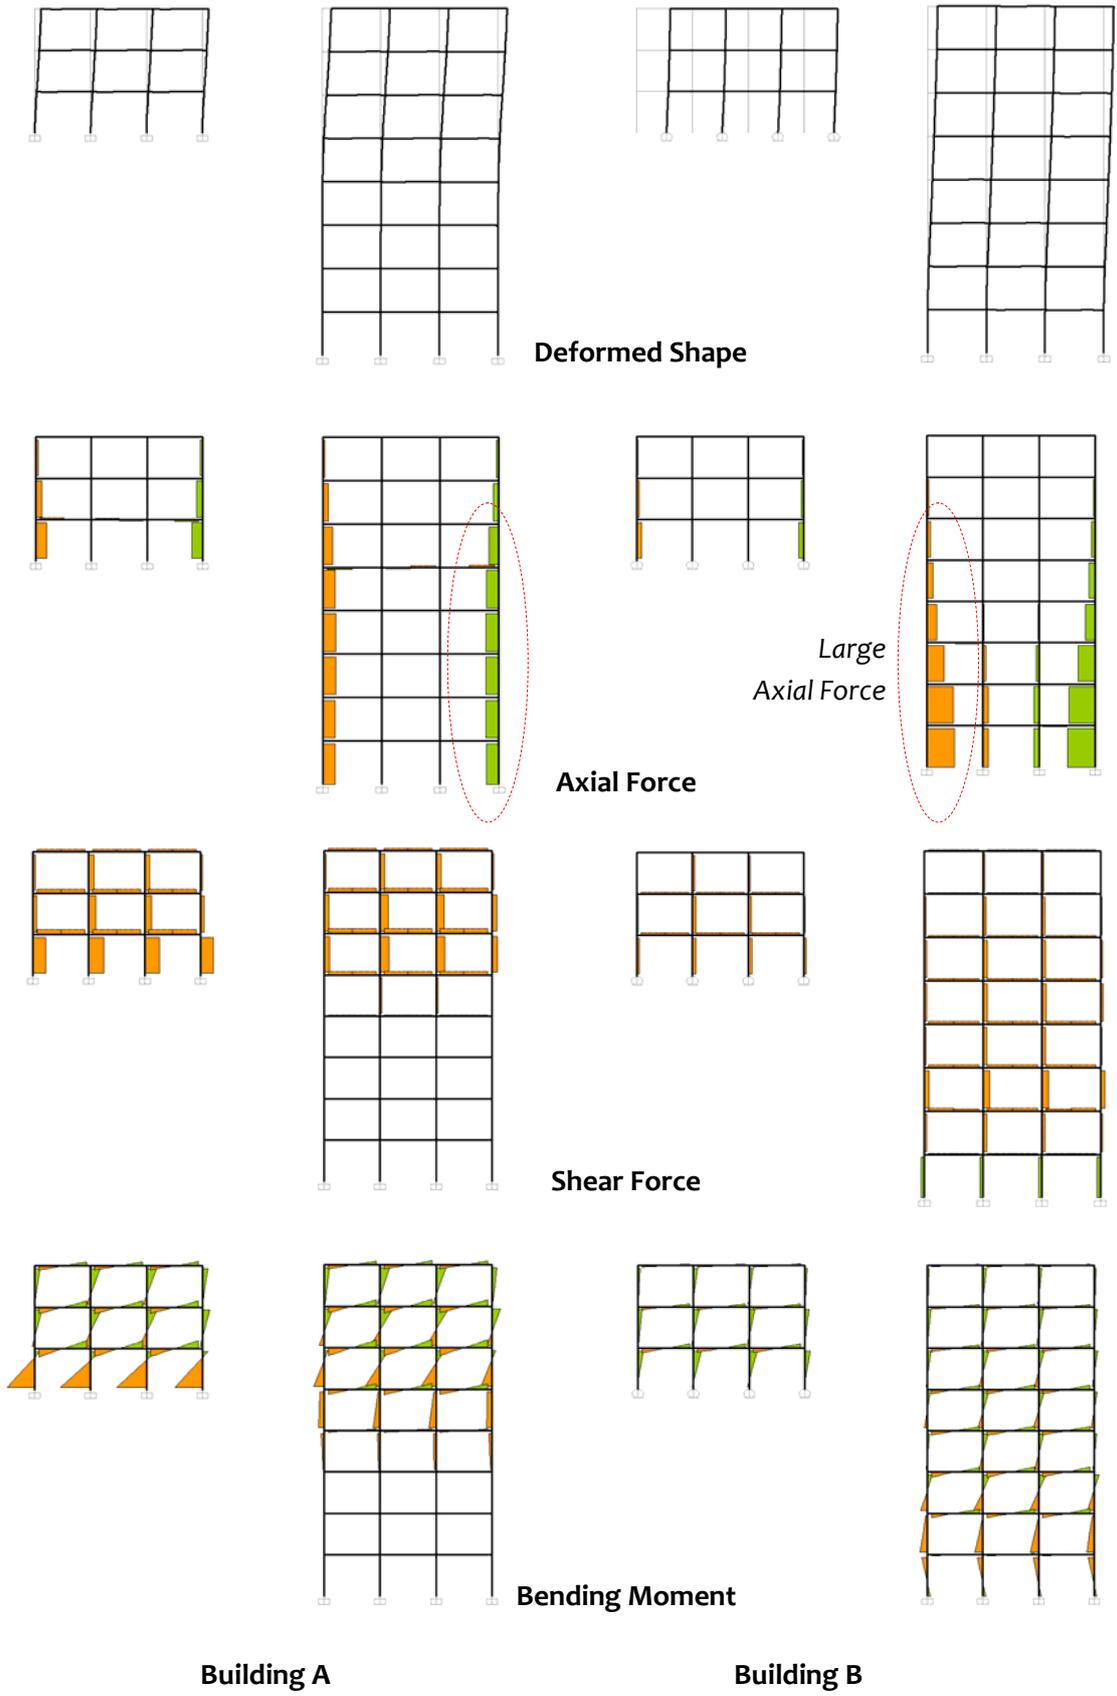
**Figure 3.4** Deformed Shape, Axial Force, Shear Force and Bending Moment Diagram for Building A and Building B subjected to lateral load; the frames shown are along ROAD direction

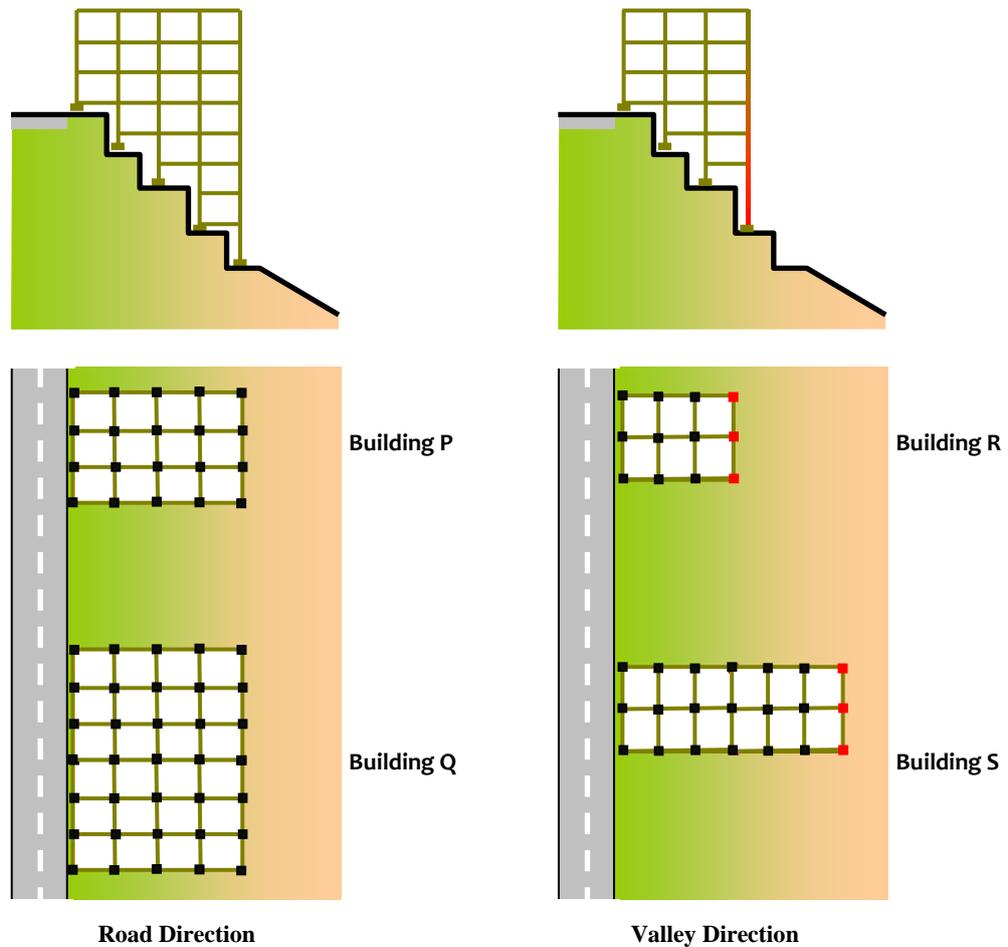
Detailed analyses of RC frame buildings on hill slopes (Figure 3.5) indicate that

- (a) Buildings that have short plan length (Building P) along ROAD direction perform better than those that of long length (Building Q); and
- (b) Buildings that have short plan length (Building R) along VALLEY direction perform better than those that of long length (Building S).

**Figure 3.5** Deformed Shape, Axial Force, Shear Force and Bending Moment Diagram for Building A and Building B subjected to lateral load; the frames shown are along ROAD direction
