Field Test of Damaged Building Structures in China

Yushu Ms7.1 Earthquake

Junwu DAI, Yongqiang YANG and Haibo WANG

Key Laboratory of Earthquake Engineering and Engineering Vibration, China Earthquake Administration, China

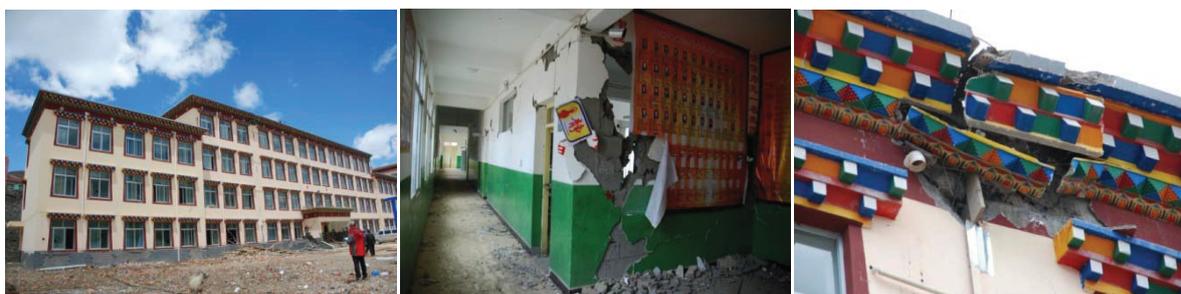
a) overview

b) wall damage in 1st story

c) roof colliding

Figure 1. Typical damage of a 4-story LCBCM school building

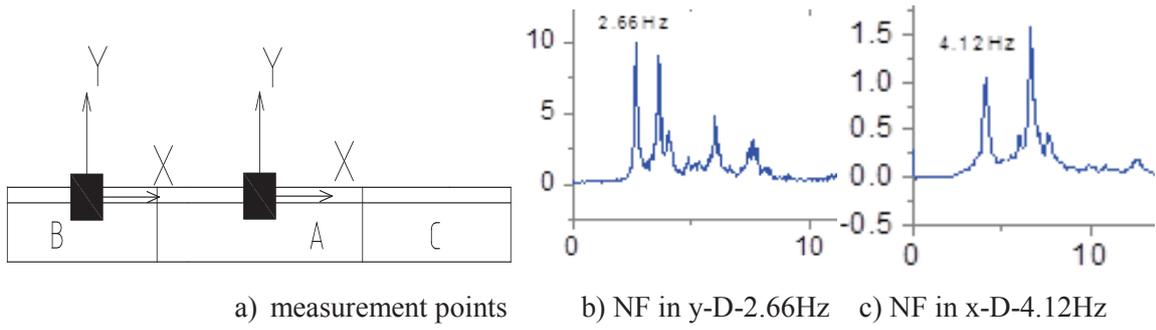
Figure 2. Natural frequency test for the seismic damaged LCBCM school building

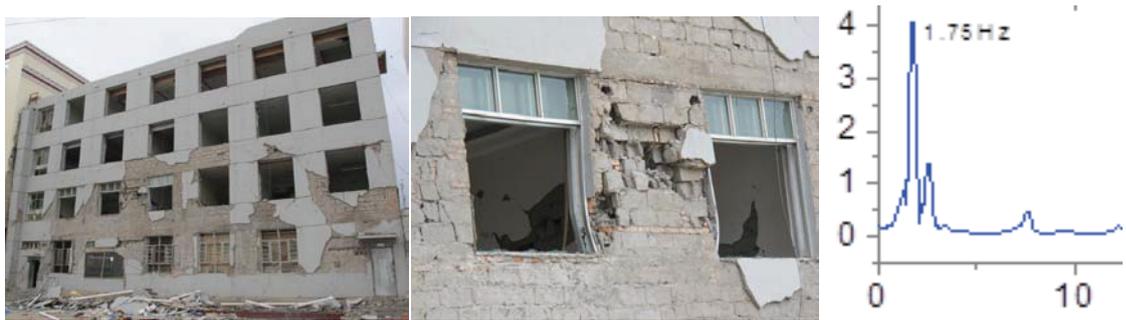
Figure 3. Seismic damage of a 4-story LCBCM office building and its' NF (1.75 Hz) tested

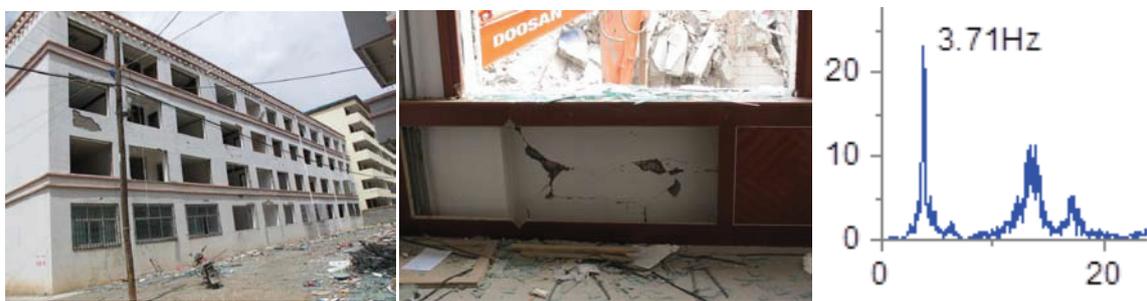
a) overview b) damage of wall under window c) NF tested (3.71Hz)

Figure 4. Typical damage of a 4-story LCBCM residential building and its' NF (3.71 Hz) tested

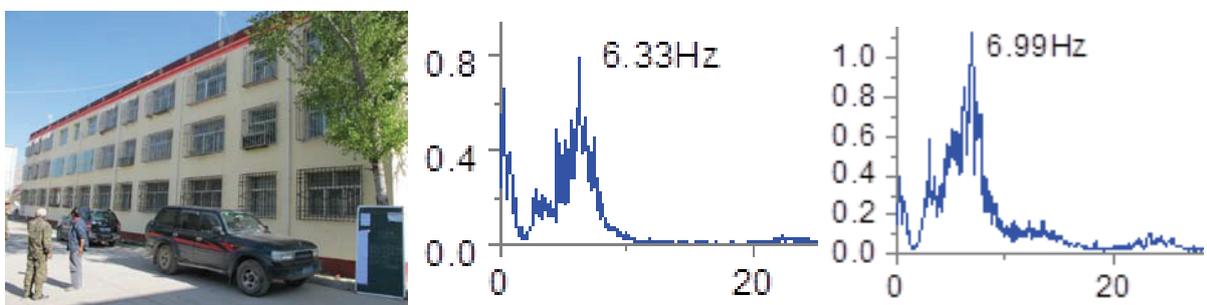
Figure 5. A 3-story LCBCM residential building without any damage and its' NF (6.33Hz) tested

From the natural frequency (NF) test results, shown in fig.1~5, it can be seen that the natural frequency changes with the damage severity happened to the structural walls. For the 3-story LCBCM residential building without any damage in the Yushu earthquake shown in fig.5, the NF along its' 2 main structural axes is 6.33Hz and 6.99HZ respectively, for the same type of 4-story LCBCM office building shown in fig.3, the NF value decreases to only about 1.75Hz due to the severe damage in the 2nd story walls without enough confine measurements. For after earthquake retrofitting design, it could be useful to help engineer evaluate the structural status.

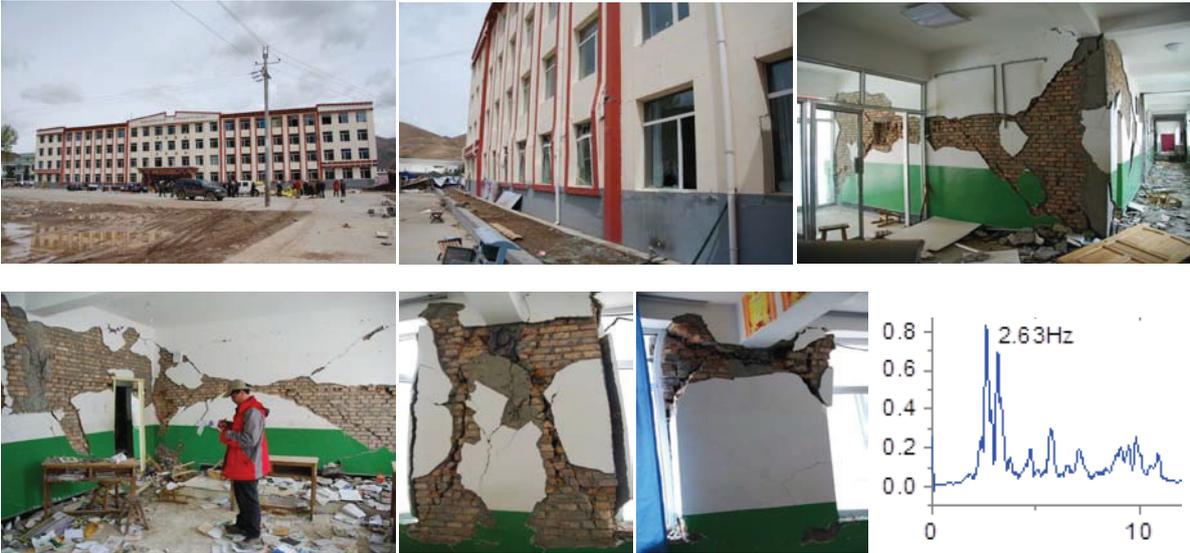
Figure 6. Typical damage of a 4-story CBCM school building and its' NF (2.63Hz) tested

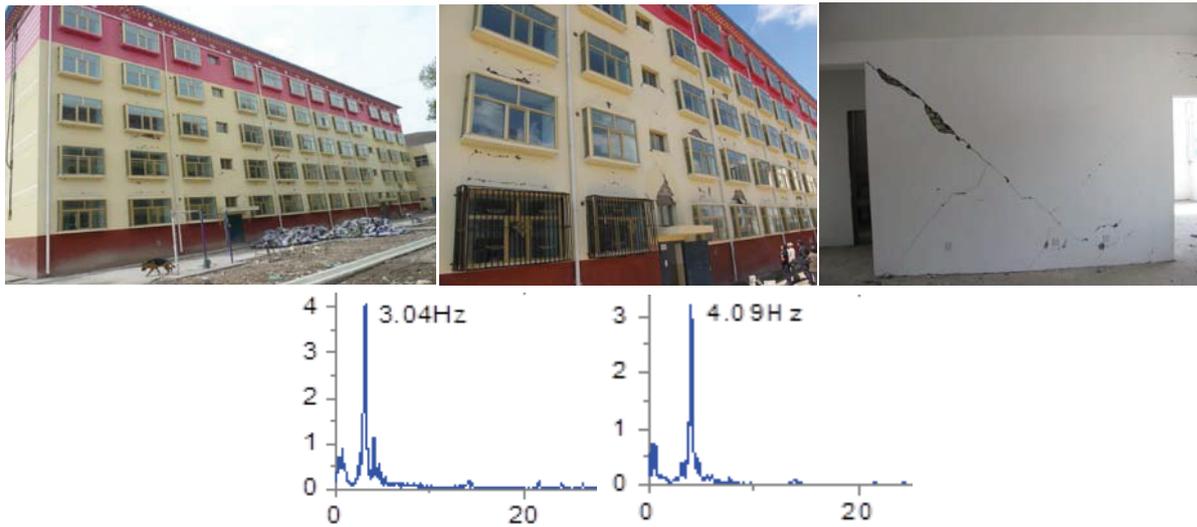
Figure 7. Typical damage of a 5-story CBCM residential building and its' NF (3.04Hz/4.09Hz) tested

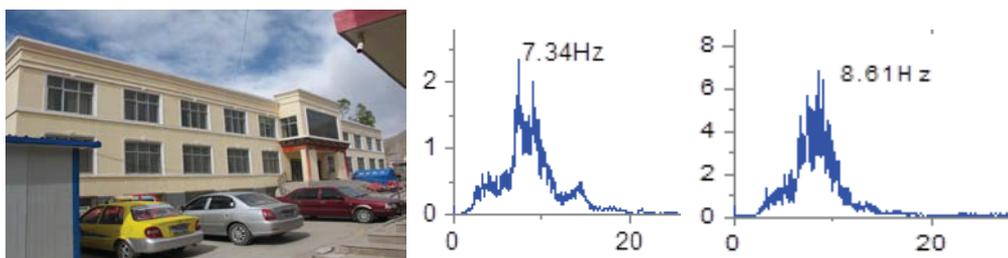
Figure 8. A 2-story CBCM residential building without damage and its' NF (7.34Hz/8.61Hz) tested

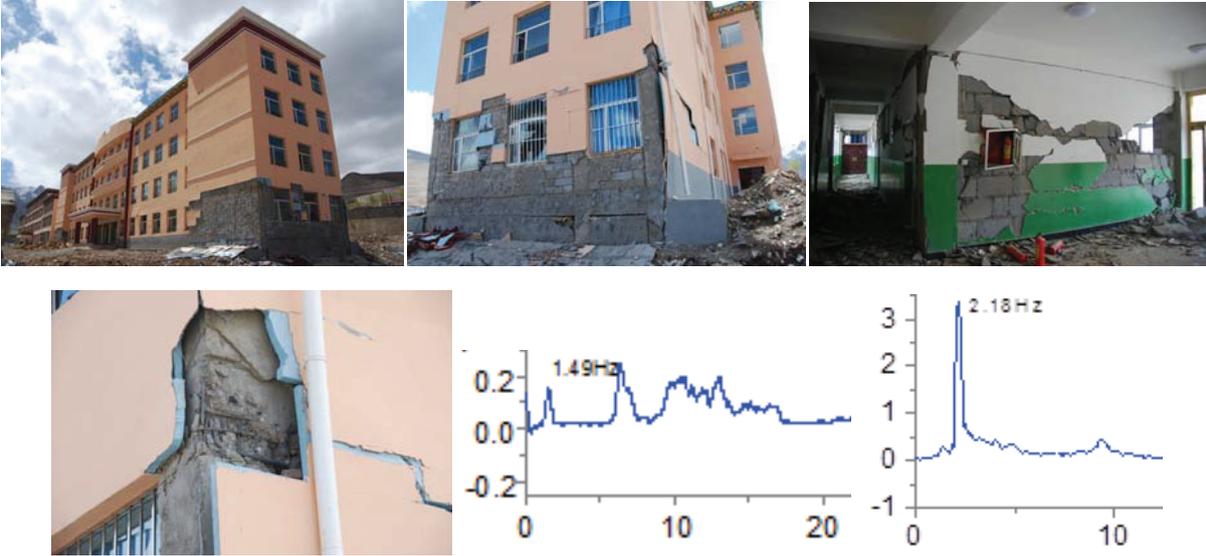
Figure 9. Damage of a 4-story RCF school building and its' NF (1.49Hz/2.18Hz) tested

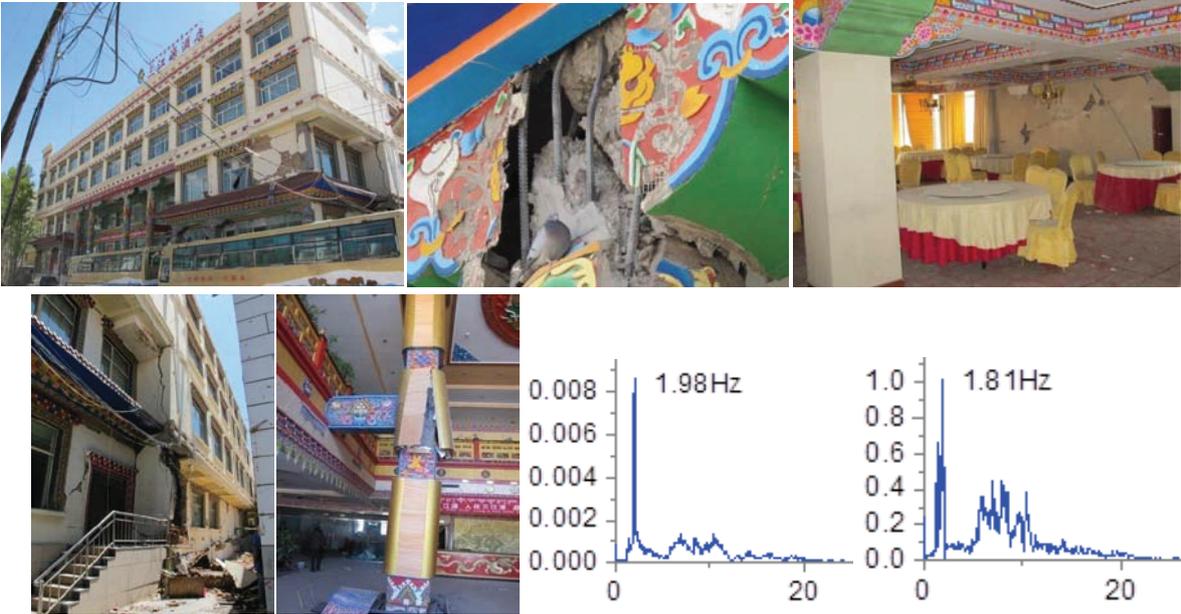
Figure 10. Damage of a 4-story RCF hotel building and its' NF (1.81Hz/1.98Hz) tested

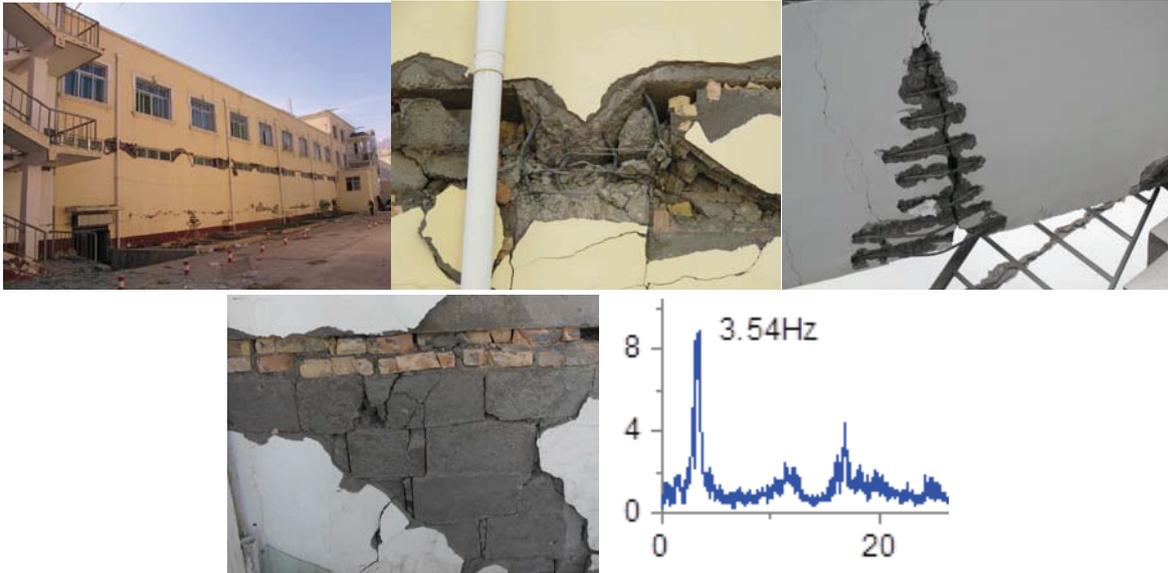
Figure 11. Damage of a 4-story RCF office building and its' NF (3.54Hz) tested

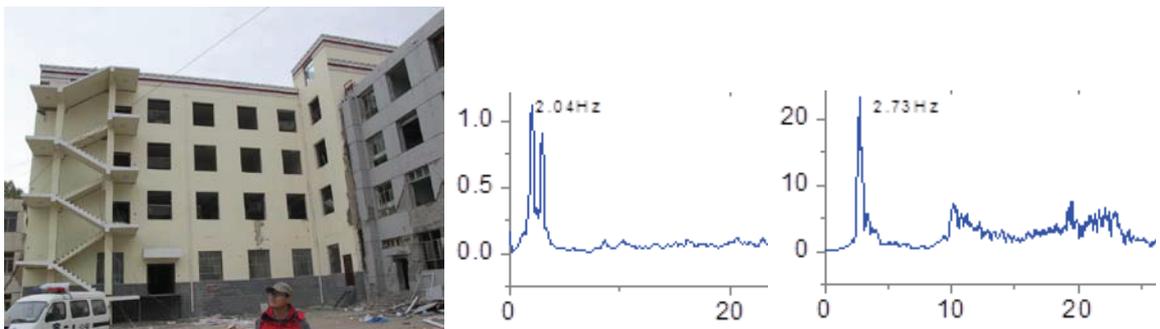
Figure 12. Damage of a 4-story RCF office building and its' NF (3.54Hz) tested

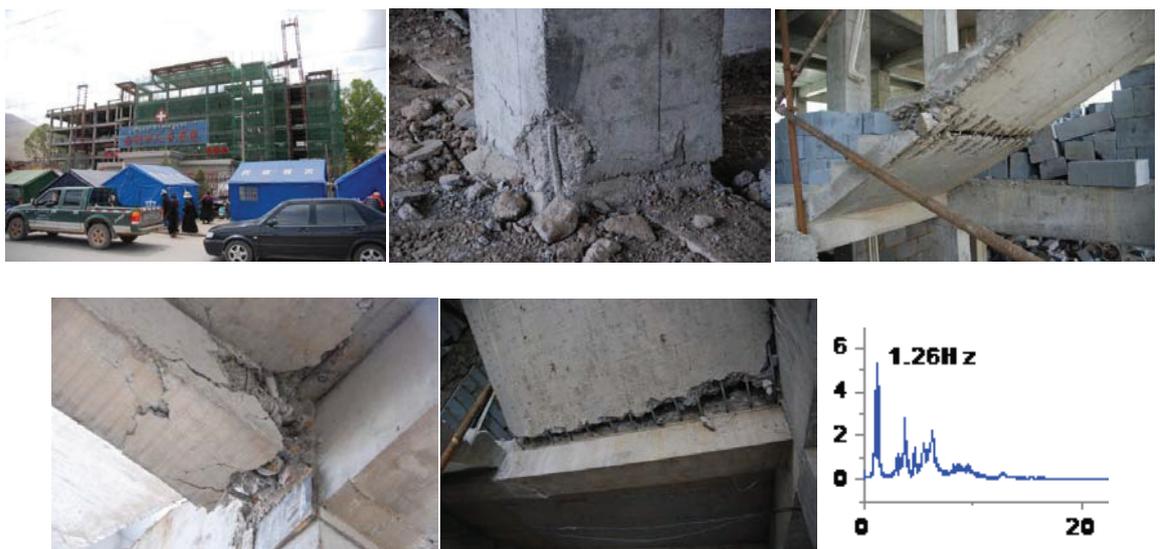
Figure 13. Damage of a 5-story RCF hospital building and its' NF (1.26Hz) tested

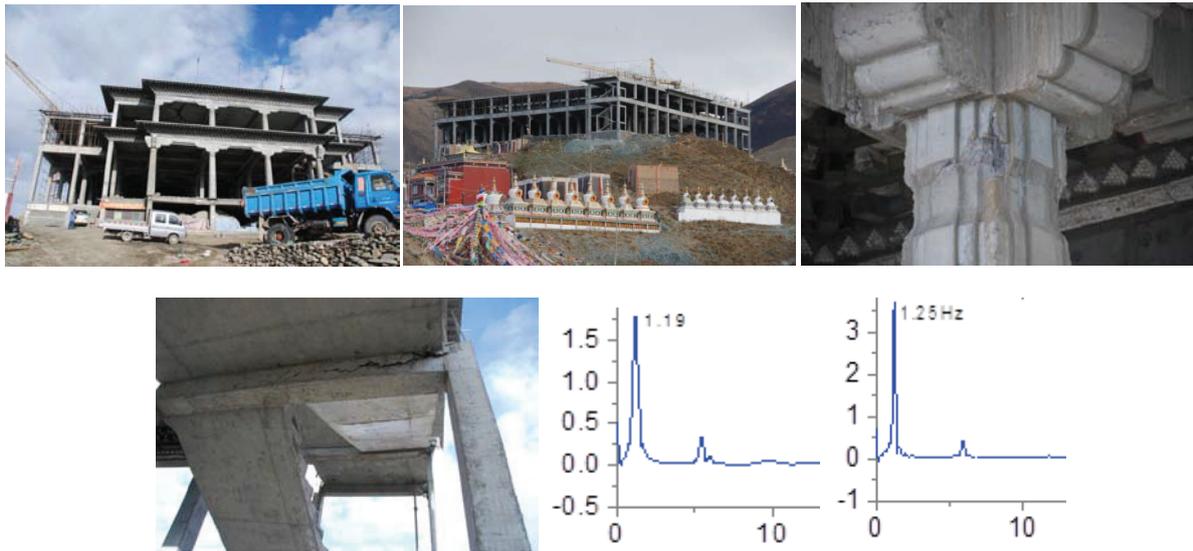
Figure 14. Damage of a 2-story RCF temple building and its' NF (1.19Hz/1.25Hz) tested

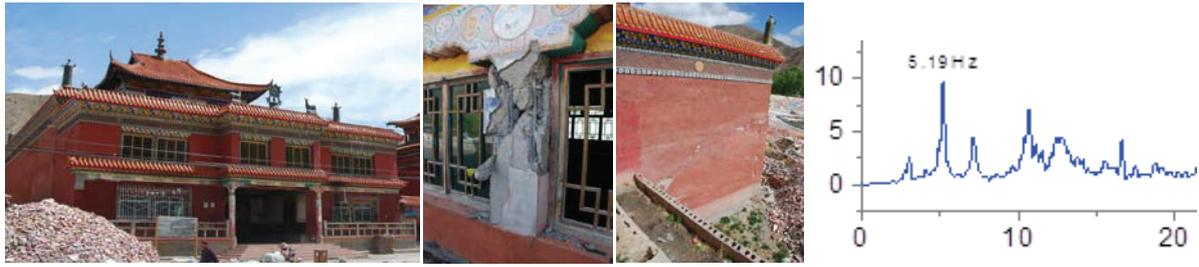
Figure 15. Damage of a 3-story IRCFSMW temple building and its' NF (5.19Hz/5.81Hz) tested

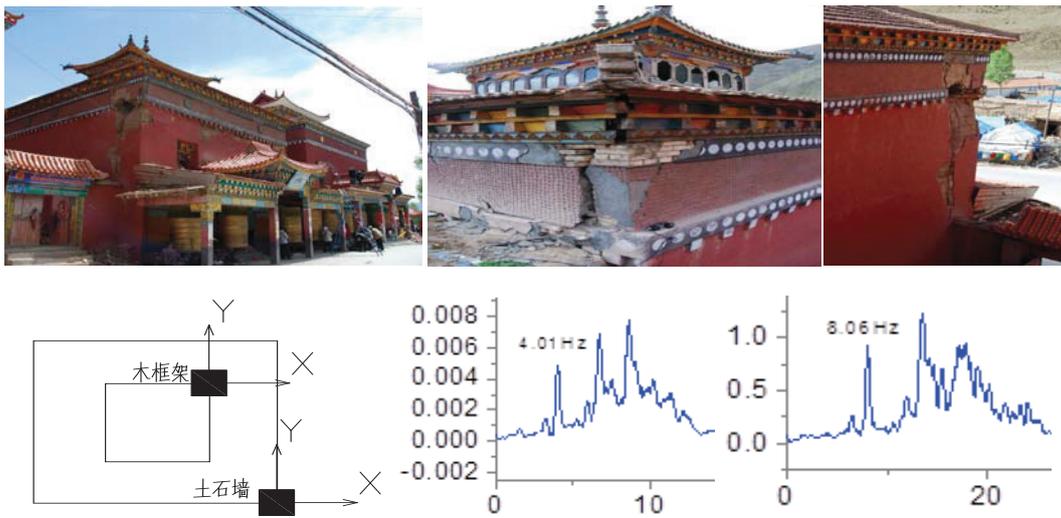
Figure 16. Damage of a 3-story IWFSMW temple building and its' NF (4.01Hz/8.06Hz) tested

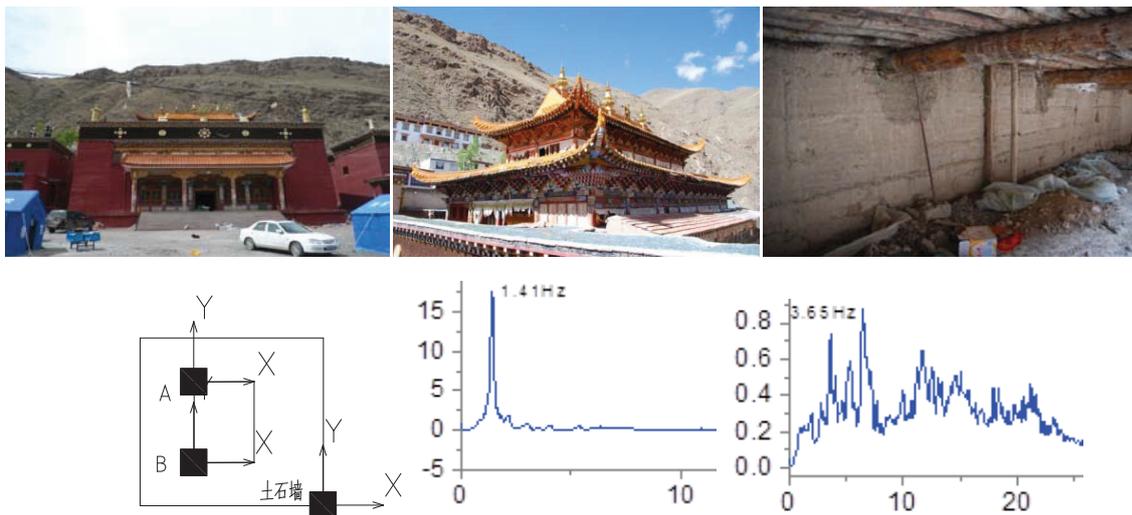
Figure 17. Damage of a 3-story IWFSMW temple building and its' NF (1.41Hz/3.65Hz) tested

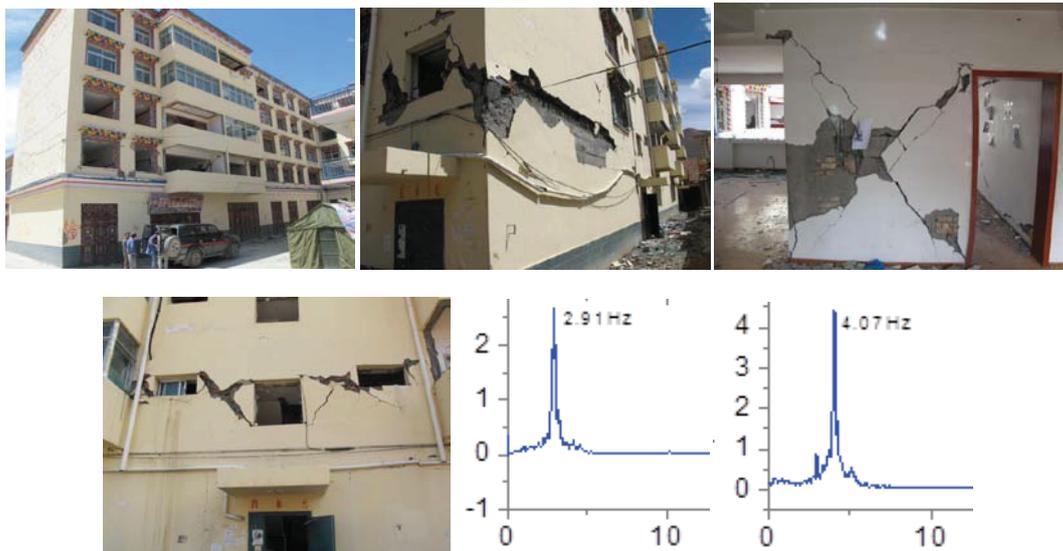
Only 1 damaged bottom R/C shear wall frame supported masonry (BSWFSM) building structure was tested in the field investigation. It's a 5-story residential building with typical characteristics of code defined BSWFSM structure. The serious shear damage is mostly concentrated in the 2 story, the code-called transition story from the bottom R/C shear wall frame to confined masonry upper stories. The damage characteristics disclose the incompatible of the lateral resistant stiffness between the first story and the transition story. The natural frequency value 2.91Hz illustrates that this building is still very stiff even with the severe damage in the 2nd story walls, as shown in fig.18.

Figure 18. Damage of a 5-story BSWFSM residential building and its' NF (2.91Hz/4.07Hz) tested
