Vulnerability Study of Electric Power Grid in Different Intensity Area in Wenchuan Earthquake

R.S. Liu, M.J. Zhang & Y.B. Wu

Institute of Engineering Mechanics, China Earthquake Administration, Harbin 150080, China

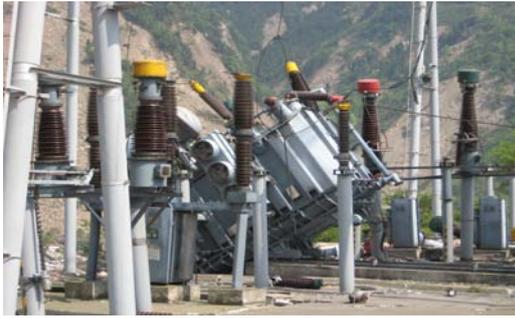
Figure 3.1. Transformer toppling down in 220kv Ertaishan substation

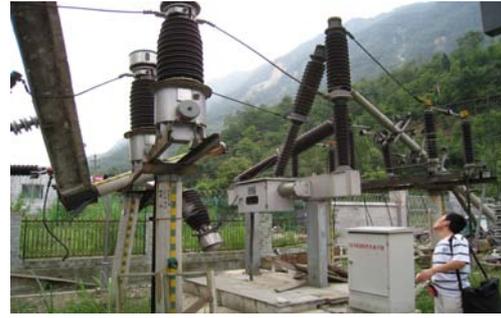
Figure 3.2. Most of transformers and circuit breakers are damaged in Beichuan 110kv Qimingxing substation

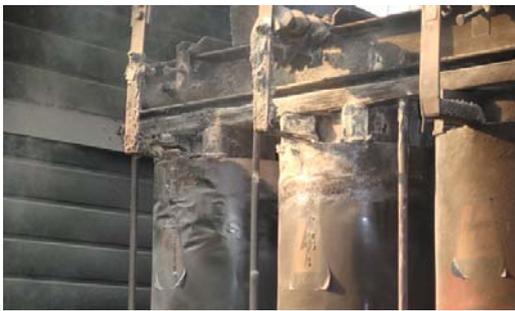
Figure 3.3. 10kv capacitor three-way reactor burnout and porcelain insulator burst in Guanghan Sanxingzhui substation

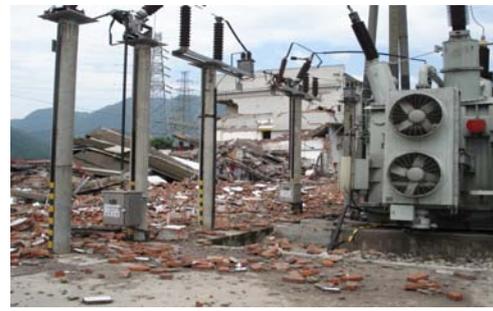
Figure 3.4. Main control room collapsed, transformer displaced and oil leaked

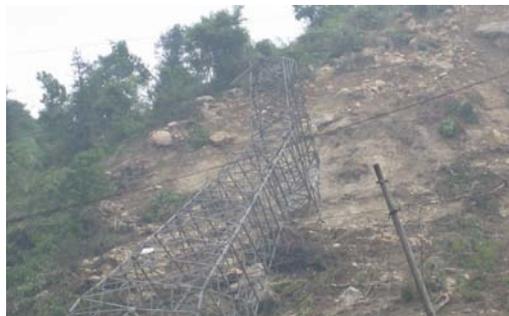
The damage of transmission lines mainly resulted from geological disasters such as landslides, rolling stones, etc., which led to the damage of the fort ridge of transmission towers, as well as the tower smashing, deformation, tilt and dumping. As for the distributed lines, the damage was often observed as a result of the nearby buildings' collapse which caused poles broken, overturning, lines disconnection, and so on. For the indoor equipments, the equipment boxes were often inclined and the equipments were destroyed by collapsed houses.

Figure 3.5. High voltage transmission tower toppled down and transmission line broken due to mountain landslide Yingxiu

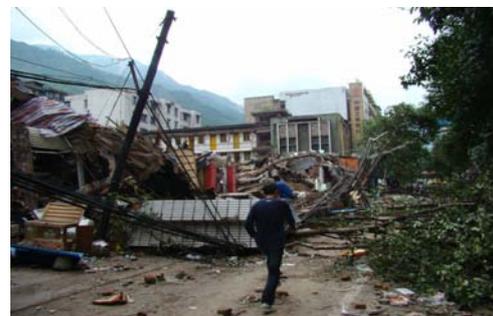
Figure 3.6. Electrical wire destroyed by nearby collapsed buildings

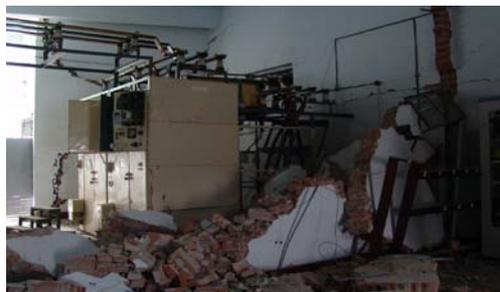
Mianyang Yuanmenba Substation	IX	110	Oil blew out and bushing fracture occurred on 1 main transformer; 11 circuit breakers was destroyed or ruptured; 19 disconnect switches and 4 CT were fractured; 6 permeability, 4 PT and 3 lightning arresters got ruptured; communication equipment / DC power supply were damaged; a bus bar insulator became tilt; main control room was severely damaged	Reconstruction
Deyang Chuanxindian Substation	X	110	1 main transformer was displaced, oil blowout and bushing fracture were observed; 1 circuit breaker got failed; 2 switches, CT, PT were damaged, one part of bus insulator became tilt; the foundation of the main control room foundation sank seriously and could not be used any more.	Reconstruction
Deyang Xiangshan Substation	IX	110	1 main transformer was displaced, oil spilled and bushing was ruptured; 2 CT were fractured; 2 lightning arresters leaked.	2008/5/15

Figure 3.7. 6kv reserve high voltage switchgear smashed in Yuanmenba

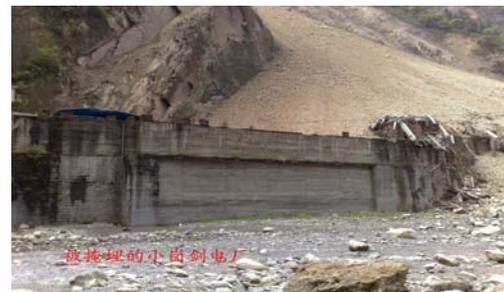
Figure 3.8. All equipments and buildings destroyed in Xiaogangjian substation
