A Framework for Forensic Examination of Earthquake-Induced Steel Fracture Based on the Field Failures in the 2011 Christchurch Earthquake

A.M. Kanvinde, D.A. Grilli & K. Marshall

15 WCEE
LISBOA 2012

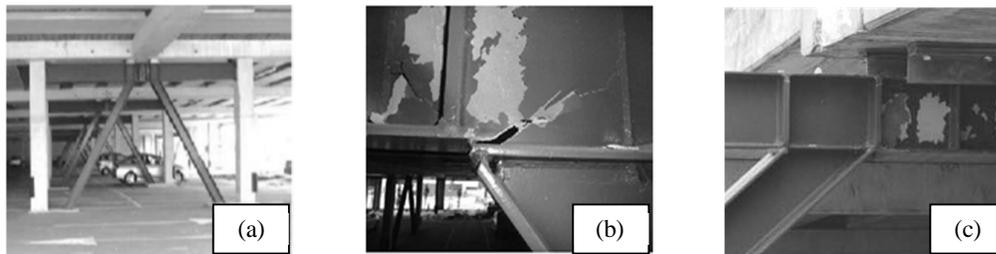
Two failures were observed and shown in Figure 2: the first a fracture located in the collector beam connecting to the shear link propagating up from the brace-beam connection weld (a); the second a shear localization in the link, resulting in significant plastic deformation throughout the beam web (b).

Figure 2. Eccentrically Braced Frames (EBFs) in St. Asaph Street parking structure (a), fracture (b), and shear localization (c)

Commonly assumed to be structural systems with excellent ductility (Popov and Engelhardt 1988), the failures in these frames are unanticipated and warrant careful investigation. Upon visual inspection of the fractured frame shown in Figure 2 (b), it can be observed that the brace flange was not welded directly beneath the web stiffener in the beam above, indicating that inadequate detailing may have been the primary cause of failure. The cause of failure due to the localized shearing in the frame shown in Figure 2 (c), however, cannot be determined through simple examination. This paper presents the robust methodology in which these failures are processed, demonstrating a rigorous ‘end-to-end’ simulation in the context of the proposed framework. Local demands resulting from actual recorded time histories from the site are obtained through high-fidelity three-dimensional frame simulations at the structural scale then inputted into a detailed local finite element (FE) model of the failed components. In addition, global and local simulations are supplemented by material property data obtained from material tests conducted on coupons extracted from the failed components. Parametric studies and probability analysis are used to pinpoint the root cause of failure. This paper will demonstrate the aforementioned framework in three distinct sections: (1) material testing (2) structural modeling and nonlinear time history frame simulations, and (3) local FE modeling and simulations, followed by a discussion of limitations.

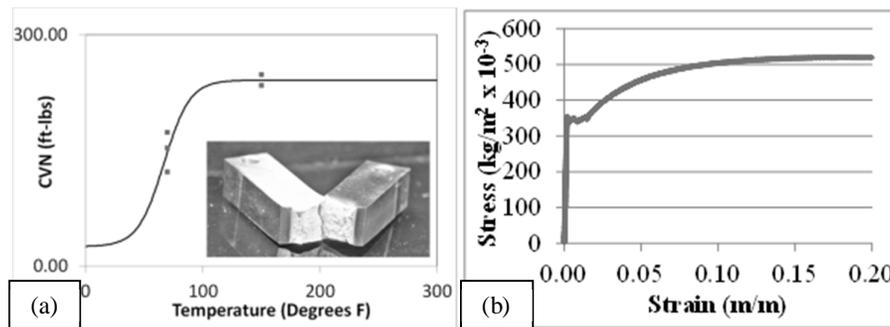
An important and distinguishing feature of the study is the acquisition by the research team of undamaged steel components from each of the failed Eccentrically Braced Frames (EBFs). Steel samples from failure locations were shipped to the University of California, Davis to undergo examination, 3-D scanning, and material testing. From these, specimens were extracted from locations shown in Figure 3(b) and were tested to obtain material toughness and constitutive properties; thus reducing the likelihood of introducing systematic errors in simulations attributed to inaccurately characterizing the material properties of the as-built steel. Calibrated parameters included: (1) parameters for continuum fracture and fatigue toughness models (Kanvinde and Deierlein 2006, 2008) and (2) material constitutive parameters for finite element simulation. Specimens consist of smooth tensile coupons and circumferentially notched tensile/compressive cyclic coupons. The specimens were extracted from various parts of the beam to capture material heterogeneity that occurs between base metal, weld metal and heat affected zones (Myers *et al.* 2009). These tests were supplemented by Charpy V Notch energies (provided by Forell Elsesser Engineers Inc. and Holmes Consulting Group). Results from Charpy tests and a sample tensile test are shown in Figure 4. The tests indicate the steel material is extremely ductile with upper shelf Charpy Values of approximately 250 ft-lbs.

Figure 4. Charpy V Notch energy results (a), and sample stress-strain curve from extracted specimen (b)

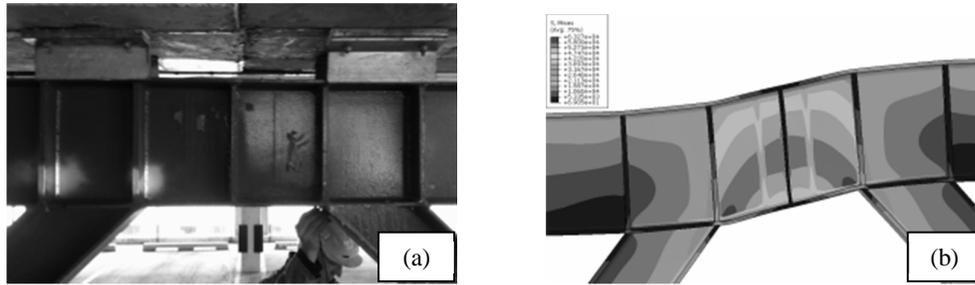
Local continuum models of the failed Eccentrically Braced Frames (EBFs) were constructed using ABAQUS, incorporating 3-D scans of the actual failed components to model each link and, in the case of the fractured frame, the fractured portion of the collector beam. As previously mentioned, visual examination of the fractured frame indicated that the location of the brace flange was not in line with the web stiffener in the beam above. This may have induced strain concentrations near the weld during loading. Preliminary FE simulations illustrate the strain concentration at this location (see Figure 9). The parameter study pertaining to the local model of the fractured frame was conditioned to place focus on the discrepancy between the as-built and as-designed conditions of the fractured link. In addition, measured fracture toughness parameters and minimum required toughness parameters were interchanged for each geometry scenario and each link to investigate the effects on fracture initiation. All scenarios were subjected to three time histories: (1) and (2) were obtained from global response to ground motion time histories as mentioned in the previous section, and (3) was obtained using a verified test protocol to determine the theoretical capacity of the link (Richards and Uang 2006).

Figure 8. Photograph of failed link (a), and loaded FE model link (b)

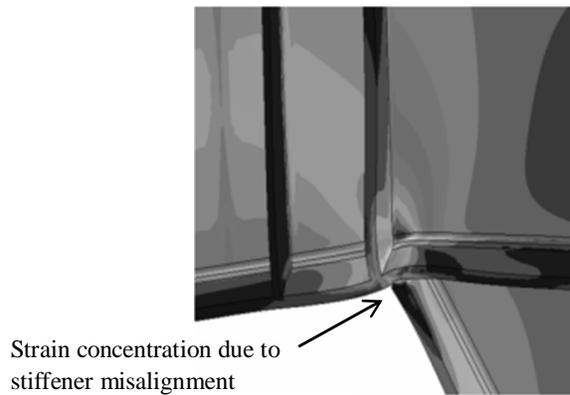
Figure 9. FE model – Stress concentration due to connecting brace and web stiffener location
