Evaluation of the Efficacy of Mud Injection to Repair Seismic Cracks on Adobe Structures via Full-Scale Shaking Table Tests

M. Blondet & J. Vargas-Neumann

Catholic University of Peru, Lima, Peru

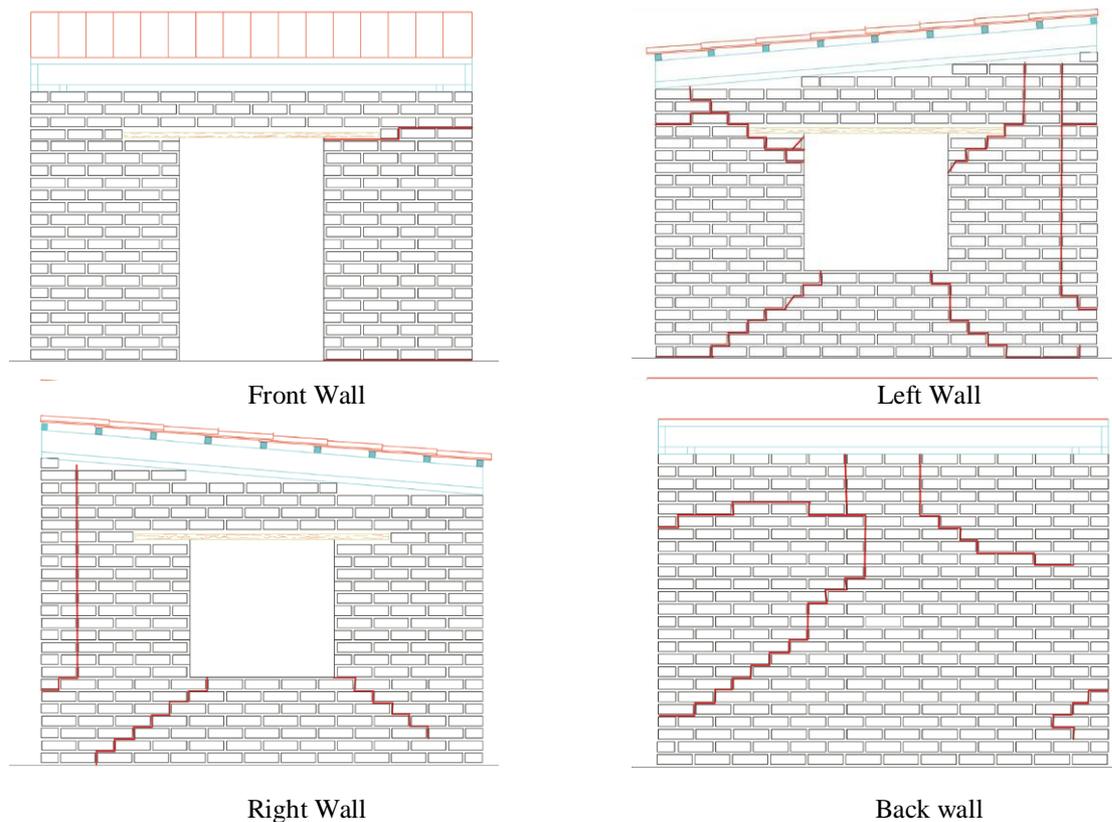
During the second phase ($D_{max} = 60$ mm), the model suffered extensive damage, as shown schematically in Fig. 6. Large diagonal shear cracks were visible in the right wall, starting in the corners of the window and propagating outwards. The left wall, suffered less damage, as diagonal cracking occurred only at the bottom part of the wall.

Important vertical cracking occurred at the corners of the walls with windows and the back wall. The free vibration frequency measured at the top of the back wall dropped from 12,88 Hz to 9,02 Hz, indicating a further loss of stiffness of about 50% with respect to the stiffness at the beginning of the test, and 80% of stiffness loss with respect to that in the undamaged state.

Figure 6. Cracking pattern after phase 2 ($D = 60$ mm)

The level of cracking produced in the adobe walls was considered to be representative of extensive but repairable seismic damage and therefore it was decided to proceed to the repair of the structure by injecting mud-based grouts in the seismic cracks.

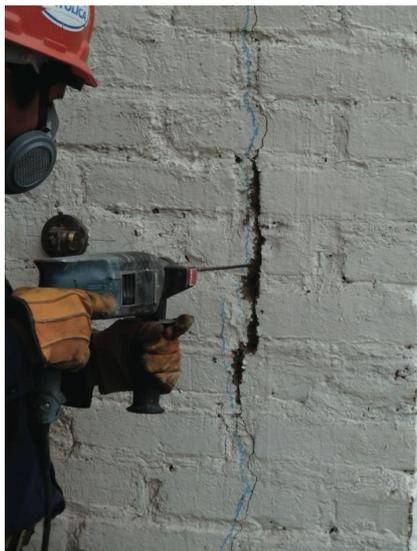
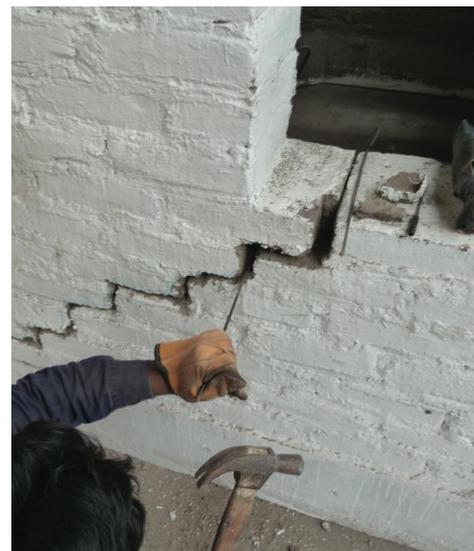
Figure 8. Opening the seismic cracks

Using a drill

Using pin and hammer

All major seismic cracks (wider than 1 mm) were opened using a drill and a hammer and pin as shown in Fig. 8, in order to facilitate mud penetration during the repair. The thicker cracks (more than 20mm after opening) were filled manually with mud (Fig. 9, left). Then the thinner cracks were prepared for injection by sealing them with a layer of silicon over them and leaving small openings at 50 mm distance approximately. The mud-based grout was then injected through these openings until the cracks were fully filled (Fig. 9, right).

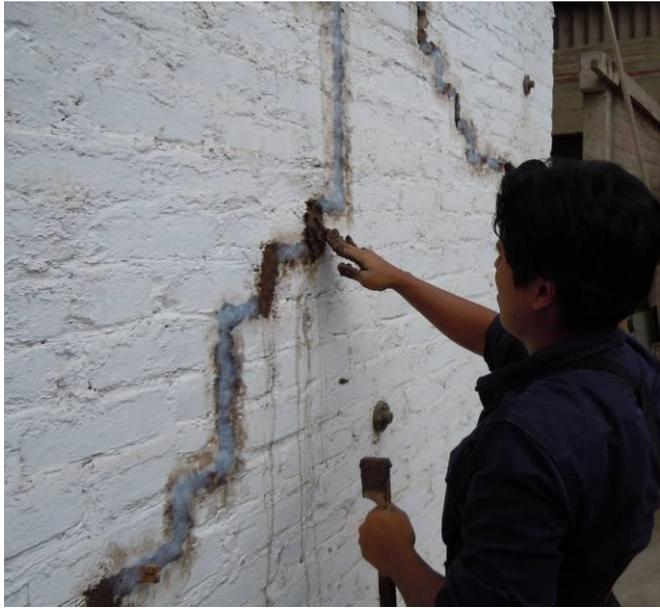
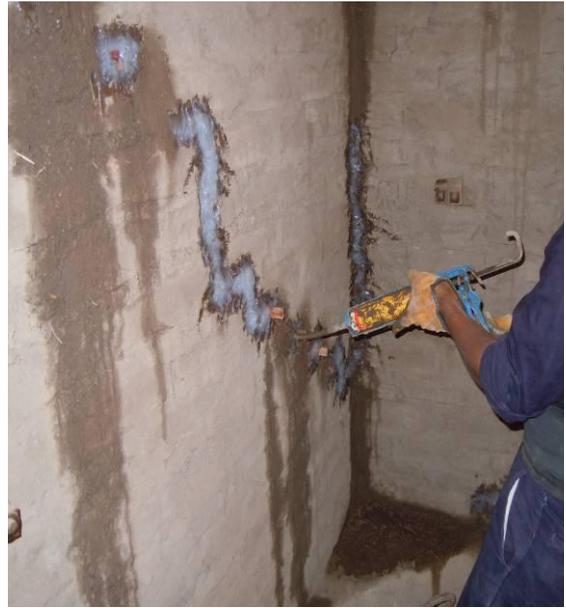
Figure 9. Repairing the cracks with mud

Filling thicker cracks manually

Injecting mud-based grout

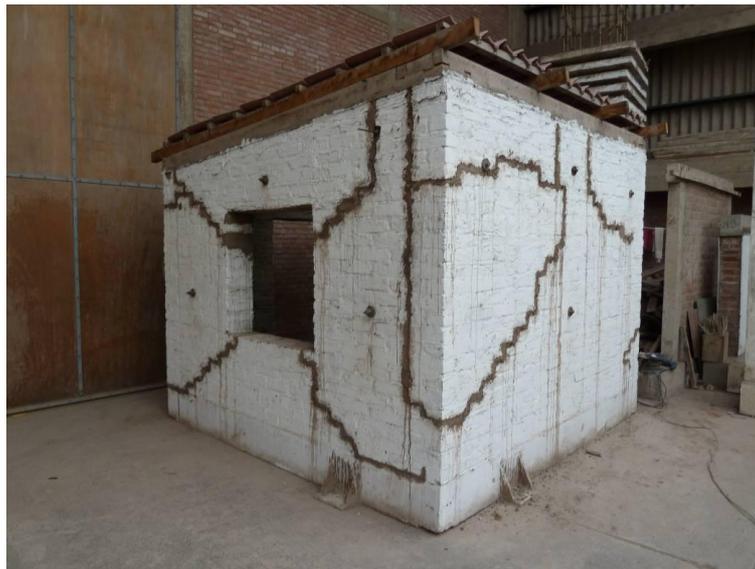
Figure 10. Adobe model with all major seismic cracks repaired

Figure 10 shows the repaired structure. After 28 days of drying the model was tested again on the shaking table.

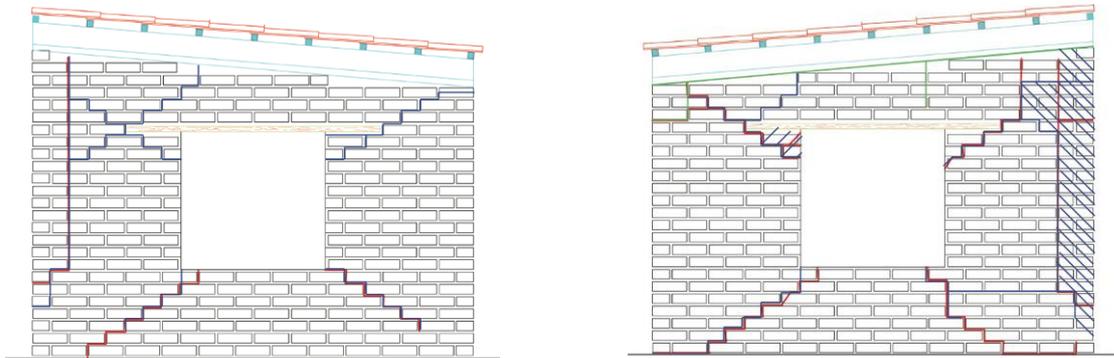
During the first phase (30 mm peak table displacement), there was no visible damage to the structure. After watching the video recordings, however, it was clear that the roof had detached from the walls. The crown beam, therefore lost its capacity to hold the walls together. Because of this, the part of the back wall collapsed during the second phase (60 mm). Figure 11 schematically presents the damage after this test. New cracks are shown in blue. Figure 12 presents a photograph of the model after the test where the partial collapse of the back and side walls can be observed. Notice also the separation of the roof and the side wall.

Figure 11. Damage after the second test

- The early detachment of the roof in the low level shaking ($D = 30 \text{ mm}$) probably caused the partial collapse of the back wall during the stronger shaking ($D = 60 \text{ mm}$).
- It seems possible that the interface between the material used to fill the cracks (mud or grout) and the existing adobe masonry was not sufficiently strong. Whereas during construction, the blocks are pressed on the mud mortar, when putting the filler material in the cracks, it is difficult to apply pressure. Thus, the bond between new and old material is not as strong as in the original masonry. Cracking due to drying shrinkage of the grout could also have occurred, preventing the development of good bond in the repaired areas.

Detachment of the crown beam during low intensity shaking prevented the walls from working together and precipitated the partial collapse of the back wall. This could have been prevented by adding extra reinforcements.

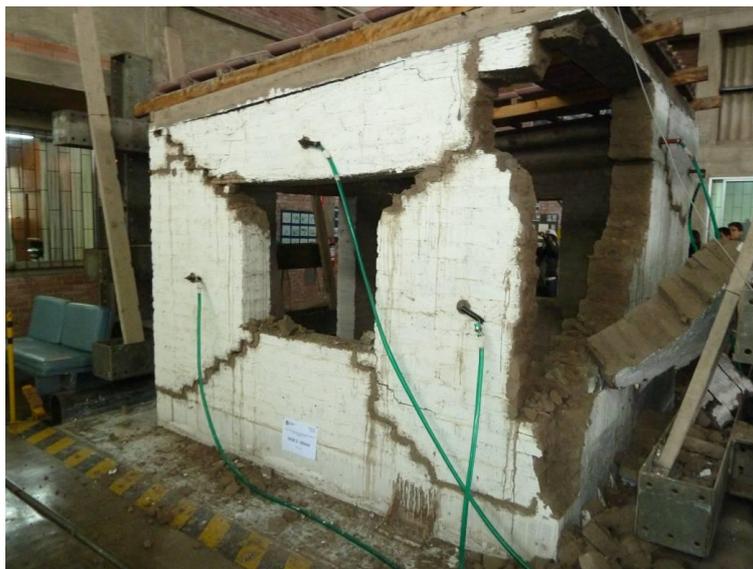
Figure 12. View on collapsed wall of module after test
