Study on the Mechanism of the Damaged Housing Lots during the 2011 Tohoku - Pacific Ocean Earthquake in Japan

S. Yasuda, K. Ishikawa, M. Watanabe & M. Yoshida

Keywords: slope failure, fill, embankment, housing lot

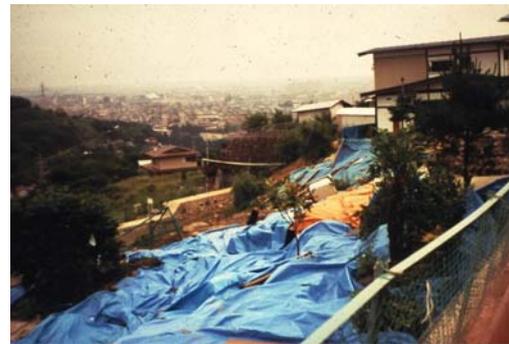
Figure 4 Damage at Midorigaoka during the 1978 Miyagiken-oki earthquake

Figure 3 shows earthquakes which caused damage to housing lots after 1968 Tokachi-oki earthquake. Recently almost all big earthquake has caused damage to housing lots because many housing lots have been developed gradually not only in big cities but also in medium dense populated cities. In 1978, several housing lots were damaged during the Miyagiken-oki earthquake in Sendai City. Of them severe slope failures occurred and many houses collapsed at Midorigaoka Ichi-chome housing lot as shown in Figure 4. In 1957 to 1958, this housing lot was constructed by filling a valley. During the

reclamation work, trees on surrounding hills were felled and thrown down into the valley. Rocks cut from the hill also were thrown into the valley, then soil cut from the hills was placed as schematically shown in Figure 5. Figure 6 shows a soil cross-section along the slope. The thickness of the fill was 5 to 15 m. The density of the fill was very low with 0 to 10 of SPT N -values. It is estimated that buried trees became humus within 30 years. Moreover, as big voids existed between buried rocks, groundwater flowed in the big voids and caused weathering of rocks. Then the bottom of the fill became very loose and caused the slope failure during the Miyagiken-oki earthquake. During restoration, steel pipe piles, 318.5 mm in diameter, were installed to increase resistance against sliding, as shown in Figure 6. The steel pipes were strengthened by filling with steel H sections and concrete. The steel pipe piles were installed in two rows at 2 m centres. A concrete retaining wall and drainage wells were also constructed. The safety factor against sliding during anticipated earthquakes was thereby increased to 1.2.

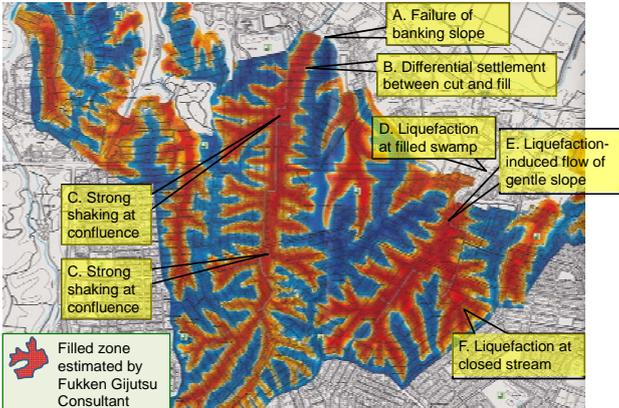
Figure 13 Six damage patterns observed at Nankodai in Sendai City

The authors conducted detailed site investigation at Nankodai where many filled grounds were constructed for housing lots as shown in Figure 13 to study the patterns of the damage. Based on the site investigation, the following patterns were found:

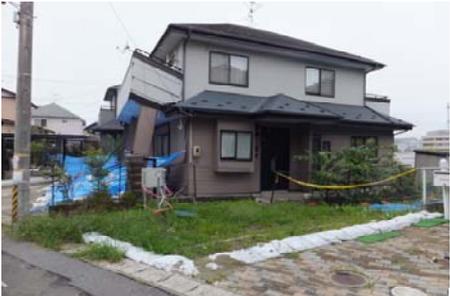
Figure 14 Damaged house at A

- A. Failure of banking slope: Several houses at the top of the failed slope were damaged as show in Figure 14.
- B. Differential settlement between cut and fill: Many houses between cut ground and filled ground were torn as shown in Figure 15.

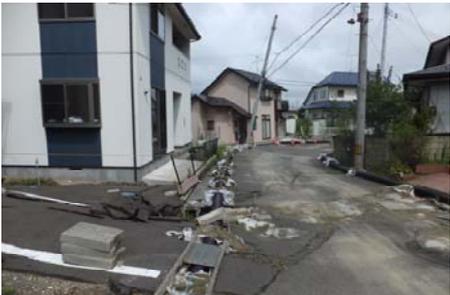
Figure 16 Settled house at D

- D. Liquefaction at filled swamp: Filled soils at a swap liquefied and caused settlement and inclination of several houses as shown in Figure 16.
- E. Liquefaction-induced flow of gentle slope: Deformation of the ground occurred as shown in Figure 17 due to probably excess pore water because the slope was filled by sandy soils.

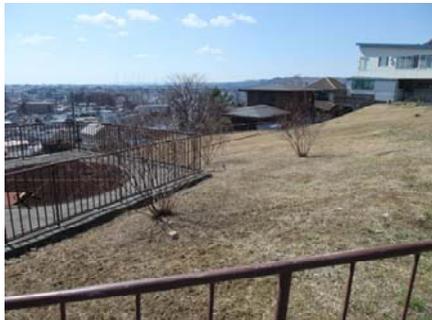
Figure 18 No damage at Midorigaoka Ichi-chome in Sendai City

At Midorigaoka Ichi-chome where severe damage occurred during the 1978 Miyagiken-oki earthquake mentioned above, no damage occurred by the Tohoku-Pacific Ocean Earthquake as shown in Figure 18. Strengthening by steel piles and decreasing of water table conducted after the 1978 earthquake must prevent the damage. On the contrary, Midorigaoka Yon-chome hosing lot where severe damage occurred during the 1978 earthquake but no countermeasure had been applied after the earthquake was seriously damaged as shown in Figure 19.

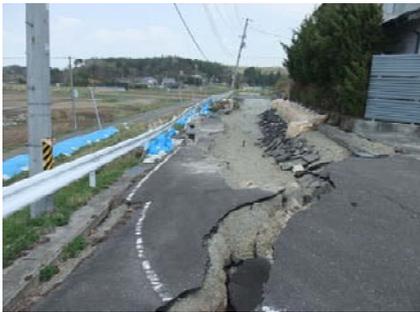
Figure 22 Failed slope at Midorigaoka in Sukagawa City

Figure 22 and 23 show photo and a cross section at Midorigaoka in Sukagawa City. Levels of ground surface before and after reclamation were estimated by two sets aero-photos taken before and after reclamation. Then thickness of fill was estimated. The thickness is about 4 to 6 m and the height of the failed slope is 5.7 m. In the site investigation, crack on the ground surface were observed up to about 33 behind the top of the slope. Water table was estimated high because spring water was found at the toe of the failed slope. Then seismic response and deformation analyses were carried out by the following three steps.

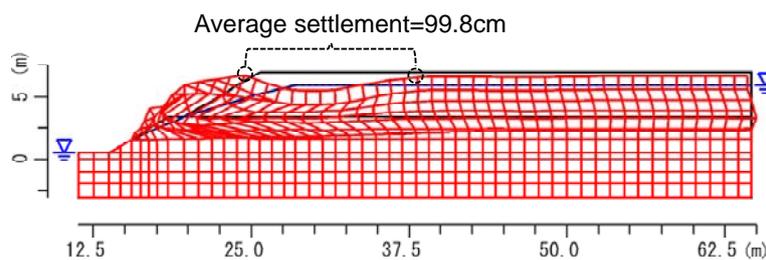
Figure 24 Analysed deformation

1) Analyse initial static stress and strain before the Tohoku-Pacific Ocean earthquake,
 2) Analyse dynamic stress during the earthquake by FLUSH, and
 3) Analyse residual deformation after the earthquake by a computer code ALID (Yasuda et al., 1999).
 In the analyses water level was assumed as GL-1 m. Figure 24 shows the analysed deformation. The estimated maximum and average settlement of the ground surface are 147.9 cm and 99.8 cm, respectively. On the contrary, measured maximum settlement was about 1.5 m. Therefore estimated deformation is well coincided with the actual deformation.
