# The Performance of Low-Rise Industrial Facilities in the 2010 Haiti and 2011 Christchurch, New Zealand Earthquakes

## **SUMMARY:**

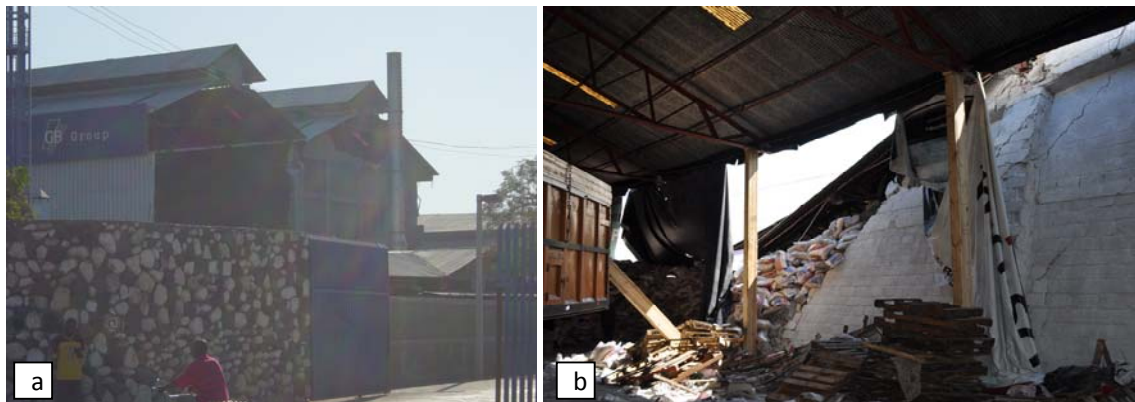
exception. The typical construction of PEMBs in Haiti utilized a masonry façade. Both types of low-rise construction experienced damage although the levels of damage and the ability to reoccupy buildings following the earthquake were different. Numerous low-rise industrial structures were located throughout industrial and port areas of PaP. Due to the wall height, typically low amounts of reinforcing and low compressive loads, wall failures primarily due to out-of-plane effects were common. This type of damage can be seen in Figure 4.

**Figure 4.** Low-rise masonry infill wall failures of industrial buildings in Haiti a) Endwall failure b) Bearing wall failure and temporary truss supports (3b Photo Credit: Steve Baldrige)

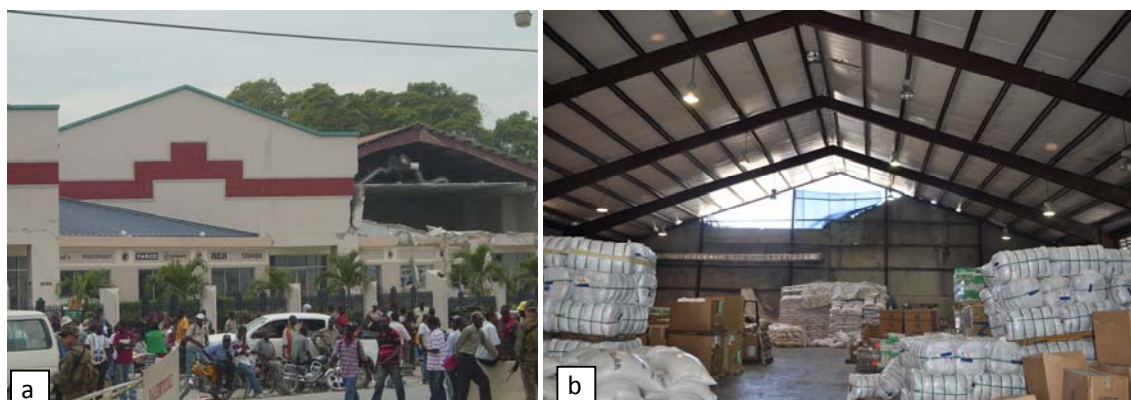
During reconnaissance efforts, several PEMBs were encountered and the damage to each of them was similar. The masonry façade failed while the primary structural framework was undamaged. Photos of this failure are shown in Figure 5. Figure 5a is a retail building located across the street from the U.S. Embassy. All of the front sections of the PEMBS observed at this location detached from the framing although some of them had not fallen. The buildings have been repaired and the masonry exterior walls were replaced by insulated metal sheathing. Figure 5b is a warehouse building in PaP with masonry cladding. This out of plane failure of the masonry walls of PEMBs was common on nearly all metal buildings observed during the reconnaissance. PEMBs in Haiti did not experience failure of the

gravity load system. This was true even of the warehouse building at the PaP port which failed due approximately 6 ft (2 m) of lateral spread between the foundations.

**Figure 5.** Low-rise masonry infill wall failures of industrial buildings in Haiti a) Gable wall failure of commercial buildings b) Gable wall failure of warehouse building (4b Photo Credit: Steve Baldridge)

the gabled ends of the structures showed that one critical detail for these structures was missing. However, these facilities still had a complete gravity load path so use of the buildings during recovery was possible. This detail should be a critical note for structures in the United States as the metal building manufacturers and the masons or cladding panel producers must ensure that these connections are designed, detailed and constructed to support the required lateral loading as falling panels or blocks present a significant potential for damage to other elements or building occupants.

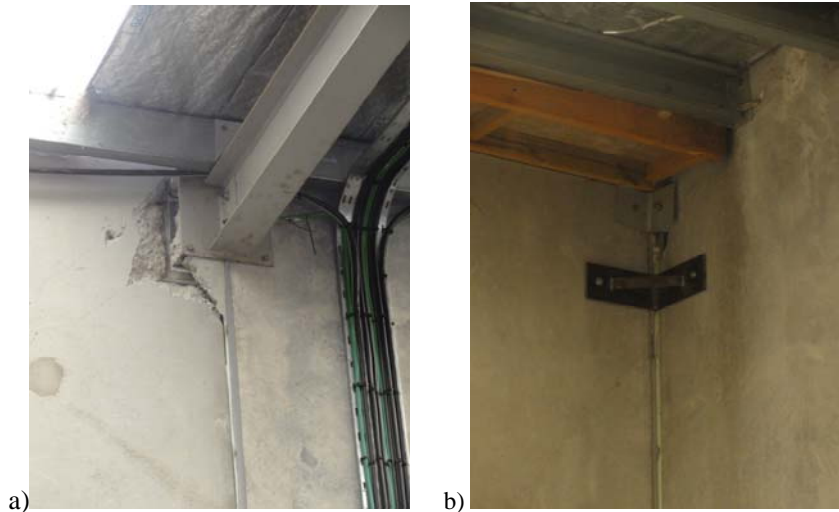
Typical damage to load-bearing concrete tilt-up panels is shown in Figure 6. Several structures of this type seen throughout the region had to be stabilized with temporary shoring and deadman anchors. In one case (Figure 6a) the building had been temporarily stabilized but was due to be demolished because of multiple failures of structural elements. Several of the beam-to-wall connections suffered significant damage, as shown in Figure 6a. The facility was evaluated by structural engineers retained by the Owner who concluded that the structure could not be economically repaired and as such, it was scheduled for demolition. Figure 6b shows damage which occurred at the corner connection which had already been repaired by the owner to allow the building to be reoccupied. While the damage to the connections at the facility shown in Figure 6b did not result in a collapse of the structure, the level of damage suggest that there was some loss of vertical load-bearing capacity of the beam-wall connection. The structure in Figure 6b is similar and close to the structure in Figure 6a, both of which experienced similar damage. In the case of Figure 6b, an overhead crane served as a strut to maintain stability of the building. Connection repairs were required but the building was able to remain and was operating at the time the photos were taken. At one light industrial facility diagonal shear cracks were observed in the load-bearing concrete tilt-up wall panels. In some cases, the shear cracks appeared to emanate from the connection of the beam to the concrete wall (Figure 7a). Damage was also seen in the flexible diaphragm in the form of fractured tension-only bracing (Figure 7b).

Design drawings were not available for these industrial facilities; however through numerous discussions with several different owners, it appears that the concrete tilt-up panels were typically lightly reinforced due in part to the perception that there was not a significant earthquake risk in the area relative to other parts of New Zealand. It should also be noted that a much older building with more complex geometry across the street which consisted of steel frames with light gauge metal sheathing experienced minimal damage although it did experience some equipment damage.

**Figure 6.** Damaged connections in tilt-up industrial structures in New Zealand a) Beam-to-panel connection damage b) Corner connection damage with post-event repair.

The primary problem with the performance of these low-rise industrial buildings with precast panels in Christchurch during strong ground motion appears to be the connections between the wall panels and the steel framing. For structures with load-bearing precast panels, the damage was observed at the roof beam-to-panel connection. This is likely occurring because all the out-of-plane wall forces are transferred to the diaphragm through the beams which are typically widely spaced. Significant normal forces are introduced into a thin wall panel. Essentially, the connection does not have a ductile fuse mechanism. One solution to this problem is to provide a continuous ledger with a positive connection to both the diaphragm and wall panels. This allows the out-of-plane forces to transfer along the length of the wall and reduces the concentrated forces at the beam-to-panel connections. It would also help to tie the panels together to provide additional capacity against panel out-of-plane failure.

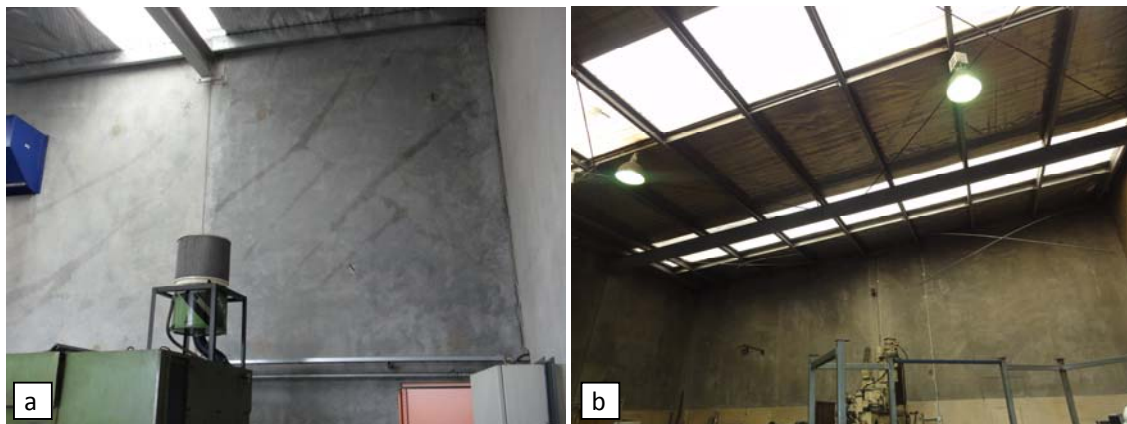
**Figure 7.** Damaged structural elements in tilt-up industrial structures in New Zealand a) Shear cracking in load-bearing panels b) Fractured tension-only roof diaphragm bracing.

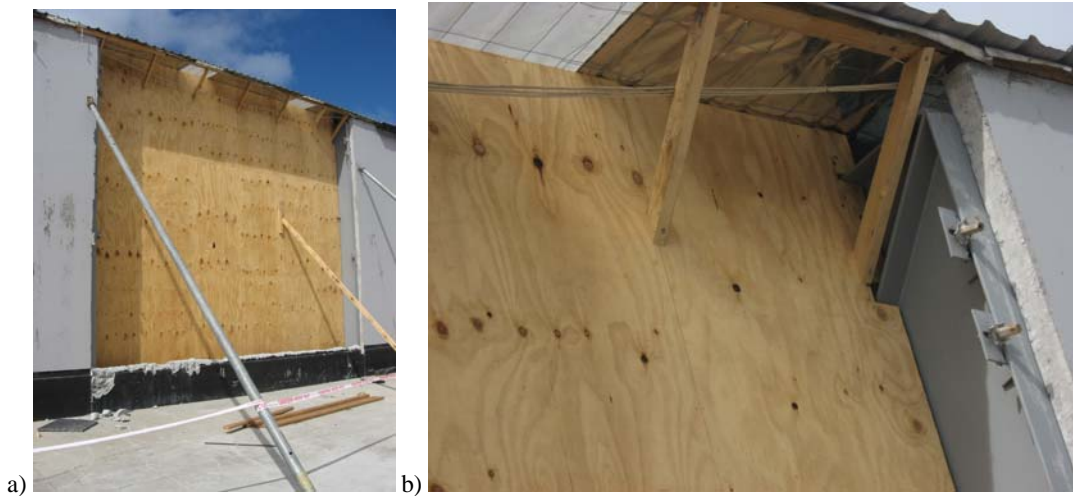
Buildings with pre-engineered steel frames supporting gravity loads and tilt-up panels for lateral resistance experienced a different failure mode. In multiple cases, the connection between the steel frame and the precast walls was insufficient and the wall panels fell away from the building. Figures 8a and 8b illustrate a typical failure of a wall panel that separated from the steel framing and fell to the ground. Even though the remaining panels did not fall to the ground, the connections were damaged to an extent that shoring was required as illustrated in Figure 8b. This failure mechanism was evident on other buildings of similar construction in throughout Christchurch.

The connections between the steel frame and concrete panels were similar in many of the structures seen during the reconnaissance effort. It was apparent from the framing of the structures that in many cases, the panels were the lateral load system for the longitudinal direction of the building. These connections are therefore a demand critical link in the load path. In some cases tension-only bracing and half height panels were utilized as the lateral system. Other damage was seen to panels of this type of buildings. Figure 9a illustrates damage to a panel with a reduced section due to window penetrations. The damage includes shear failure of the reduced section and out-of-plane flexure of the panel. Figure 9b shows cracking of the end panel which is typically not used to resist loads but did so because of the panel stiffness compared to the steel frame. This type of damage was seen in multiple structures in the area.

**Figure 8.** a) Loss of panel and temporary shoring of adjacent panel b) Concrete anchor connection failure.

For non load-bearing panels the problem is the deformation incompatibility between the stiff wall panels and the flexible steel frame. Two options are presented here which would likely alleviate the problem. The first is to provide a header element along the top of the panel with all the connections provided along this element. The inertial load could be transferred from the diaphragm at this point. The column and panel could move relative to each other without affecting the tie between the steel frame and the panel. An alternative would be to modify the connection between the column flange and wall panel. This includes increasing the number of connections and/or the strength of the connection. Current research on metal buildings with concrete cladding panels has used a welded connection between the panel and the frame which performed well in shaking table testing at the University of California San Diego.

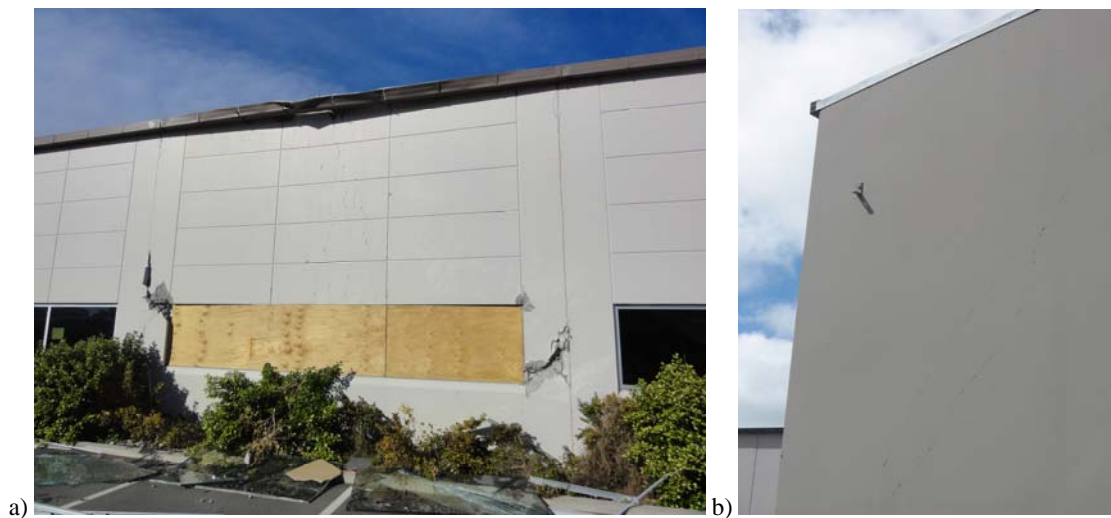
**Figure 9.** a) Damaged panel due to reduced section b) Cracking of end panel.

End panels on manufactured buildings experienced cracking due to acting as a part of the lateral system due to their stiffness. While this is a feasible load path if the connection is designed to transfer the lateral loads, another option, which is to utilize the steel frame may be better. The panels will often

crack due to relatively small lateral loads as the panels are typically lightly reinforced. The steel frame has the flexibility to deform without damage. In order to get the load into the steel a connection is required which allows the load to transfer into the frame. Providing a slot in the connections which allows the panels and frame to slide without degrading the tensile capacity of the concrete anchor would meet these requirements. It is also possible that the connection would dissipate energy through friction without damage to the structure. This would require careful design to determine the length of the slot and the appropriate direction of the slotted hole.

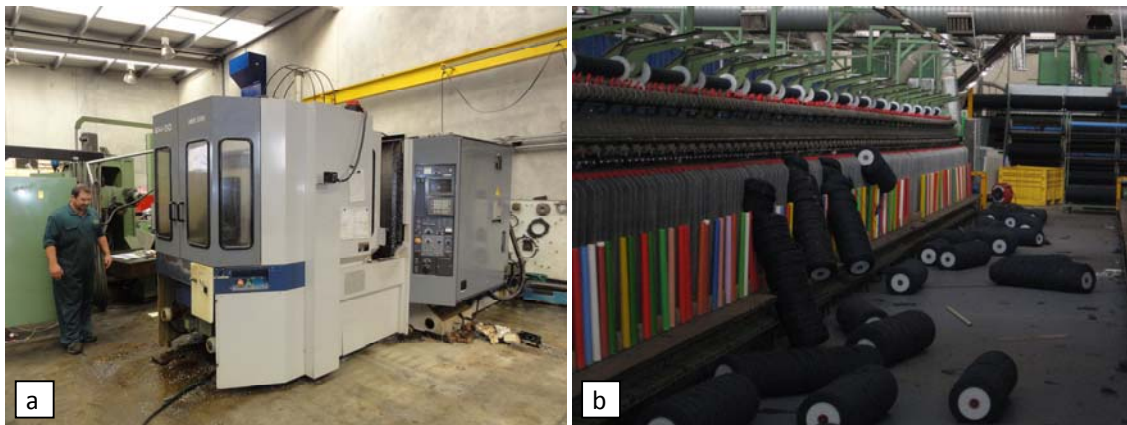
damage. Considering that the demand for contractor services is very high following an event, multiple effects may contribute to a significant cost increase to get back to an operational status. In the industrial areas east of the CBD, several manufacturing facilities were observed with substantial non-structural damage to critical equipment and supporting infrastructure. At one location in Bromley, high vertical and horizontal accelerations in the area combined to translate machining equipment weighing 25,000 pounds (110 kN) approximately 4 ft (1.2 m) from their original position, as shown in the Figure 10a where the workers right foot indicates the original location. Workers at the facility described seeing the large equipment literally “bounce” across the floor. Multiple pieces of equipment within the same facility as well as in other surrounding facilities moved in excess of 2 ft (0.6 m). In some cases, the non-structural damage is not directly shaking related. A textile factory in the Bromley area experienced a significant amount of both structural and non-structural damage. Much of the damage was repairable; however one particular effect rendered the factory inoperable. A combination of strong ground motions and liquefaction induced slab damage resulting in displacements in critical equipment that significantly exceeded levelness tolerances. This equipment damage resulted in facility shutdown and the loss of hundreds of jobs to the facility. Figure 10b shows the equipment damaged by the combination of strong ground motion and the slab displacement resulting from liquefaction.

**Figure 10.** Non-structural damage in industrial facilities a) Heavy equipment moving 4ft (1.2m) from initial position b) Liquefaction damage to slab supporting low tolerance manufacturing equipment.

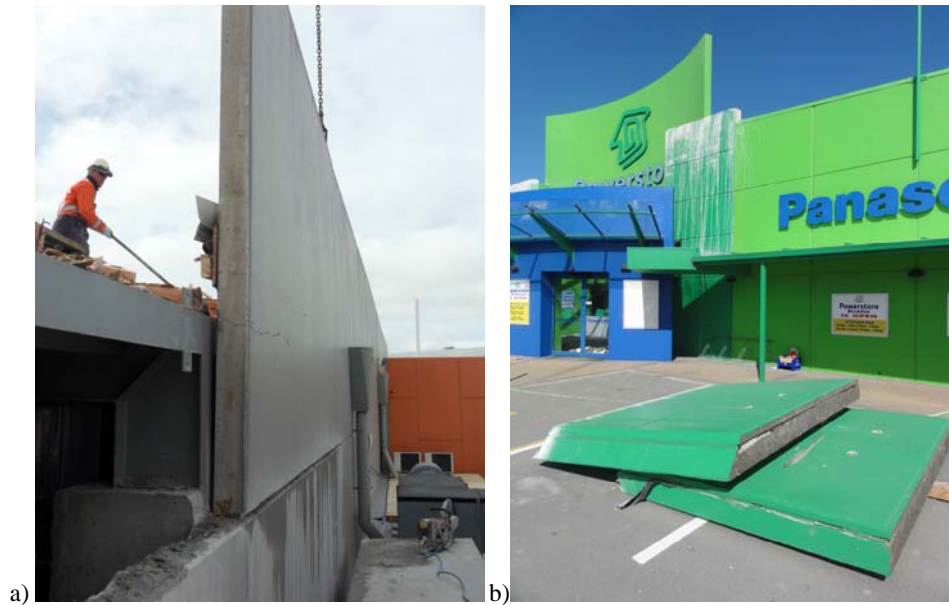
Another interesting aspect of non-structural damage in New Zealand occurred in low-rise commercial buildings. The first is a commercial mall east of downtown. The structure was composed of a pre-engineered steel frame with precast concrete cladding panels connected to the frame with a concrete pour strip around the steel columns. The pour strip utilized rebar extending out from the precast panels. The problem with the structure was a long cantilevered parapet, approximately 6ft (1.8 m), above the top of the column. This led to significant cracking of the panels which necessitated removal of the panels. This operation is shown in Figure 11a. A similar condition existed with a commercial tilt-up building just south of the central business district. In addition to removal of the long cantilevers, the tilt-up structure was temporarily supported by jack posts and deadman blocks. This structure can be seen in Figure 11b with the removed cantilevers in the foreground.

**Figure 11.** Precast panels with vertical cantilevers greater than 6 ft (1.8m) a) Commercial mall wall panels attached to pre-engineered steel frame b) Commercial tilt-up building.

The approach for design of the long parapet would be to ensure that either the panel has the capacity to resist the loads or to provide bracing to achieve the desired behavior. These issues must be considered as part of rigorous design to ensure that buildings and businesses they house, do not experience significant downtime and severe economic impacts due to seemingly insignificant construction details.
