The Response of Houses to the Canterbury Earthquake Series 2010-2011

G. J. Beattie

BRANZ Ltd, Porirua, New Zealand

The Response of Houses to the Canterbury Earthquake Series 2010-2011.

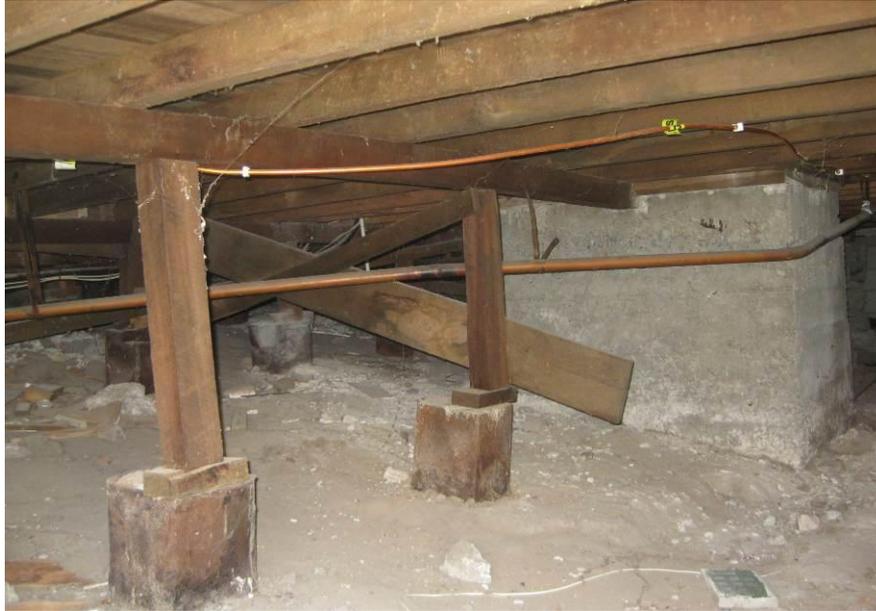
Figure 3. Jack studs beneath a hillside dwelling (tilt due to superstructure lateral displacement)

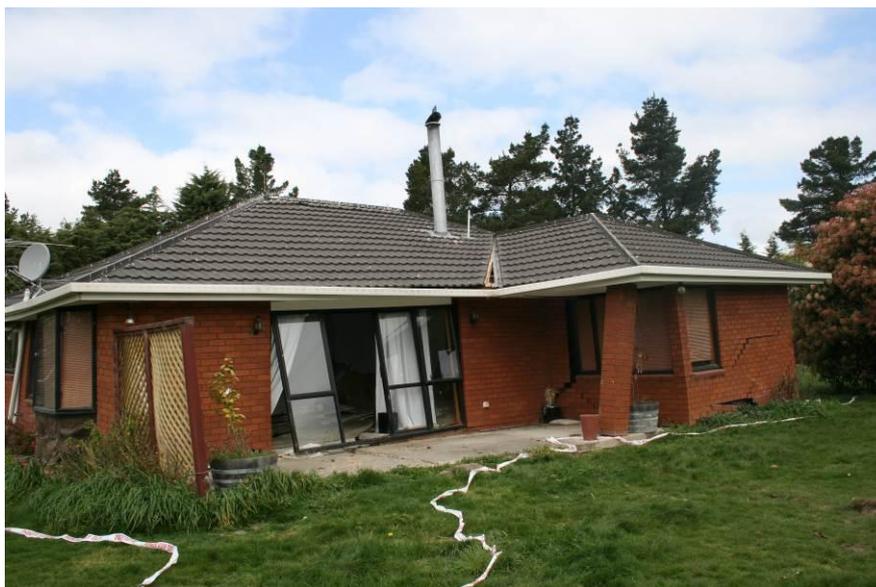
Much of the damage to houses on the flat was due to differential ground settlement and lateral spreading associated with liquefaction and varied from quite minor to major (Figure 4). The most obvious signs of house damage viewed from the outside were failed unreinforced masonry chimneys on older houses and the loss of portions of veneer.

Figure 4. Severely damaged house from differential ground settlement and lateral spreading

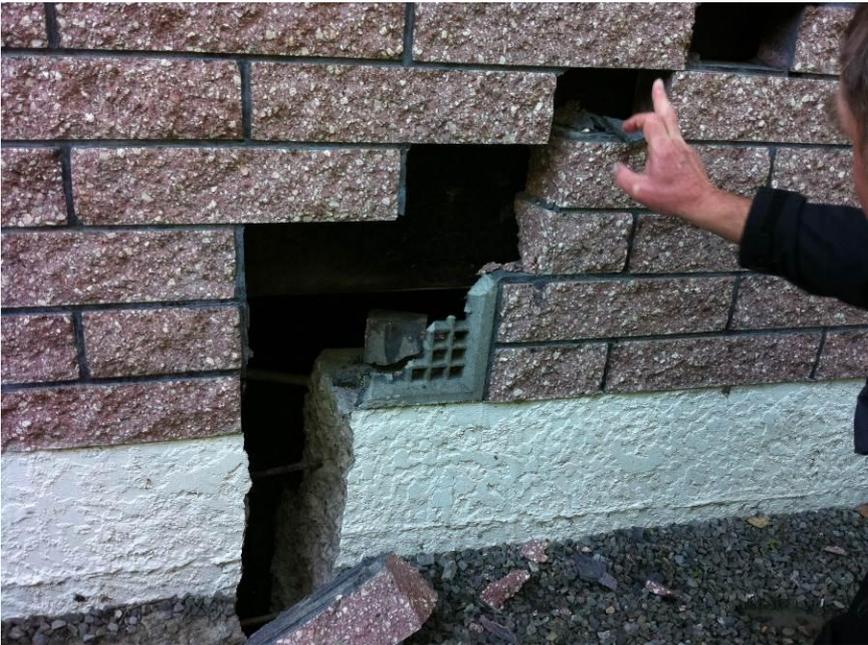
Slab on grade foundations performed well under earthquake shaking. However, ground deformations beneath these slabs, caused either by liquefaction settlement or lateral ground spreading on the flat or ground slumping in the hill suburbs, resulted in sometimes severe distortions of the concrete slabs. The common perimeter concrete foundation with internal piles also fared well under ground shaking but was affected by varying degrees by the ground movement. It was common for these perimeter foundations to be unreinforced in the early to mid 20th century houses but most foundations constructed after this contained at least one 12mm diameter bar, often plain. Whether reinforced in this way or not, these foundations were unable to resist the ground deformations and fractured (Figure 5).

Figure 5. Example of reinforced concrete perimeter foundation pulled apart by spreading ground

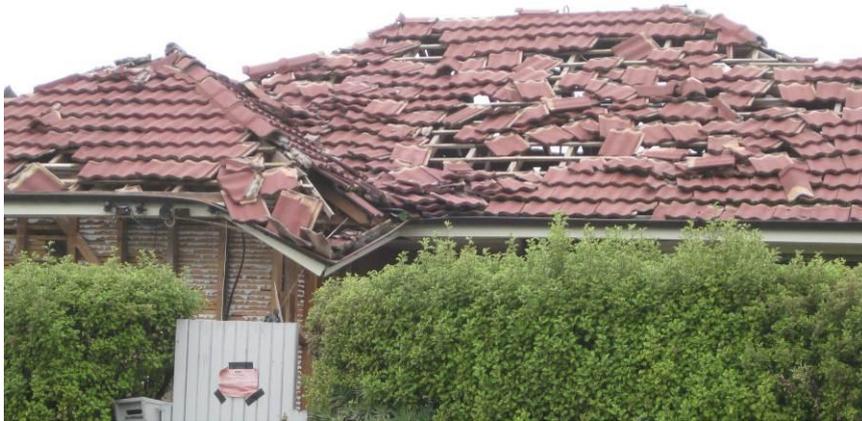
Damage to sheet roof claddings and metal tiles was confined mainly to damage sustained from falling chimneys and tended to be minor. Concrete and clay tile roofs also sustained damage from falling chimneys but those in the hill suburbs often suffered from dislodgement of the tiles from the supporting battens (Figure 6). It was common for such tiles not to be tied to the framing or for the ties (if they were present) to have corroded. Very high vertical peak ground accelerations ($>1g$) were recorded in February 2011 in the hill suburbs and this is sure to have contributed to the tile dislodgement.

Figure 6. Dislodged concrete roof tiles
