A Study of Seismic Strengthening Behavior for The Dry-wall With Mortar-filling System in Taiwan

SUMMARY:

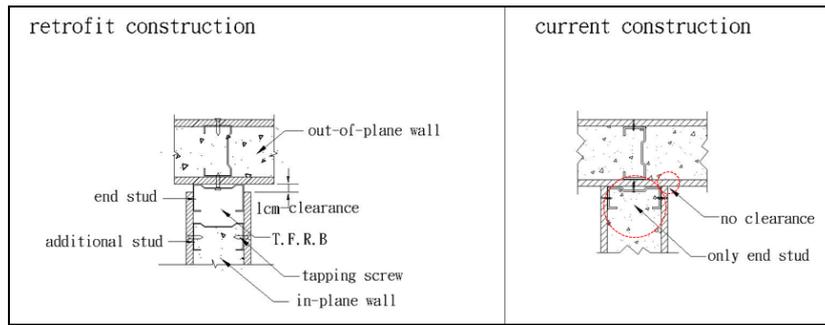
Figure 7. Retrofit construction in T shape wall

W7 and W8 specimens were T shape walls and the construction was similar to W6. In comparison with W3 specimen, which had panels of the in-plane wall directly connected to the out-of-plane wall, a 1cm spacing was left in W7 and W8 specimens (see Figure 7). W8 was almost the same as W7 but an additional stopper was placed at the top junction of the two perpendicular walls, shown in Figure 8.

The testing results of W7 and W8 specimens were shown in Table 4. In comparison with the results of W3 specimen, many problems had been improved in W7 except the raked out-of-plane walls. This problem was due to the impact from the in-plane wall with increasing imposed drift. In order to solve this problem, a stopper was installed in W8 specimen at the top junction of two perpendicular walls.

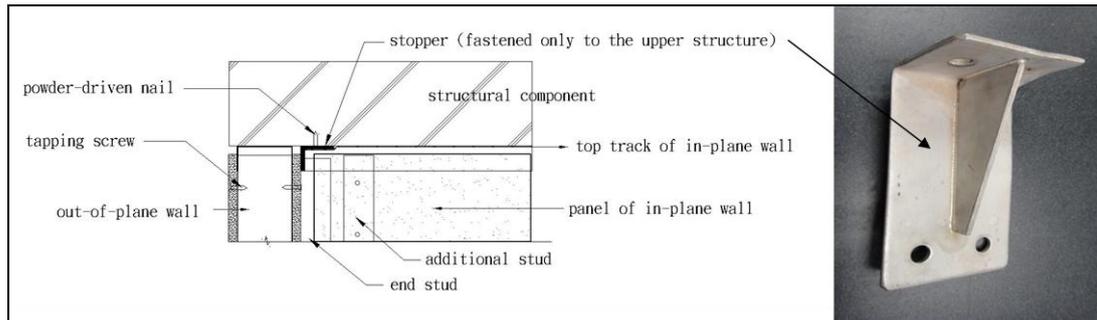
Figure 8. Details at the top junction of two walls in W8 specimen

The stopper provided its own stiffness to resist the impact and therefore the out-of-plane wall was leaned slightly at a 3.0% drift ratio. Furthermore, the same degree of slope like W3 specimen occurred at a drift ratio of 5.0%.

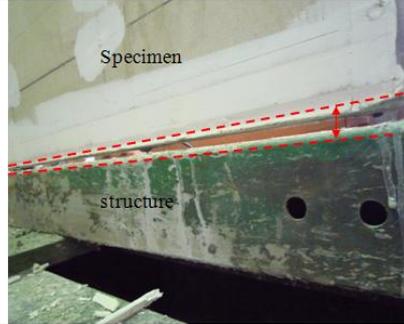
1. End studs failure		
<p>Separation between the end studs and the structure components.</p>	<p>Most of the nail heads were pulled out from the end studs and the nails were also damaged.</p>	<p>Screws fastened to the panels were embedded.</p>

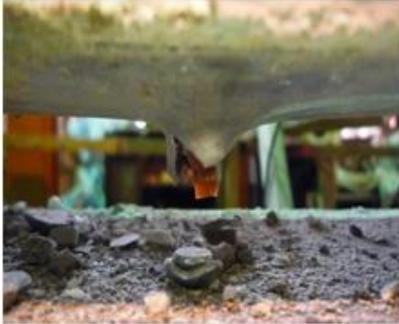
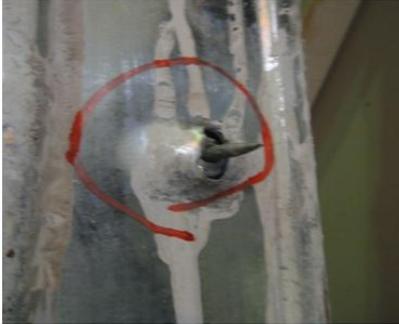
2. Bottom tracks failure

The specimens were uplifted from the structures.	Most of the fasteners were threaded through the bottom tracks.	Some nails were directly pulled out from the structures.
3. Panels failure		4. Water pipe failure

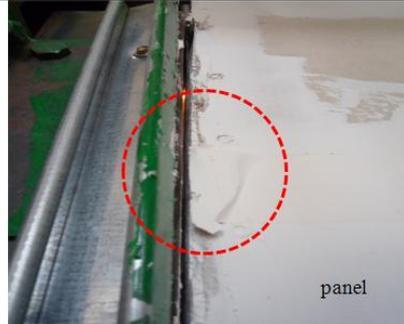
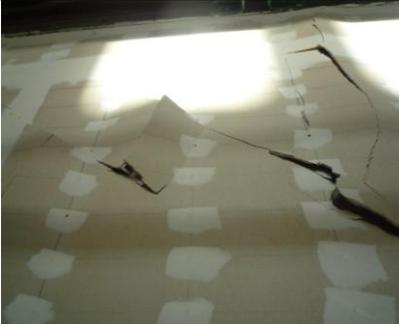
Local cracking of the panels.	Widespread collapse of the panels.	Shear failure of the water pipe.
5. Junction failure of the two walls

The 1 cm clearance between the panels and the structure components was lost as testing progressed. Subsequently, at large drifts the panels came into contact with the structures and were under compression and shear. The panels sustained localized cracking at the top corners of the walls at a drift ratio of 1.1%, and widespread collapse appeared at a drift ratio of 2.1%. At the same drift level, the water piping experienced shear failure.

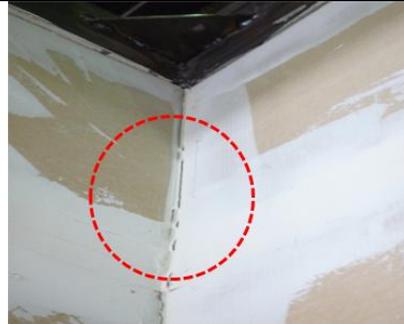
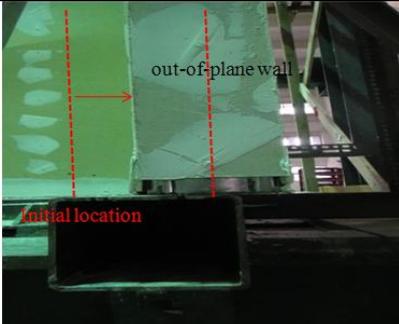
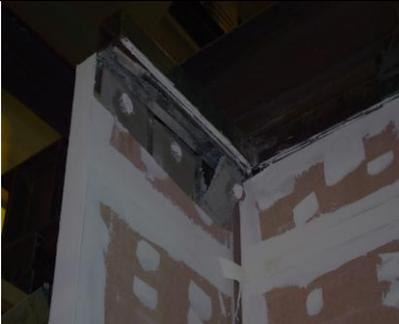
Separation at the junction of the two walls.	The fasteners of the bottom tracks were all damaged and the out-of-plane walls moved.	The top track flanges were bended and the out-of-plane walls leaned.

For W3 and W4 specimens, the damage progression of the in-plane walls resembled that in W2. But another significant failure occurred at the out-of-plane walls. As the specimens were cycled back and forth, the interaction between in-plane and out-of-plane walls was damaged most severely at the connections. In addition to the separation appeared at the junction, the top track flanges were bended and no longer restrict the out-of-plane walls. The separation was visible at a drift ratio of 0.8% and was totally separated at a 1.5% drift ratio. At a drift ratio of 3.0%, the out-of-plane walls leaned seriously and the testing stopped in fear of collapse.
