Vulnerability Assessment Of Building Stock At Historic City Of Pune , India.

With Reference To Pounding Hazard

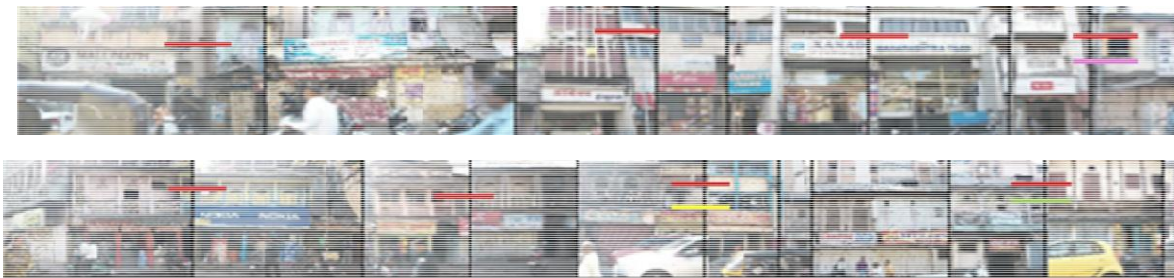
Figure 2 : Streetscape Kumthekar Road, Pune

A highly congested and a major traffic carrying street “Kumthekar Street” have been selected for detailed study. Buildings located on this street are surveyed with reference to floor plan, seismic separation with adjacent buildings, relative position with adjacent buildings, age of the buildings, material and technology used for construction, floor height, building height, faced treatment, presence and type of openings, building facade details, use of building, occupancy, accesses to the building.

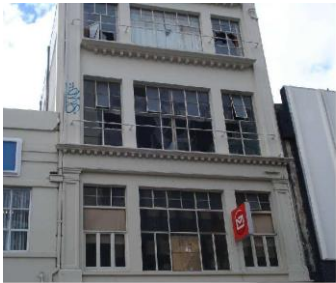
In case of minor or negligible pounding, there may be the initiation of mechanisms leading to building failure under further seismic activity. In Christchurch earthquake moderate to serious pounding damage occurred in unreinforced masonry (URM) structures, while concrete structures suffer localized damage. A damaged building is shown In figure 3.

Figure 3. Moderately damages building at Christchurch.

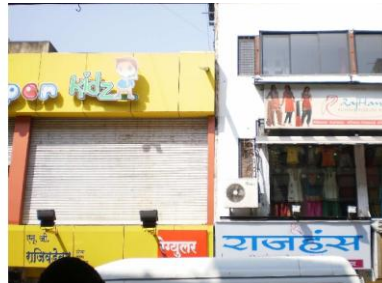
Figure 4. Building at Laxmi Road , Pune

There are a large number of such building with similar configuration are in existence in the selected study area which are likely to suffer from such damage. If URM buildings do not have adequate seismic separation pounding may occur. A four storied building at High St (figure 5). It also suffered localized damage because of the brittle nature of the unreinforced masonry, and presence of R.C.C. lintel immediately above the parapet of the adjacent building result in the damaged masonry. Buildings were identified with identical details in the selected study area (figure 6) which are highly susceptible for damage in case of earthquake occurrence.

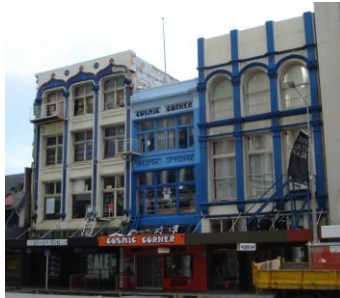
Figure 5. Building at High Street, Christchurch.

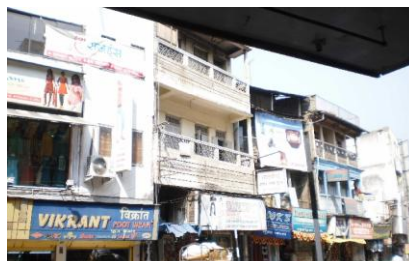
In highly populated area of city a number of buildings are in existence without seismic separation. In such circumstances the buildings at the central part may suffer badly. Figure shows the central two of four consecutive buildings with zero separation, where damage was confined to the interface between the two buildings. In addition considerable at first floor level masonry crushing is observed (figure 7,8).

Figure 8, Building in series, Pune

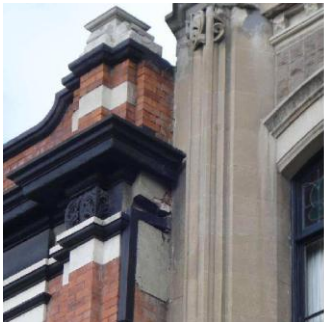
In downtown area many buildings façade is not in a single line. In such cases where adjacent buildings have a façade setback they are susceptible to pounding damage at the exposed corners (Figure 9). This is a common phenomenon as observed in existing building stock in selected study area (fig 10).

Figure 9. Damaged building with façade setback, Christ Church.

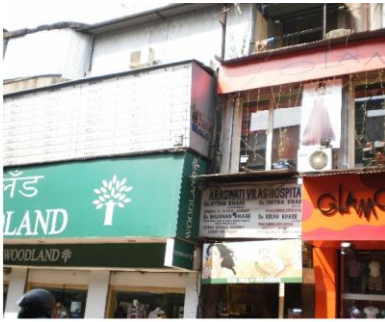
Figure 10. Building with façade setback, Pune.

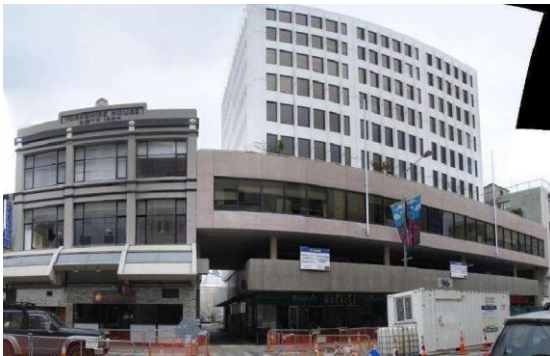
Adjacent buildings with greatly differing total heights displayed surprisingly little damage, while the most severe damage observed between buildings differing by three or more storeys. In such kind of damage buildings suffer damage to their vertical structural elements and not their horizontal elements (figure 11, 12.).

Figure 11. Minor damage to adjacent building with different height., Christchurch

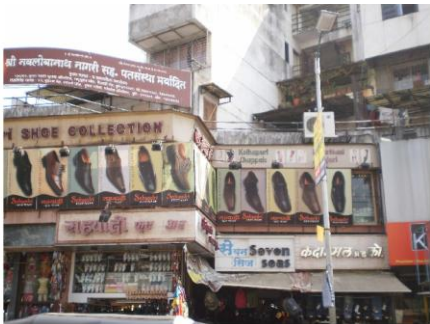
Figure 12. Adjacent building with different heights Pune.
