Study on Partial Collapse of a Five Story Reinforced Concrete Building during the 2010 Chile Earthquake

M.A. Hube, P. Vizcaíno, D. Lopez-García & J.C. de la Llera

Pontificia Universidad Católica de Chile, Chile

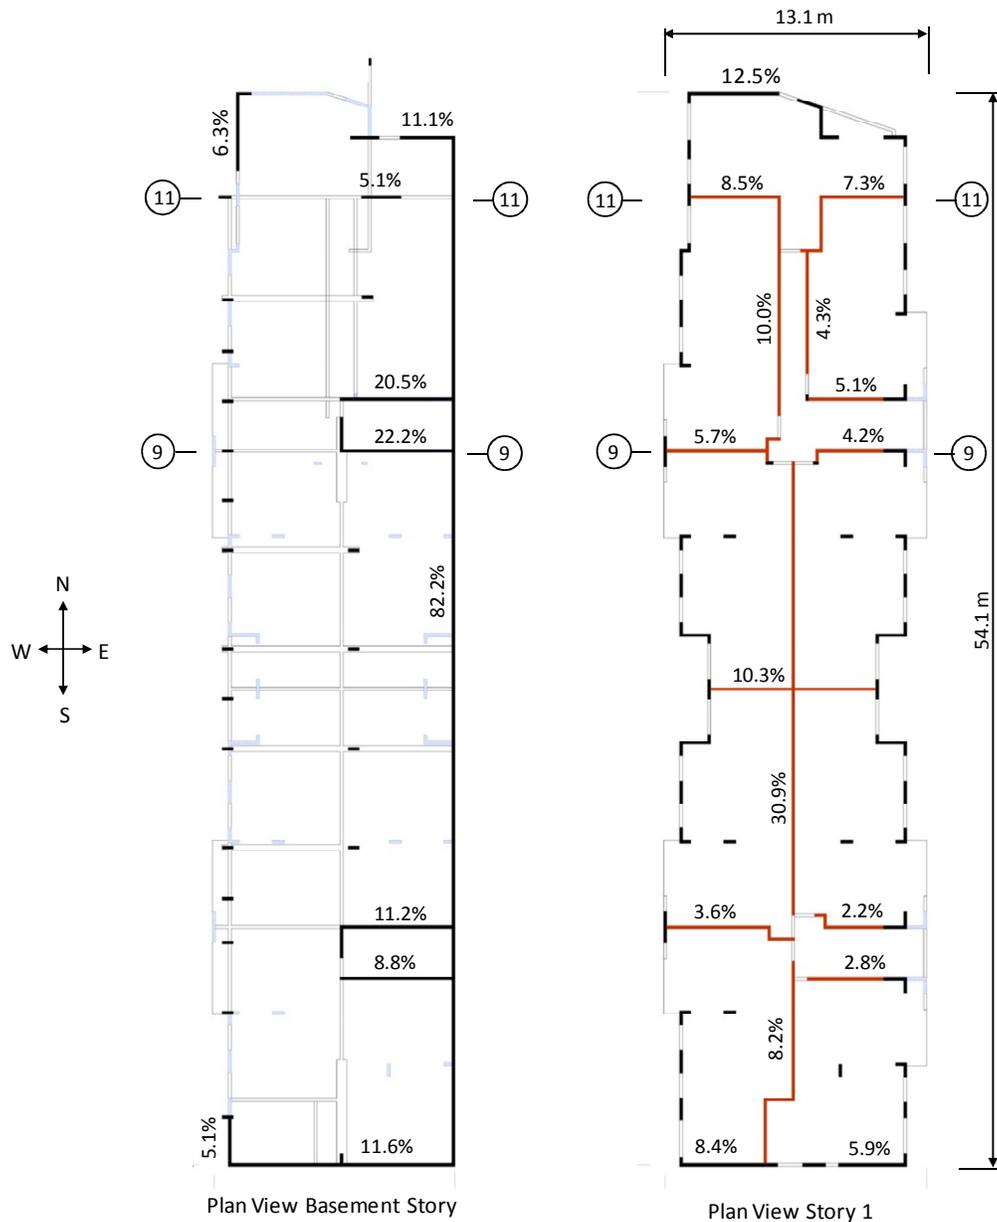
Figure 1. Plan view of basement and story, and percentage of story shear taken by longitudinal and transversal walls. RC elements are shown in black and CM elements in red.

Vertical irregularity of Don Tristán building is evident from the plan view (Fig. 1), where only 44% of wall area of the first story was continuous towards the basement story. In the longitudinal direction, the CM walls located at the center corridor of the first story did not continue towards the basement story. Additionally, in the longitudinal direction of the basement story, most wall area is concentrated in the perimeter wall of the east side, which induces torsion. In the transverse direction, most of CM walls located at the west side of the first story did not continue towards the basement story, and slender RC walls of 55x15 cm were detailed at the west side at the basement story (shown in black in Fig. 1). The vertical irregularity of the building can also be observed in the elevation of axis 9 and 11 in Fig. 2. In both axis, RC was considered for the basement story and mostly CM was considered for the upper story. Additionally, there is a large vertical discontinuity of the walls between the first story and the basement.

The percentage of the story shear that takes the principal walls in the longitudinal and transverse direction for the basement level and first story, when accidental torsion is ignored, is shown in Fig 1. For the transverse direction of the basement level, most of the story shear (90.5%) is distributed within seven walls, where the most demanded wall takes 22.2% of the story shear. For the longitudinal direction of the basement level, 82.2% of the shear wall is taken by the perimeter wall of the east side, which induces torsion to the building. For the transverse direction of the first story, 52.3% and 47.7% of the story shear is taken by CM and RC walls, respectively. For the longitudinal direction of the first story, 59.9% and 40.1 of the story shear is taken by the CM and RC walls, respectively. Since RC walls takes less than 50% of the story shear in the first story, a reduced R^* that takes this fact into account is considered in this dynamic analysis, according to NCh433. It is important to notice that the discontinuity of the vertical elements between the basement level and first story implies that the shear force needs to be distributed throughout the slab from. However, shear damage in the slab could not be observed by the authors because access to the interior of the building was not allowed.

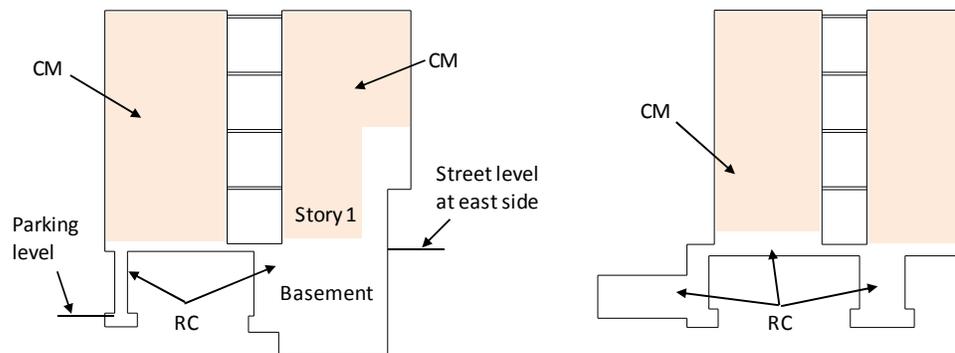
Figure 2. Vertical irregularity in elevation of axis 9 (left) and 11 (right)

The vertical irregularity of the building could also explain the building collapse by causing stress concentration and localized damage in the basement walls. Example of vertical irregularity of the building is shown in Fig. 2, where high axial load is induced from the overturning moment which is transferred from the CM walls of the first story to the slender RC walls of the basement. Another important vertical irregularity is located in the transverse axis at the center of the building. In this axis, RC walls at the basement transfer some of the shear force resisted by the center CM wall (10.3% of story shear is resisted by this CM wall in story 1, Fig. 1) to the foundation level. Therefore, the vertical discontinuity at this section results in excessive shear demand in the slender RC walls of the basement (Fig. 8).

(4) The vertical irregularity at the basement stories in current residential buildings is somehow excessive. This irregularity induces concentration of stresses and localized damage. The vertical irregularity issue must be incorporated in Chilean design code.

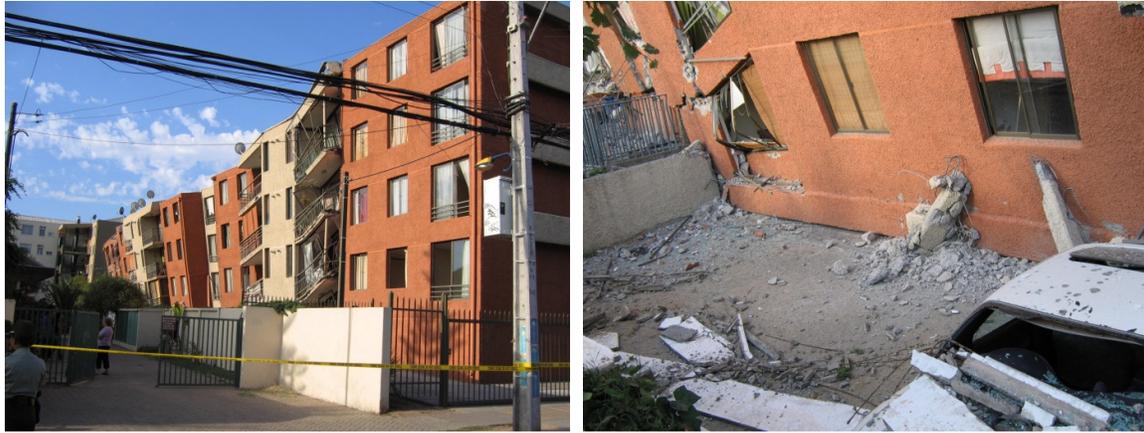
During the 2010 Chile earthquake, all the columns located in the basement story along the northern half of the west side and the longitudinal wall located at the north-west corner lost their capacity to carry gravity loads, and were completely crushed by the upper stories as these fell directly on the ground (Fig. 3). The east-south part of the building, however, did not fall because the perimeter walls located along the east and south sides remained basically undamaged. Hence, huge differential vertical displacements were induced between the falling part of the building and the part that did not fall. These large differential displacements destroyed many slab edges, particularly at the boundary between the falling and non-falling parts of the building (Fig. 3). The falling part also rotated along a horizontal longitudinal axis as it fell, which caused further damage at the walls located along the northern half of the east side (Fig.4).

The described observations suggest that the collapse of Don Tristán building can be characterized as a partial weak-story failure at the (partially buried) first story. Unfortunately, possible reasons why some vertical elements at the first story lost their load-carrying capacity could not be observed in the field because these elements were totally destroyed.

Figure 3. Damage of Don Tristán building after the 2010 Chile earthquake: (left) general view from the southwest, and (right) the first floor level resting directly on the ground at the basement level (the remains of totally crushed columns can be observed)

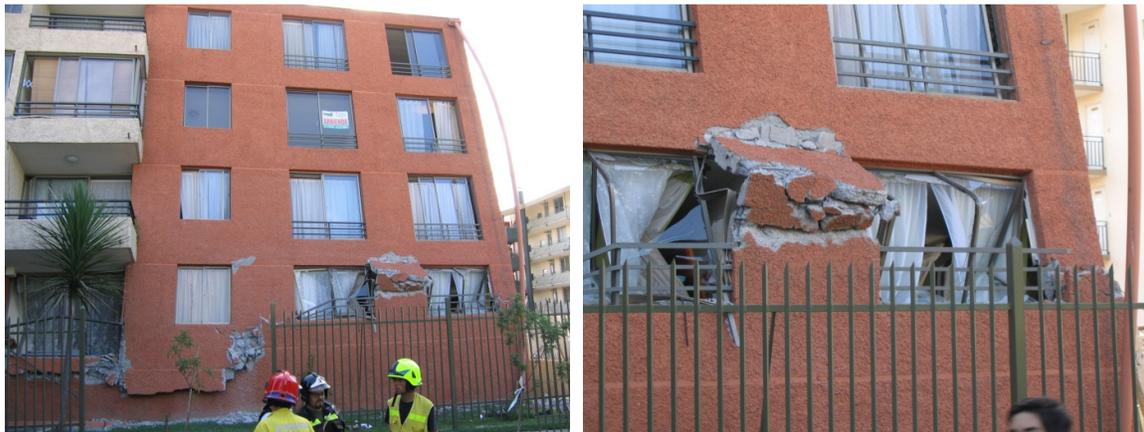
Figure 4. Northern part of the east side of DonTristán building after the 2010 Chile earthquake

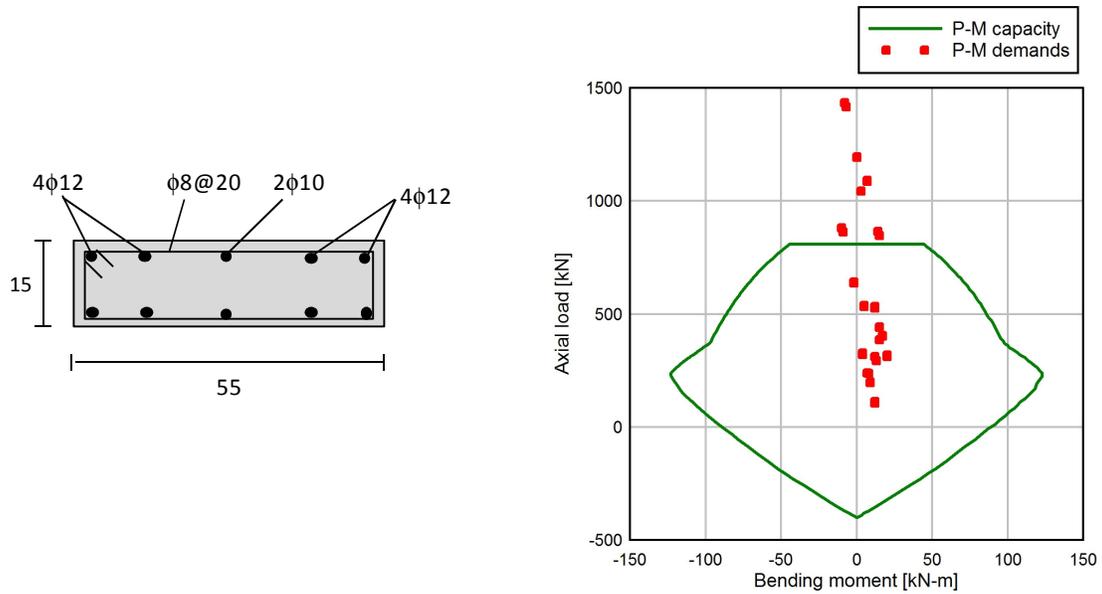
The critical elements of the building are the 55x15 cm RC walls located at the west side of the basement. The detailing of these walls is shown in Fig. 6, which considers 4 ϕ 12 vertical bars at the boundary and stirrups ϕ 8 spaced at 20 cm. The interaction diagram for combined axial load and bending moment of the 55x15 cm wall, located at the west side of the basement of axis 9 (Fig. 2) is shown in Fig. 6. In this diagram, demand/capacity (D/C) ratio is 1.77 and the maximum factored compressive load from the load combinations represents $1.1f'_c$. The large compressive load in this wall is induced by the overturning moment which is generated by the seismic action in the transverse direction. To prevent brittle compressive failure in RC walls, NCh433 was modified in 2011 introducing a limit in the axial stress of walls of $0.35f'_c$ (2011).

Figure 6. Typical detailing of 55 x 15 cm walls and confined concrete at the stirrups level (left) and interaction diagram of 55x15 cm wall in the basement of axis 9 (right)

Besides the limited strength of the basement walls, the confinement provided to the 55 x 15 cm walls is negligible because of the large stirrup spacing, the lack of cross ties, and the thin section of the wall. This limited ductility is not appropriate for the reduction factor considered. Using the Mander approach (Mander et. al 1988), the area of confined concrete at the stirrups level, shaded regions in Fig. 9, is 18% of the area of confined core. Considering the stirrups spacing of 20 cm, the area of effectively confined concrete core at midway between stirrups is only 1% of the concrete core. With such confinement, crushing of concrete is achieved at a strain of about 0.003 and a brittle compressive failure is expected beyond that strain.

(3) The confinement requirements for RC walls need to be revised to prevent brittle behaviour. However, the confinement requirements and the limit of the axial stress in RC walls have already been modified in Chilean code after the 2010 Chile earthquake.

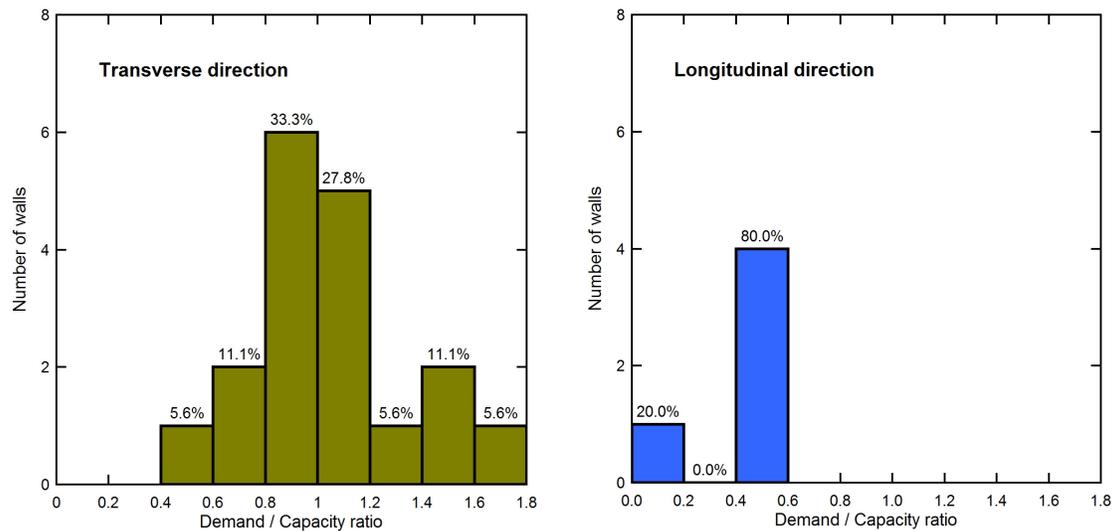
The frequency distribution of D/C ratios for combined axial load and bending moments of the basement walls is shown in Fig. 7, where the D/C ratio is the quotient of the distance between the origin and the demand point, and the distance between the origin and the capacity curve. For the transverse direction 10 walls has D/C ratios larger than 1.0 and for the longitudinal direction the D/C ratios of every wall are less than 1.0. The basement walls with D/C ratio greater than 1.0 are shown in Fig. 8, where most of this walls are located in the west side and the center of the building, which is consistent with the observed damage (Fig. 3).

Figure 7. D/C ratio histogram for combined axial load and bending moment for basement walls

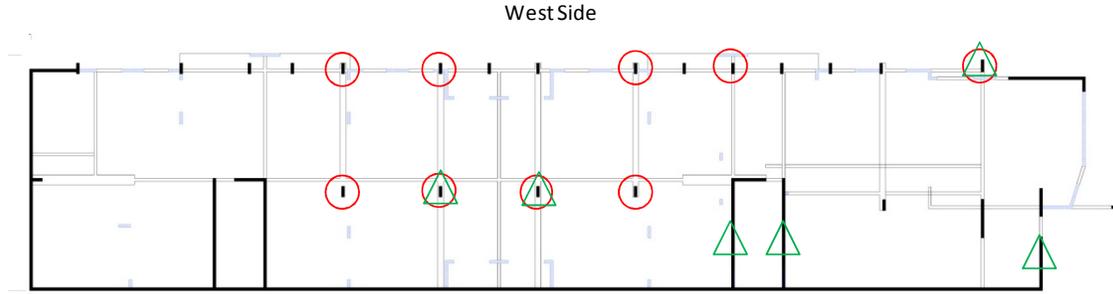
Figure 8. Walls of the basements with combined axial load and bending moment D/C ratios > 1.0 (red circles) and with shear stress beyond ACI limit (green triangles)

The shear stresses of the RC walls of the basement are also verified. For the transverse direction, six walls exceeded the shear stress limit of $0.66\sqrt{f'_c}$ (MPa) required by ACI. These walls are marked with green triangles in Fig. 8. For the longitudinal direction, the walls of the basement do not exceed the shear stress limit.

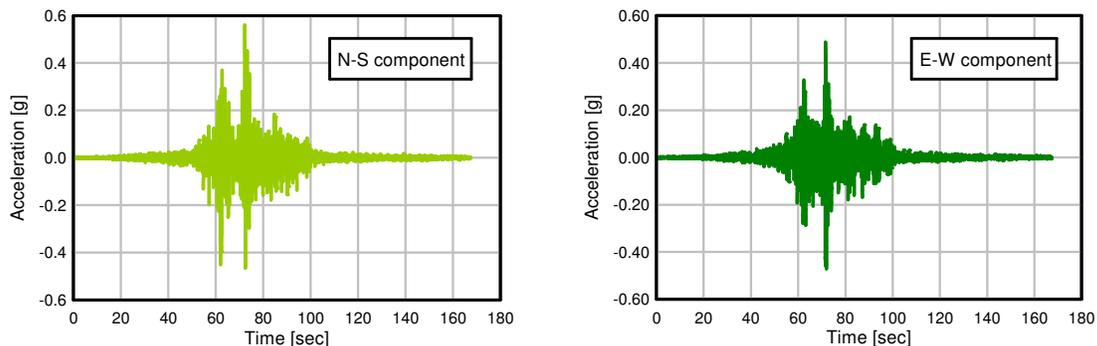
Regarding the ground motion, the only ground acceleration histories recorded during the 2010 Chile earthquake in the Maipu area are the ones recorded at the Maipu station, located just 2 km away from the building. Both horizontal components are depicted in Fig. 10. They are typical Chilean records in that the duration is long and near-fault effects are absent. Since soil conditions at the Maipu station are similar to those at the location of the building, and the Maipu area is not close to the main rupture area, these records give a good idea of the ground accelerations the building must have been subjected to during the 2010 Chile earthquake. PGA values of the N-S and E-W components are equal to 0.56 g and 0.49 g, respectively, which are significantly greater than the design PGA of 0.30 g indicated in NCh433. A comparison between the pseudo-acceleration response spectra (damping = 5%) of the Maipu records and the NCh433 elastic design spectrum can be seen in Fig. 11 (left), where it can be observed that, at least in the range of periods considered (up to 2 sec), the spectral ordinates of the Maipu records are always greater than the ones of the NCh433 design spectrum. In particular, the spectral ordinates of the records are essentially equal to that of the design spectrum at the first lateral period of Don Tristan building in the transverse direction (0.181 sec), but are 30% greater at the first lateral period in the longitudinal direction (0.140 sec). Therefore, the amount of damage in the transverse direction could not be explained by the level of ground shaking, even though the ground shaking appears to be greater than the level of ground shaking for which it was designed. However, the periods of the building may have increased by the induced damage, where the spectral ordinates of the records are much higher than the ordinates of the design code.

Figure 10. Ground acceleration histories recorded at the Maipu station during the 2010 Chile earthquake

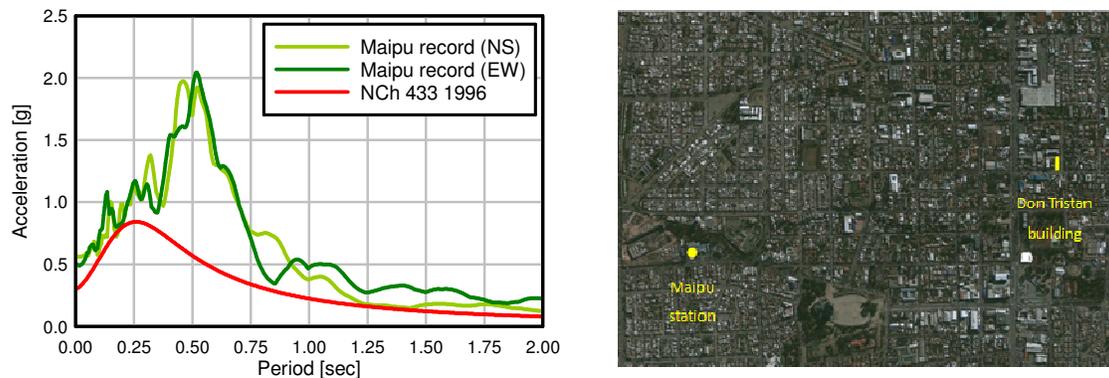
Finally, Don Tristan building was just one of the many engineered buildings located in the urban Maipu area, which can be appreciated in Fig. 11 (right). Only a handful of these buildings suffered some degree of structural damage during the 2010 Chile earthquake, and the only other one that collapsed (actually a structural collapse, i.e., damage well beyond repair) was the Don Luis building, which is nearly identical to Don Tristan building. These observations strongly suggest that the reason for the collapse of Don Tristan building are related to its structural characteristics rather than to the level of ground shaking it was subjected to.

Figure 11. (left) Comparison between pseudo-acceleration response spectra and Code design spectra for 5% damping and (right) aerial view of the Maipú area
