# The Role of Timber Roof Structures in the Seismic Response of Traditional Buildings

M.A. Parisi, C. Chesi & C. Tardini

*Politecnico di Milano, Milano, Italy*

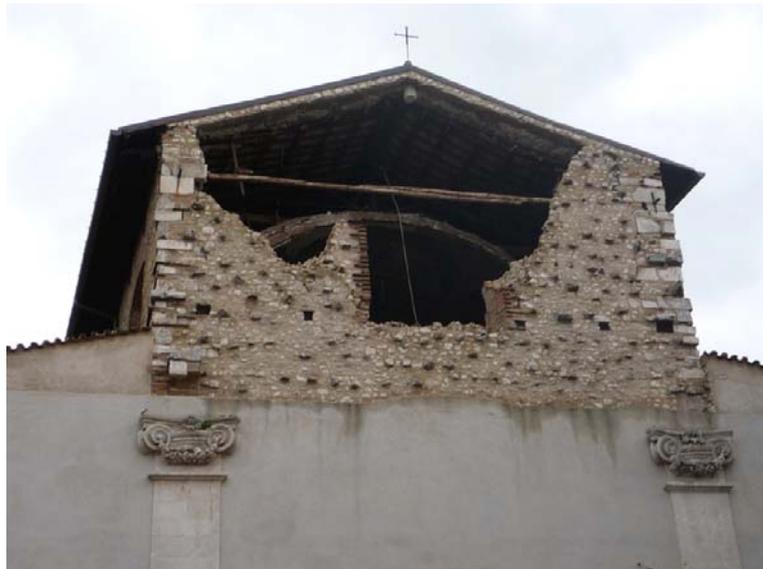
The church of San Biagio Amiterno at L'Aquila is an interesting case of heavy seismic strengthening, which could be observed also in other heritage buildings in the area. The church, which suffered severe damage during the earthquake of 2009, including the collapse of the tympanum, as in fig. 1, is located in the historical town center and dates back to the first part of the 13<sup>th</sup> century. The timber roof structure that was present at the time of the earthquake could be dated to the beginning of the 18<sup>th</sup> century, but had undergone at different times in its history restoration interventions as well as seismic strengthening.

Figure 1. Façade of the church of S. Biagio Amiterno, L'Aquila, with the tympanum collapsed after the earthquake of 2009

These massive and stiff strengthening interventions carried out in the L'Aquila region raised much debate on whether, and possibly to what extent, they triggered damage rather than avoiding it, and consequently whether they should be removed where still standing during reconstruction. For the church of San Biagio in particular, the data available on the roof history, the possibility of inspection of the church after the earthquake, and again at the beginning of reconstruction gave occasion for investigating the relationship between the strengthening of the roof and the collapse of the tympanum. An extended discussion is reported in (Parisi et al., 2012).

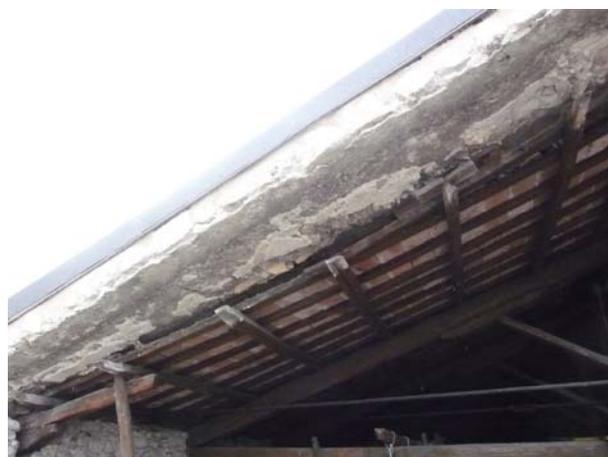
For the church of San Biagio, as for many others in town, slabs composed of hollow brick elements and concrete, bordered with a concrete ring, were cast over the roof structure at the beginning of the eighties of the 20<sup>th</sup> century. The objective of this operation was to create a strong link connecting the opposite walls in contact with the roof and develop a box behavior. This would protect particularly the upper part of the church that appeared more vulnerable with respect to the lower building, restrained transversally by the surrounding buildings forming an aggregated block. Figure 2 shows details of the section of the slab laid over the original roof structure.

Figure 2. The roof structure loaded with a brick slab bordered with a concrete ring beam.

A finite element model of the structure in different mass conditions has been developed and a series of modal and seismic analyses have been performed. Given the type of failure, the most interesting quantity to compare was the maximum longitudinal displacement in correspondence with the ridge beam. Synthetically, values reached for the original structure were approximately 4.5 cm and 3.7 cm for the code spectrum at 975 and 475 years of return period respectively, and 3 cm for a spectrum based on the L'Aquila sequence. This included records of the main shock and of pre- and post-event shocks, necessarily scaled. Corresponding values for the heavier structure were 7.5, 5, and 3.8 cm, respectively. In the case of overload from the intervention, the longitudinal displacement increased of about 26 percent. The levels of stress in the elements were checked and found in the elastic domain for all the cases.

The displacement value at the ridge beam, as noted above, grows appreciably from the original structure to that with increased mass derived from the intervention. Yet, in the two cases the displacements are in the same order of magnitude. It has to be pointed out that the increase of stiffness, which would likely reduce the deformability of the system also in the longitudinal direction, conservatively has not been taken into account in the above figures. Therefore, for the case of San Biagio it seems not possible to attribute the collapse of the tympanum directly to pounding due to the augmented mass of the intervention performed, as originally proposed by a first inspection. Very likely a lack of connection between the roof and the top of the tympanum left the latter widely unrestrained at its borders and was not remediated during the intervention, considering as well the presence of a large window at its base and some irregularities in the masonry texture on its left side visible in pictures before the earthquake. The lack of connection very likely existed also in the primitive conditions. A more effective intervention should have limited the displacement of the roof, possibly with light systems as in a following case, and simultaneously developed a connection for the tympanum top to increase restraint at its border.

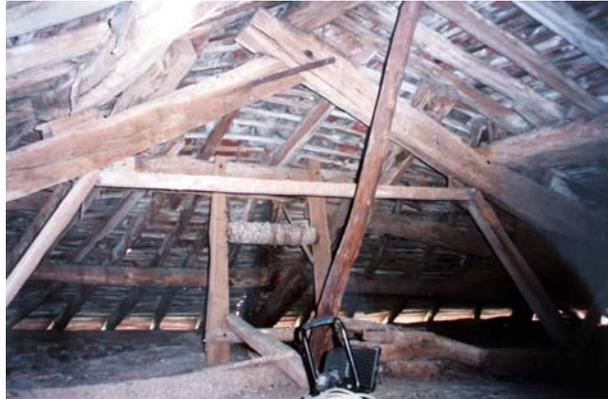
A very different case is that of the church of Santi Pietro e Paolo at Mettone, near Milano. In this case, at the beginning of this century, interventions were carried out on the timber roof structure, in order to improve its general stability, with no special reference to seismic response. The church is, indeed, located in an area characterized by very low seismicity. Yet, the interventions performed are of interest in general. The roof structure, dating back approximately to year 1570, consisted of a series of 6 trusses with a span of approximately 8 m, spaced 4.6 m. Diagonal bracing elements were present in the longitudinal direction, that is in the direction normal to the truss planes. Trusses had a scissor type of scheme with a half-depth joint between rafters, a very unusual layout in the country (fig. 3).

Figure 3. The original roof of the church of Santi Pietro e Paolo, Mettone.  
The joint at the rafters crossing and the diagonal bracing are visible.

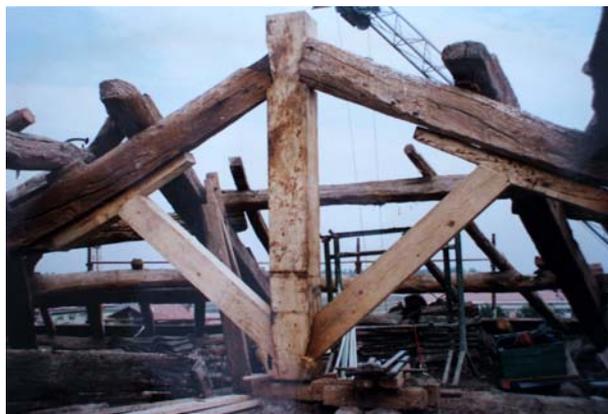
In order to improve the state of the structure, some refurbishing operations were performed on the timber elements, remediating some localized decay problem. The main intervention, however, regarded directly the trusses. The original layout was modified, cutting the top part of the rafters and introducing a post and struts, that is, transforming the structural scheme into a king post type (fig. 4). Additionally, the original diagonals were eliminated, in order to solve, with due cause, a problem of contact, as they were pointing into the vault underneath. At their place, shorter struts between the post and the ridge beam were applied.

The main result of interest here is that, given the size of elements and the general structural scheme the roof structure has a fairly low level of vulnerability, confirming the synthetic analysis by the vulnerability procedure, and is not likely to incur problems also in consideration of the low seismicity of the area. Yet, as effect of the intervention, the insertion of short struts that influence only the upper part of the trusses and the corresponding elimination of a more global bracing system has increased significantly the deformability in the longitudinal direction. In general, this deformability is particularly dangerous for the possible pounding effects on walls, as discussed in the case previously presented. The strengthening intervention, that was surely intended and meaningful for normal working conditions, has actually produced an increase of seismic vulnerability. This effect could have been avoided or limited studying a more suitable bracing system.

Figure 4. The truss after the intervention has acquired a king post scheme.

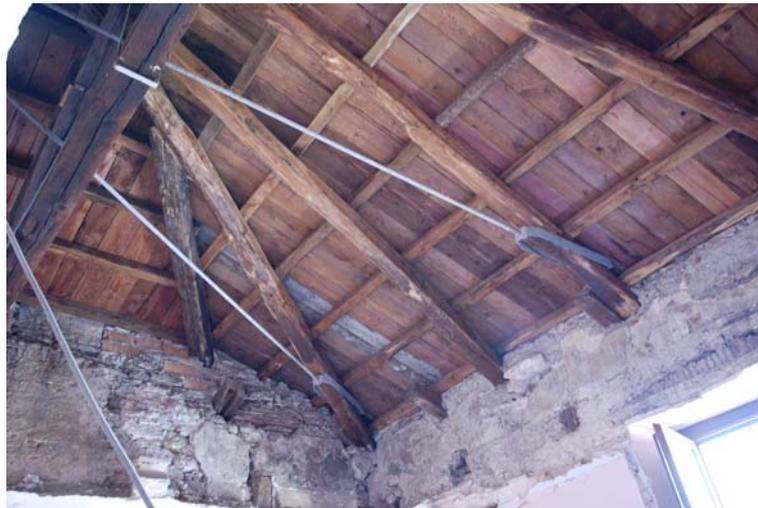
The strengthening intervention that had been recently performed on the roof may be seen in fig. 5. This inside view was possible from the opening caused by the unfortunate collapse of a vault. The roof had undergone intervention with light elements to improve its interior and exterior connectivity and remove thrusts. In order to appreciate the positive effect of this work, it must be considered that the earthquake had caused the opening of a significant crack on both sides of the corner corresponding to the picture. This crack pattern typically evolves into the detachment of the angle and of its subsequent possible collapse as a rigid block. In this case, the crack was well open up to the mid-height of the walls, but became narrower and was barely visible at the top, near the roof, indicating that a restraining action had occurred in this area. The roof action avoided more dramatic damage and probably collapse of a significant part of the building. The building is currently under repair.

Fig. 5. Low-mass intervention on a timber roof in L'Aquila.

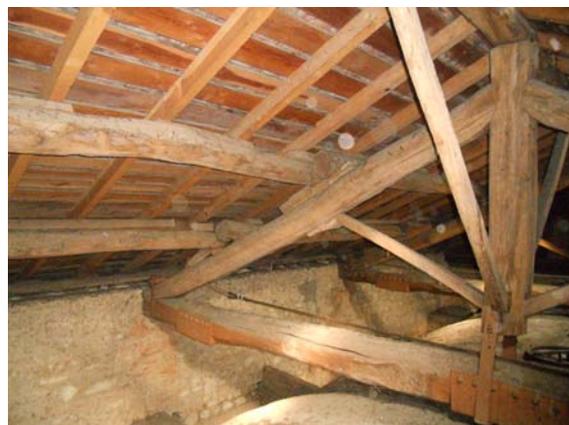
The second case is still under analysis, but it seems interesting because the intervention recognizes a possible problem in case of horizontal longitudinal motion of the truss top and takes care of it. The church of St Michele, in Vimercate, near Milano presents a roof structure composed of a series of king post trusses, which were irregularly spaced because one truss was missing at the intended spacing, an apparently strange situation which, on the contrary, was found also in other cases (Parisi et al, 2011b).

Fig. 6. Trusses of the church of St. Michael, Vimercate; the bracing element is visible.

The structure has been recently subjected to an extraordinary maintenance intervention intended to eliminate some local decay problems in timber elements and in the state of some metal connectors. Structurally, the main interventions consisted in adding a truss at the proper location and reconstituting regularity in the layout. Also, the roof system included here as well diagonal elements in the longitudinal direction (fig. 6). From the last truss near the tympanum area the bracing pointed directly onto the façade wall, inducing an extremely high risk of thrust on the most delicate area of the wall in seismic conditions. This situation, deriving from a conceptual error for not considering horizontal effects, was promptly corrected by eliminating the element, separating the structure from the wall, and creating a different horizontal retaining system. The detailed analysis of this case is in progress.
