Performance of Eccentrically Braced Framed Buildings In The Christchurch Earthquake Series of 2010/2011

G.C. Clifton, H. Nashid, G Ferguson, M Hodgson and C Seal
The University of Auckland, New Zealand

SUMMARY:

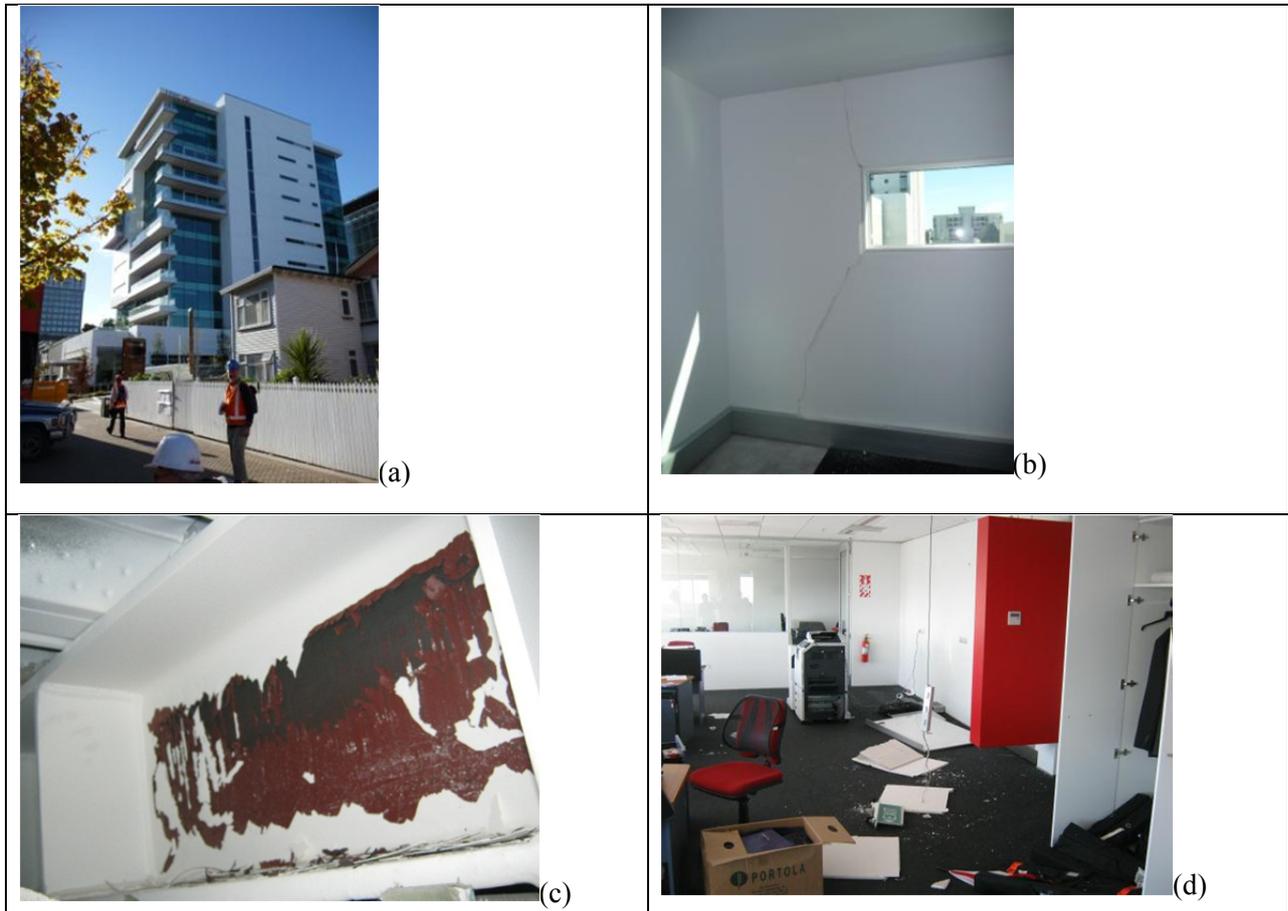
Figure 3.1 Club Tower [Photos by M. Bruneau and C Clifton]: (a) Global view; (b) cracking of partition in cantilevering portion of story; (c) paint flaking of EBF link in the ceiling space; (d) general view of office showing minor disruption

For the 12 storey building, estimates of the peak inelastic demand in the active link shown in Fig. 3.1(c) were made by two independent means. Firstly, through visible assessment of the active link yielded web metal and secondly through estimation of the peak interstorey building drift and conversion of this to a peak inelastic demand in the EBF active links. Both methods gave a peak shear strain of approximately 4%. The links were free of visible residual distortions. Assessment of damage accumulation in the steel at a peak shear strain of 4% over an estimated two complete cycles of loading using the damage criterion developed by Seal, (Seal, Hodgson et al. 2009) and change in transition temperature based on the work of Hyland, (Hyland and Ferguson 2006) showed that the yielded active links have used less than 20% of their total cumulative strain capacity and were therefore sufficiently robust to be left in place. Previously reported slab cracking (Bruneau, Anagnostopoulou et al. 2010) could not be detected as the concrete floor slab was covered by floor carpeting, except at the fixed end of one segment of the floor cantilevering on one side of the building (a feature present only over two stories for architectural effect). Crack widths in general monitored after each earthquake in the series did not increase after February 22, 2011, indicating that inelastic

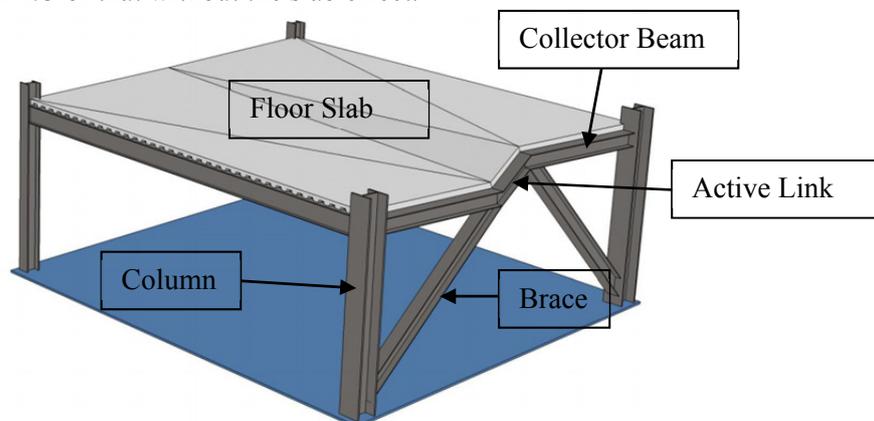
When the EBF system deforms inelastically it pushes the floor slab out of plane, as shown in Fig. 3.2. A composite floor system comprising concrete slab on steel deck on composite steel beams has a high out of plane resistance to this movement. This has been quantified through research into this system's performance in fire (Clifton, Gillies et al. 2010). A comparison of measured inelastic response of the 12 storey open plan building (based on sliding marks on the stairs) with the predicted response of the design models showed the building to be between 2 and 2.5 times stiffer than modelled and that the building has a post-earthquake residual drift of only 0.14%. This led to consideration that the out of plane resistance of the floor slab might be a significant source of this stiffness and unexpected ability to self-centre. An undergraduate study in 2011 (Mathieson 2011; Volynkin 2011) provided an initial quantification of these effects based on simple yieldline theory and showed that the floor slab decreased the peak lateral deflection of a hypothetical, 10 storey V-braced EBF designed to current New Zealand design practice (NZS3404 1997/2001/2007; Feeney and Clifton 2001) under a range of 10 representative earthquake records scaled to the ULS level by between 10 and 50% and the peak residual drift to less than 1/3 of that without the slab effect.

Figure 3.2 Floor slab contribution to EBF strength and stiffness

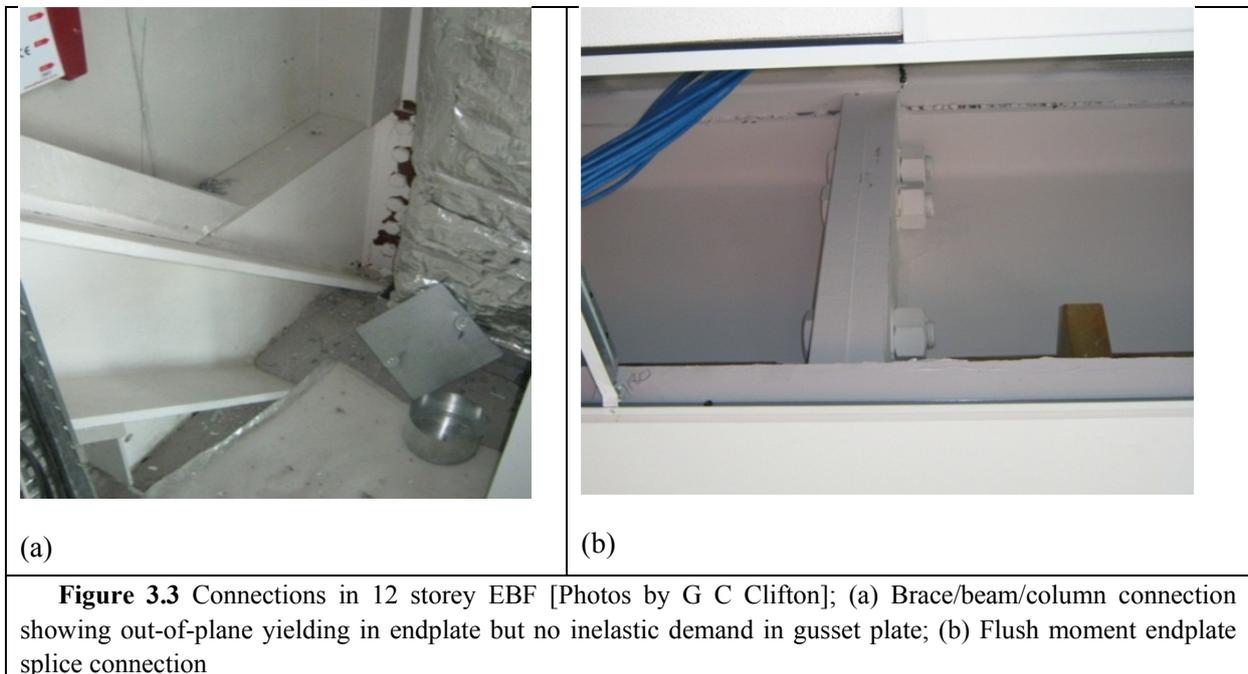
Connections in these EBFs performed very well and as expected; similarly with all well designed and detailed connections from multi-storey buildings in the Christchurch CBD. Two examples from the 12 storey building are shown in Fig. 3.3. Fig. 3.3 (a) shows a brace/beam/column connection in which the gusset plate is welded to the beam and bolted to the column with a flexible end-plate connection, which is designed and detailed to be rigid for vertical load transfer and flexible in the horizontal direction, to accommodate change in the angle between beam and column during the earthquake. This flexible end-plate has undergone limited out-of-plane yielding, protecting the gusset plate from inelastic demand as required by NZS 3404 for gusset plates. Fig. 3.3 (b) shows a flush endplate splice in a MRF beam that has performed well. Bolted splices in seismic-resisting systems inspected showed no signs of slip, consistent with expectations in NZS 3404 and HERA Report R4-76.

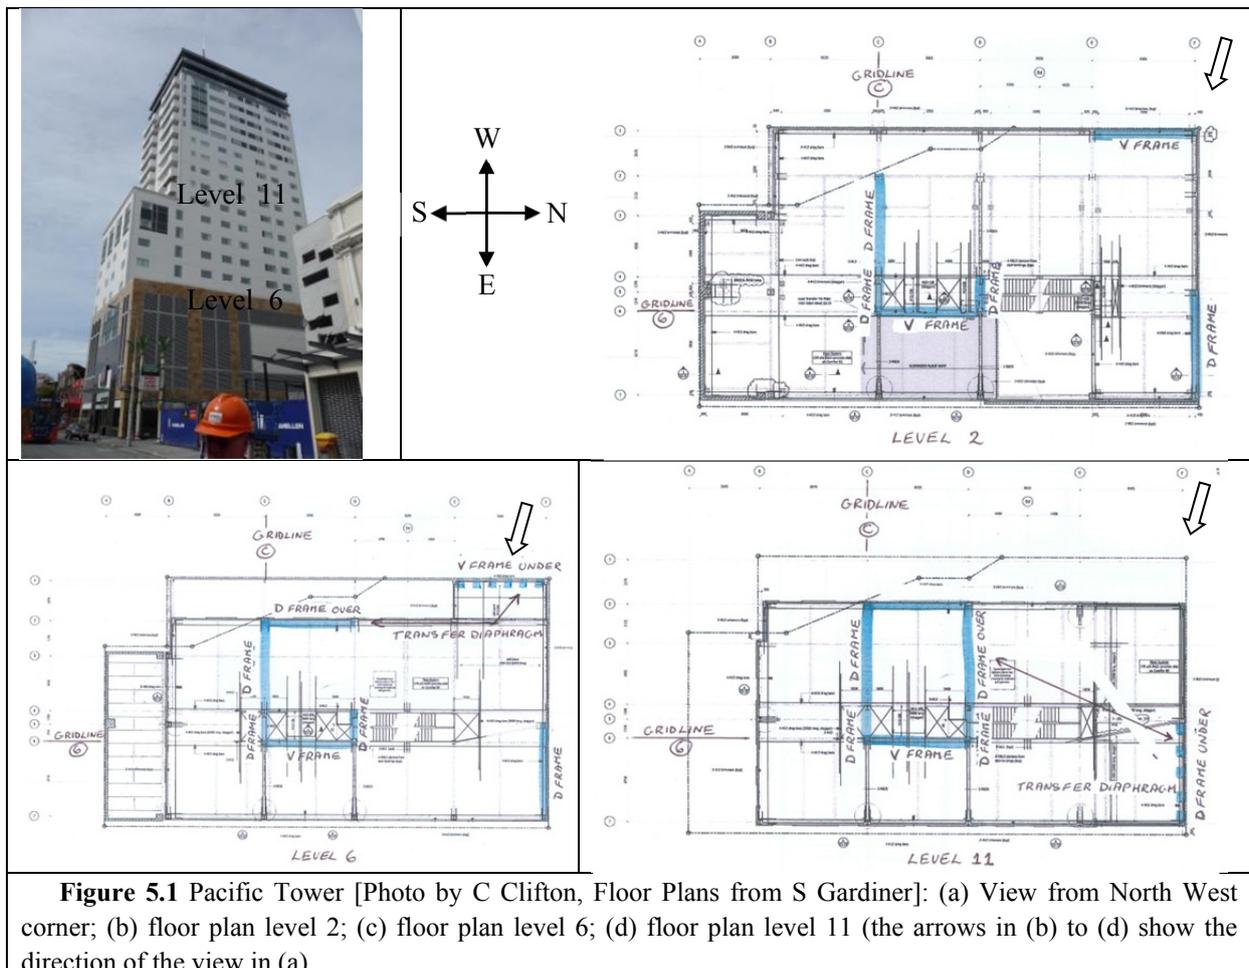
Fig. 5.1 shows a general view of the building and three floor plans, at levels 2, 6 and 11.

Highest demand has been from the very short active links in the North-West V braced frame, which is the frame shown in the top right corner of the floor plans at levels 2 and 6 in Fig. 5.1. Average HLD readings of 480 have been recorded in the fractured link. These links are being replaced and comprehensive testing on the extracted samples is scheduled for May 2012.

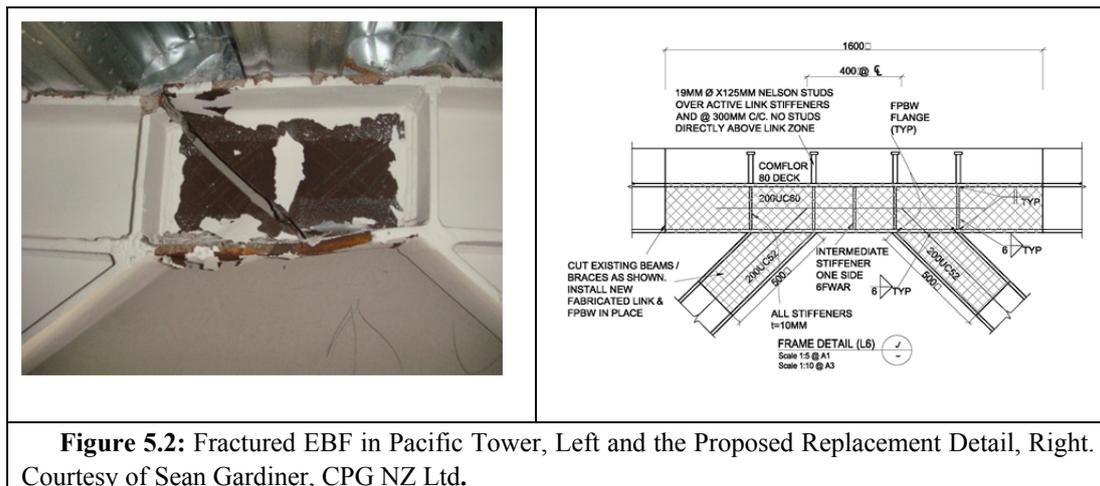
- The EBF frame on the west side near the north west corner that runs from level 2 to level 6 and comprises a V braced configuration with links at 400mm clear length is having all active links replaced, as the top link has fractured, as shown in Fig. 5.2(a). The clear length of all other active links in the building are around 800mm and so inelastic demand in these links is approximately double that of the others.

Figure 5.2: Fractured EBF in Pacific Tower, Left and the Proposed Replacement Detail, Right. Courtesy of Sean Gardiner, CPG NZ Ltd.

Replacement of the active links will be achieved by cutting out the active link and adjacent braces and collector beam (approximately 300mm outside the active link and panel zones) and replacing these with the shop fabricated detail shown in Fig. 5.2(b) which is site welded to the existing stub collector beams and braces. Replacement will take place in early May 2012.

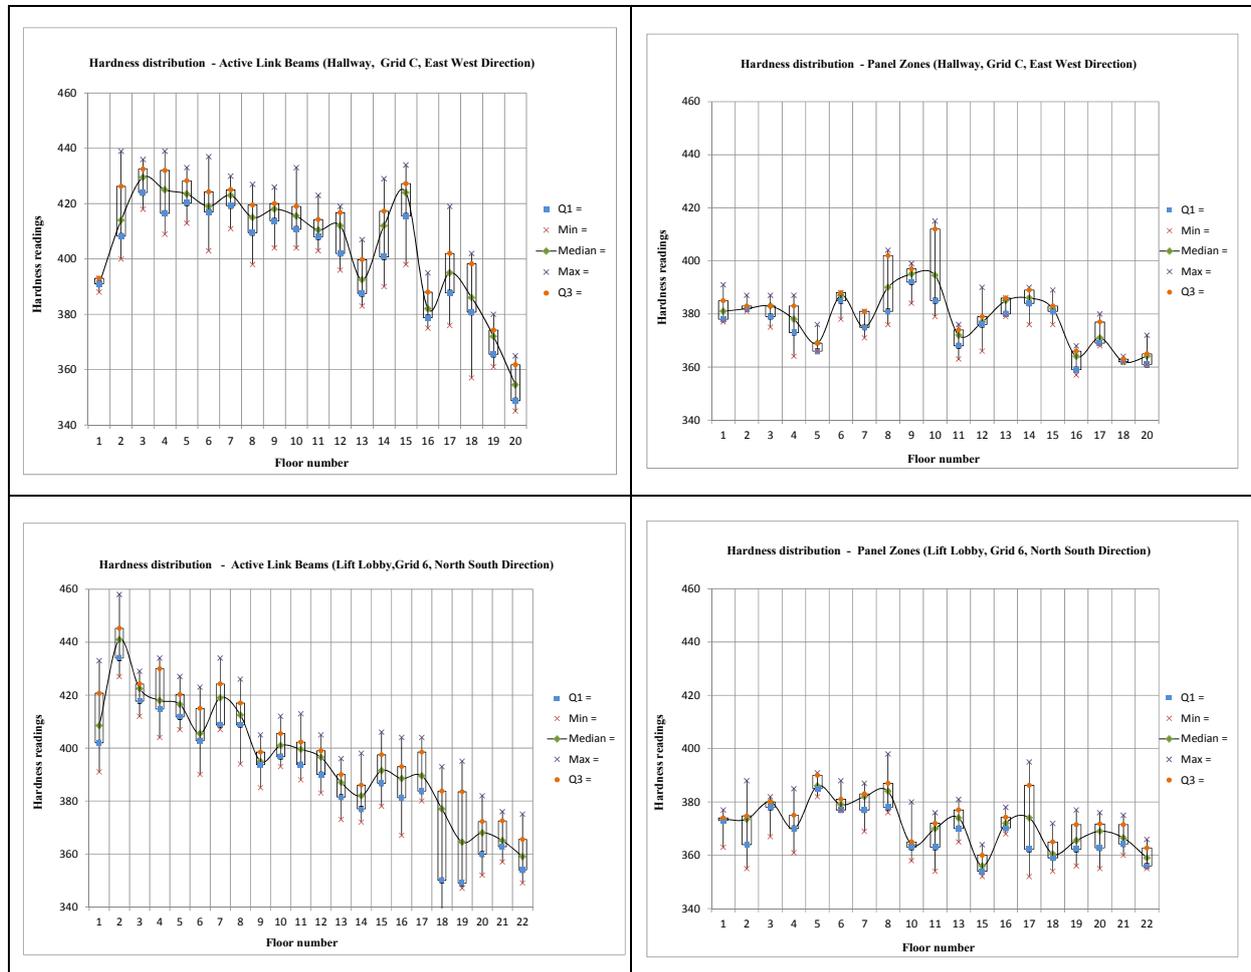
- For the grade of steel, all results are consistently lower than the expected HLD value of 420 (ref) by around HLD 40. At the time of writing this paper the reason for the low values is not known; it will be reported on at the conference. However, clear trends are apparent from the data. The baseline for the hardness from the panel zones can be taken as 380 for both frames, as the differences are very minor.
- From work undertaken by the second author in his PhD research, HLDs of 420 and 440 correspond to monotonic strains of around 7% and 20% respectively.

Figure 5.3: Leeb hardness values for selected components for two of the full height EBF systems in Pacific Tower. Clockwise from top left: (a) Hardness values for the active links in the D braced frame in the stairwell on gridline C, oriented East-West; (b) Hardness values for the panel zone in the collector beam adjacent to (a); (c) Hardness values for the active links in the V braced frame on gridline 6, oriented North-South; (d) Hardness values for the panel zone in the collector beam adjacent to (c).

The hardness evaluations have been undertaken on all active links shown in Fig. 5.1; the above are two typical examples. The results show that maximum inelastic demands have occurred on levels 2 and 6 and that, above level 16, inelastic demand has been negligible.

3. For these two frames, any average reading over HLD 420 implies that the active link may need replacement once a more robust evaluation is performed.
4. For the two frames any average readings of around HLD 440 may mean immediate replacement is recommended. One link meets this criterion, being that at level 2 on Grid 6 and it has been recommended that this link is replaced before the building is reopened.
