# Seismic Strengthening of the Parliament Building of Republic of Macedonia: Necessity, Solution and Construction

**Z. Bozinovski, V. Shendova, G. Necevska Cvetnovska, R. Apostolska, E. Gjorgjievska & G. Jekic**

*Institute of Earthquake Engineering and Engineering Seismology, (IZIIS)  
"Ss. Cyril and Methodius" University, Skopje, Republic of Macedonia*

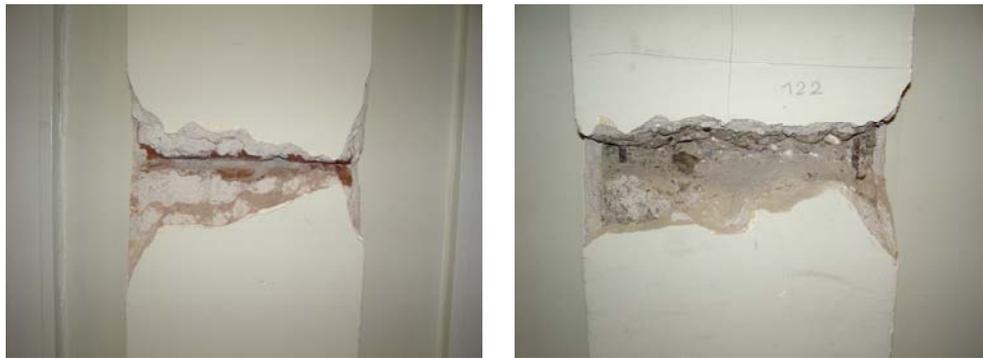
indications by a minimal number of research boreholes meaning opening of grooves down to the bearing elements (Fig. 2.2).

**Figure 2.2.** Research boreholes in corridor pilasters (left – brick, right – RC column)

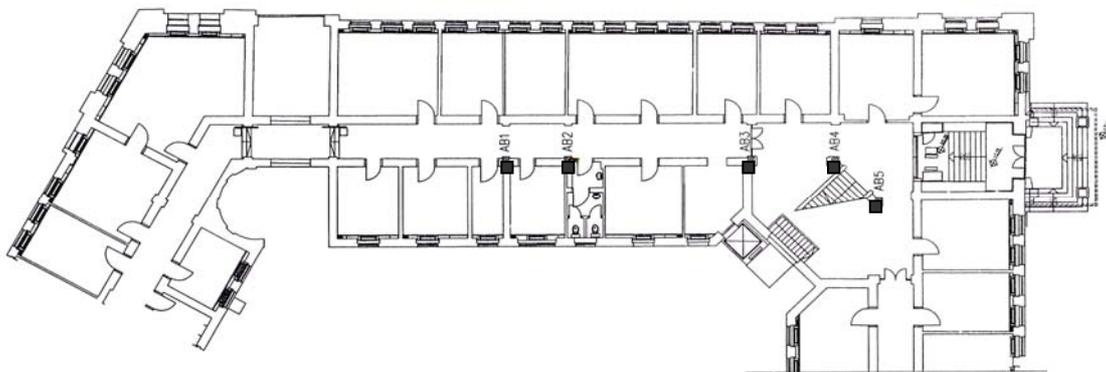
**Figure 2.3.** Position of identified RC vertical belt courses in the southwest unit

The selected unit has completely been inspected along its entire length for the purpose of obtaining as many as possible data. Based on the conclusions drawn from these investigations and from the subsequent research boreholes, the position of the existing RC vertical units in the measured southwest unit has been defined (Fig. 2.3).

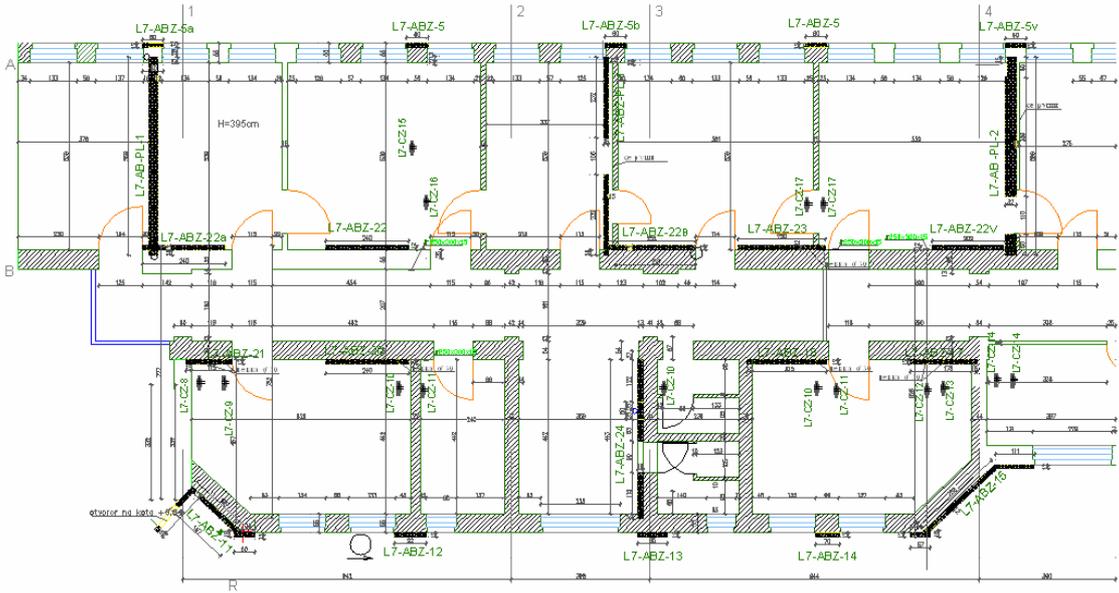
Figure 4.1. Strengthening of representative unit – L7

- Connection of the bearing walls with reinforced concrete horizontal belt courses over the last storey, i.e., by horizontal ties at the level of the floor structures, for the purpose of providing integrity to the bearing structural system in both orthogonal directions and enabling synchronous behaviour during dynamic excitations;

- Increase of the strength and deformability characteristics by jacketing of parts of the bearing walls. The jackets, as vertical bearing elements, are connected with the horizontal belt courses and ties and are founded on new reinforced concrete foundation cushions;

- Replacement of existing partition walls or insertion of new easily reinforced and relatively thin reinforced concrete walls connected by horizontal belt courses and ties and founded on own reinforced concrete foundation;

- Increase of the proportions and the reinforcement of existing reinforced concrete columns connected with horizontal belt courses and ties and founded on enlarged existing foundation;

- Injection of possible cracks in the walls upon removal of the mortar;
- Guniting of existing walls constructed of solid bricks in case a network of cracks occurs upon removal of the mortar.

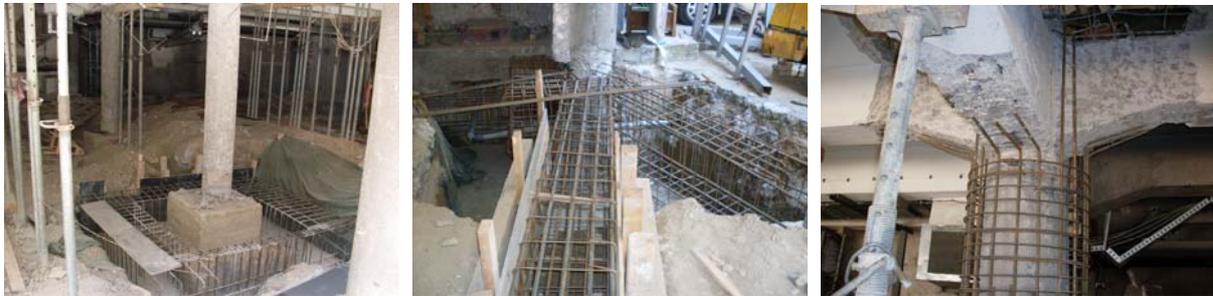
**Figure 5.1.** Strengthening of a characteristic column with a plastic hinge, Unit 3

task. The strengthening of the building that started in April 2010 is being carried out quite successfully despite a lot of limitations. Strengthening of units L1, L2, L3, L7 and partially unit L6 (Fig. 5.1) was realized by February 2012. The process is being carried out under continuous supervision involving:
