Performance of cultural heritage of Lorca (Spain) during the two small earthquakes of May 11th, 2011

M. Feriche, F. Vidal, G. Alguacil, C. Aranda, J. Pérez-Muelas
Andalusian Institute of Geophysics, University of Granada, Spain

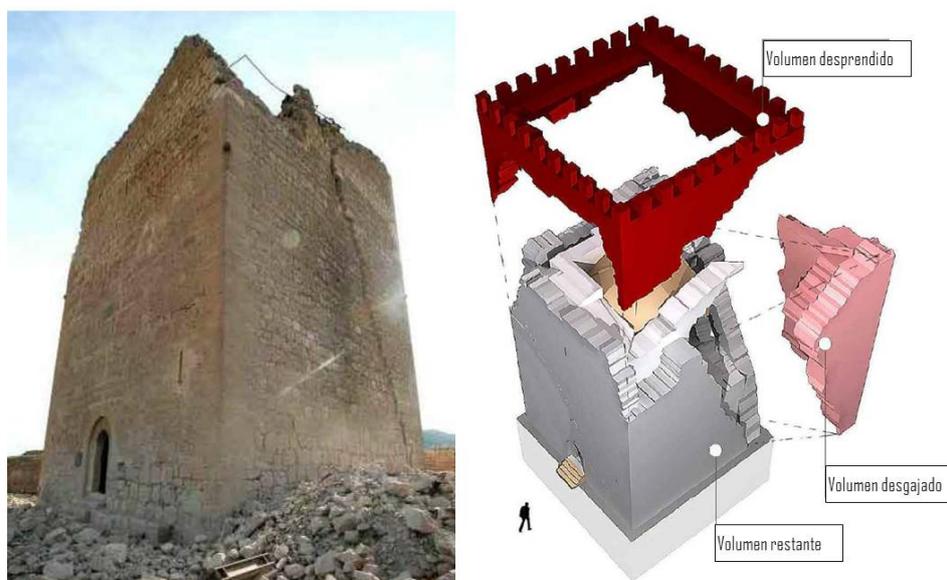
Figure 4. Picture example and illustrative graphic of the damage caused to the Espolón tower (according to one of the fact sheets of the Master plan for the recovery of the cultural heritage of Lorca).

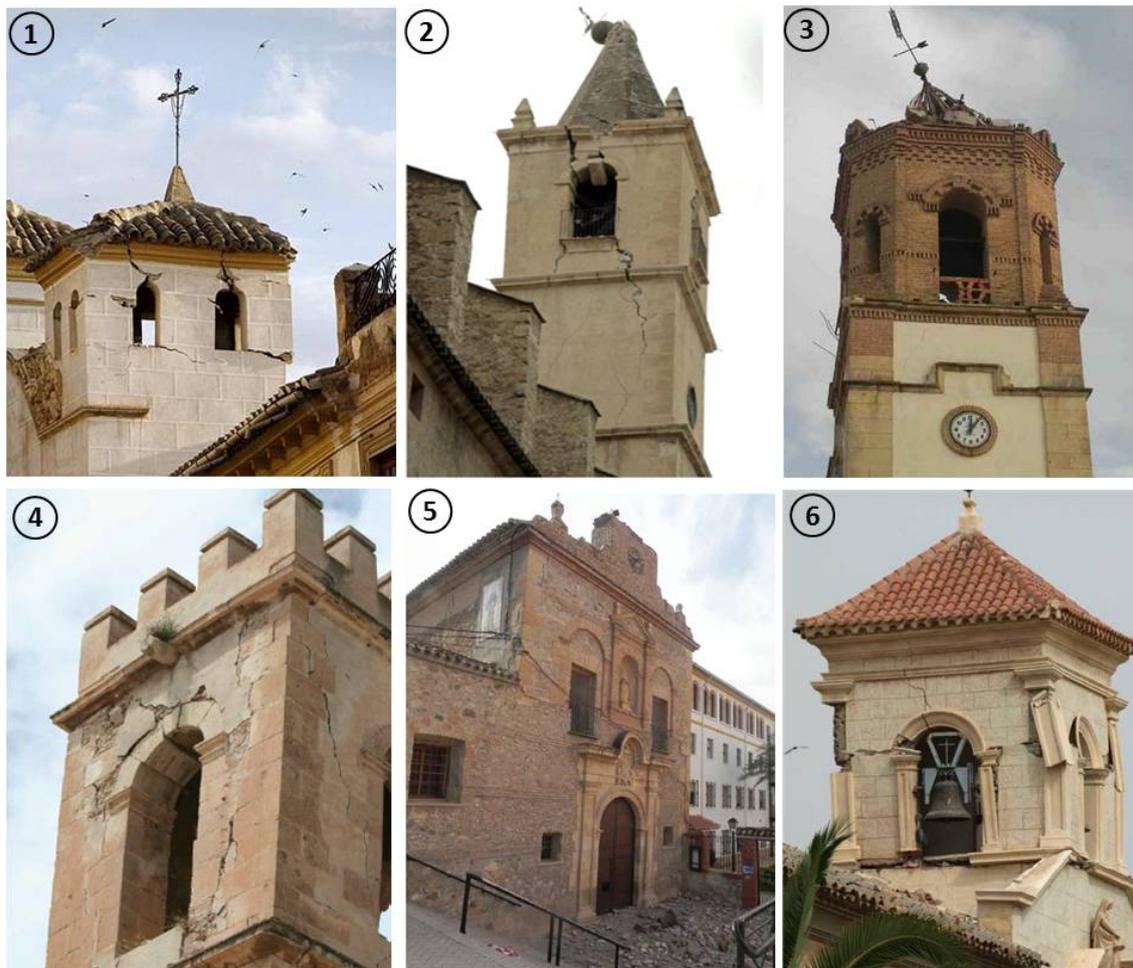
The churches have been the more affected heritage buildings, particularly their towers (Fig. 5), and elements such as arches, vaults, domes and roofs. Most of the towers have been seriously damaged. During the second earthquake, the bell towers of the church of San Diego and the sanctuary of Virgen de las Huertas collapsed. Apart from these, the towers of the chapels of Rosario, Santo Domingo, San Francisco, Santiago, San Juan and Santa Maria were seriously damaged and they needed provisional emergency measures (clamps) to prevent their collapse during the aftershocks. Although the towers of San Mateo, San Cristobal, Santa Maria, Nuestra Señora del Carmen and San Pedro were not on the point of collapse, but they suffered shear cracks. The palatial buildings were less affected than the Churches, a fact that may be related to their geometry, weight and smaller size.

Figure 5: Damages to the towers of, 1) Chapel of Rosario; 2) San Francisco; 3) Virgen de las Huertas; 4) San Pedro; 5) San Diego (belfry fall); 6) Convent of Clarisas.

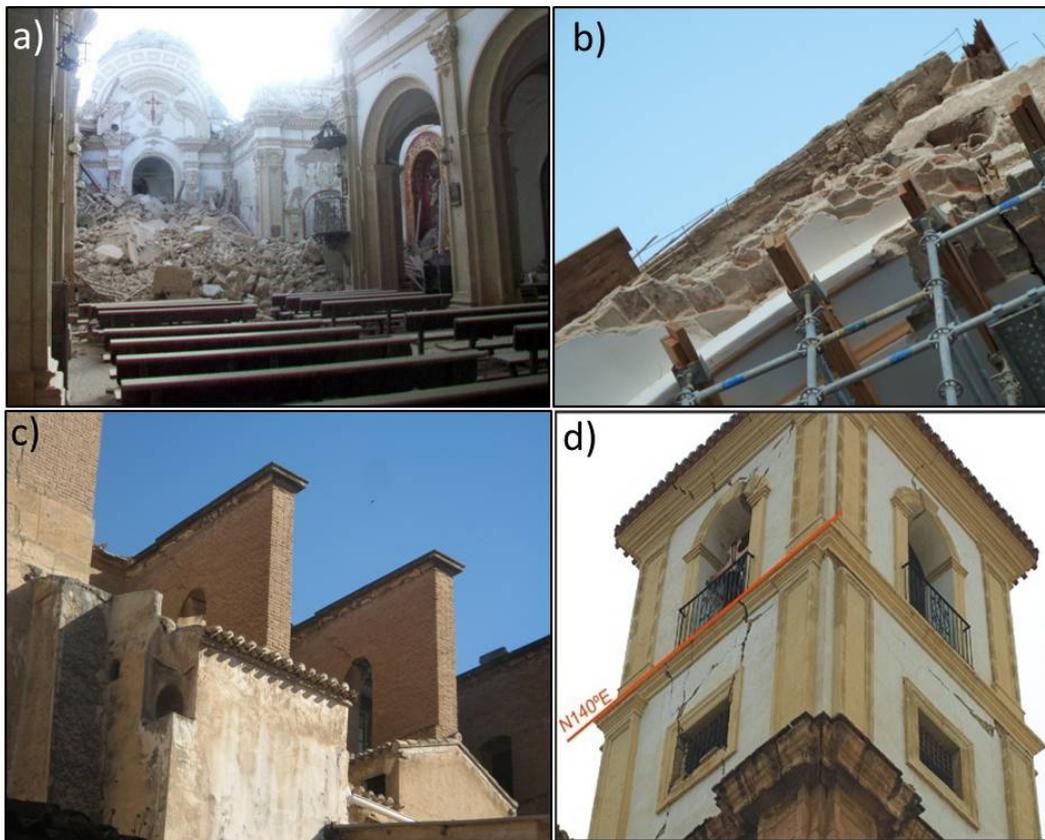
The constructive systems used in consolidation and restoration interventions carried out during the last century have not always responded adequately to seismic actions. The use of very heavy concrete for the roofs has raised the efforts and damages. One example is the Church of Santiago, where its partial collapse has provoked the total destruction of the crossing (roofs, domes and vaults collapse). The building roofs underwent several repairs before, including among them the addition of a compression layer of mesh-reinforced concrete, which must have contributed to the damages. The influence of this pathology was proved in similar buildings being damaged by the earthquake of L'Aquila in 2009 (Galli and Camassi, 2009). The lack of buttresses in that temple area in the direction of the strong motion and the structure weakening (cracks) caused by the foreshock have also influenced the collapse. Although in the rest of the

temple the existence of lateral naves and external buttresses avoided the collapse, paraments and buttresses cracks were caused. The tower also suffered damages, such as shear cracks and cornice collapses (Fig. 6).

Figure 6: Damages to the Church of Santiago. a) Transept collapse; b) Detail of the RC compression layer of the roof; c) Damages to the buttresses; d) Damages and tower orientation (IGME, 2011)
