# Fujinuma Dam Performance during 2011 Tohoku Earthquake, Japan and Failure Mechanism by FEM

## **SUMMARY:**

*Keywords: Dam, Fujinuma, Failure, Earthquake*

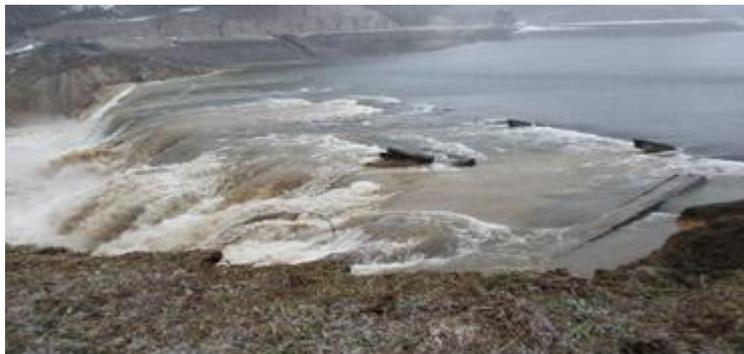
The photos 2, 3 and 4 shows that some reasons caused the storage water to flow over dam and to destroy it. This article try to become clear the main cause of event.

**Figure 2.** Dam during the earthquake

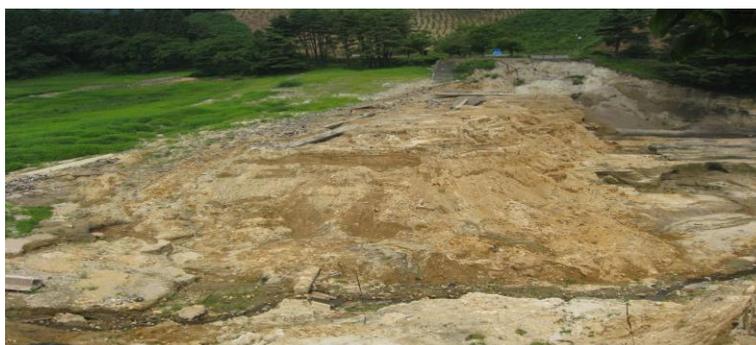
According to JCOLD this dam was constructed very well and has suitable maintenance after finishing construction in 1949. According to EERI, their Satellite image observation shows the embankment dam started to fail after the earthquake occurred and completely destroyed during 20 minutes. Before the earthquake occurrence, the dam reservoir was full.

**Figure 3.** Dam failure after earthquake

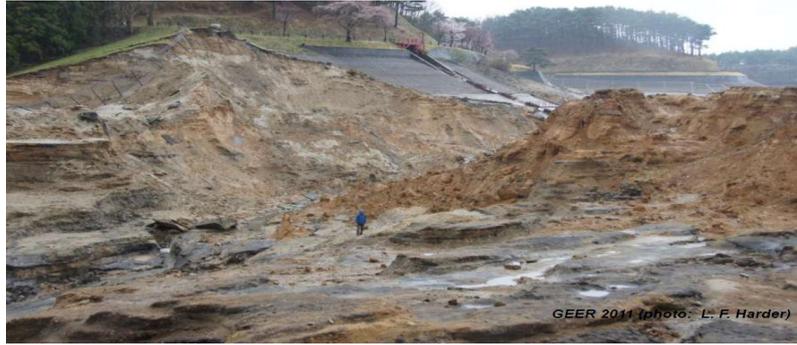
**Figure 4.** Dam Section after earthquake

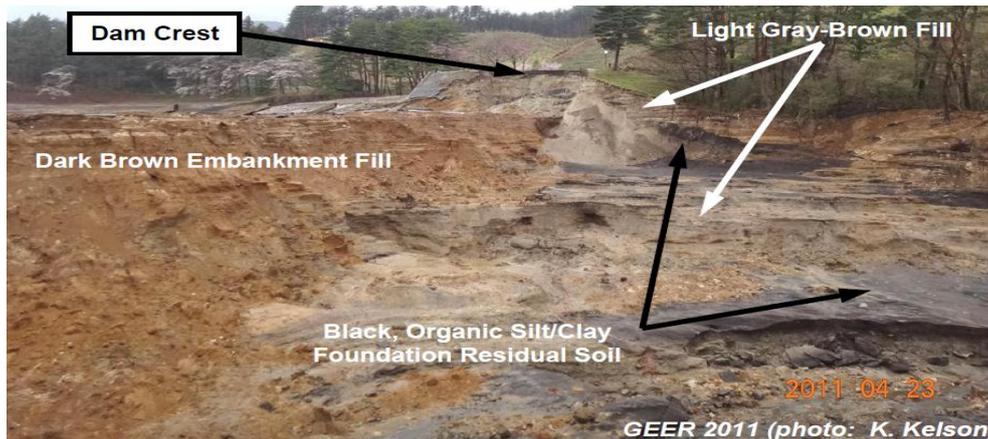
It should be noted that according to Harder et al. (2011) Fujinuma dam has some problems on permeability that repaired with performing diaphragm wall in 1994. It goes without doing that, it reduces the seepage in some degree through the dam and this issue is incorporated in the model.

**Figure 6.** Cross section after earthquake [Harder et al., 2011]

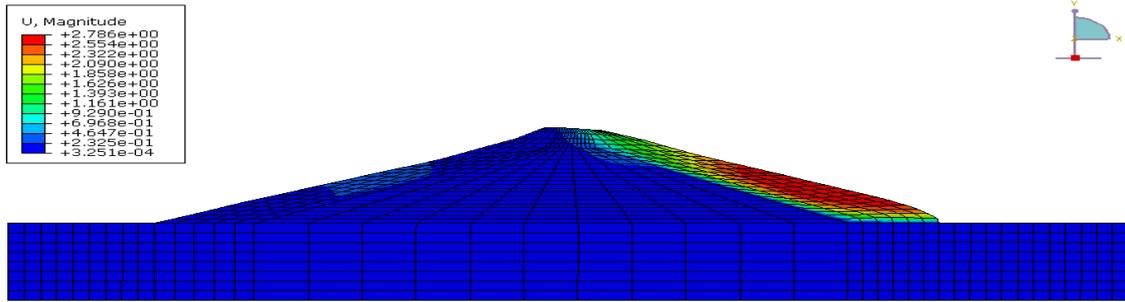
**Figure 14.** Displacements in t=96s of earthquake

Displacements results show that in downstream sides of dam the slip phenomenon occurred and maximum displacements of downstream sides is equal to 2.78 meters.

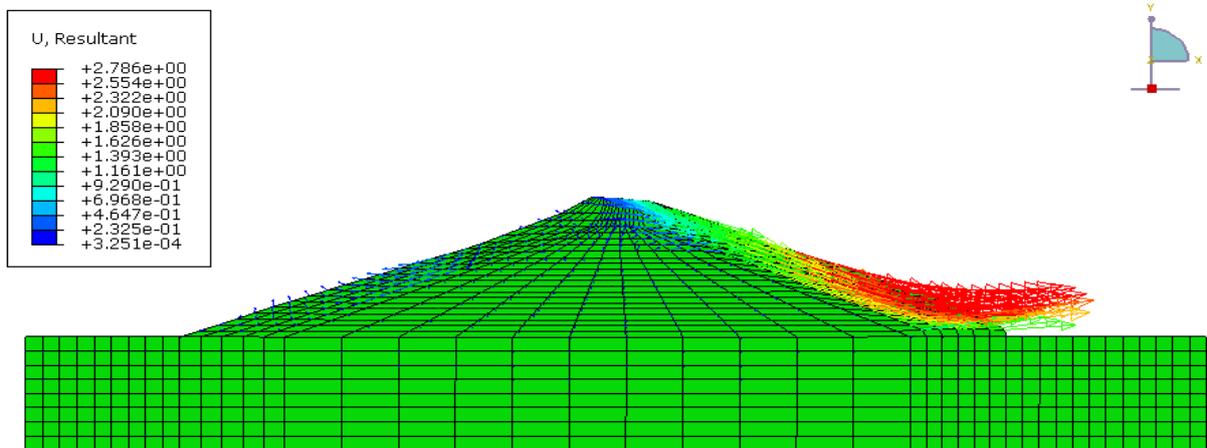
**Figure 15.** Displacements Vectors in t=96s of earthquake

Above photos relate to displacements vectors that show the maximum displacement of elements in base of downstream side. Also, the settlement of dam crest is very clear and equals to 1.1 meter therefore the reservoir water can easily flow above dam crest.

According to information presented in this paper, the general trend of the earthquake can be determined. A summary of the overall process has occurred, so, during the earthquake, dam is deformed and experienced some settlements. In downstream side, slip phenomenon occurred. This phenomenon is due to seepage of dam and relatively low resistance of downstream layer. Effect of earthquake escalated these conditions and cause to fail downstream during earthquake.
