Performance of Port Facilities in Southern Chile during the February 27, Maule Earthquake

S. Brunet, J.C de la Llera

Pontificia Universidad Católica de Chile, Chile

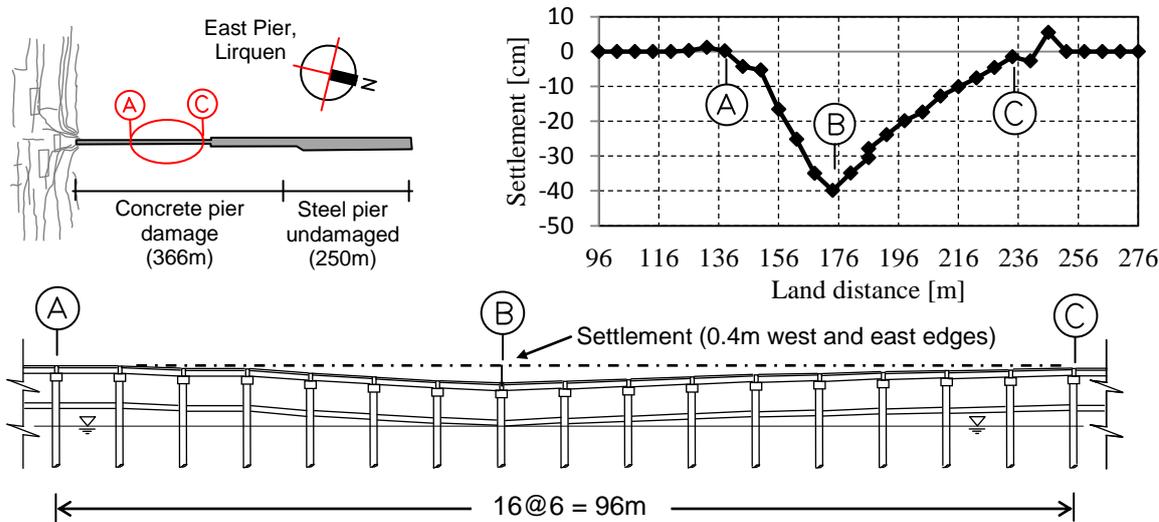
Soil liquefaction was perhaps the most frequently observed problem in these port structures. Settlement and inclination of sections of piers occurred repeatedly along the coastline due to the temporary loss of stiffness and bearing capacity of soils. As an example, Figure 2.2 presents the differential settlement of 17 pairs of piles placed on the approach zone of the East Lirquén Pier, causing a deformation of 40cm between axes A and C (at a distance of 138m and 228m from the abutment). The approach zone of the pier remained in good operative condition and diagonal cracking observed did not compromise the lateral stability for operational loads, but had to be repaired in order to restore the seismic lateral capacity of the pier.

Figure 2.2. Settlement of the approach zone in Lirquén east pier due to liquefaction.

For ground shaking of this magnitude, soil liquefaction in saturated loose sands is almost inevitable. Furthermore, if soil layers happen to be on a certain slope, they will tend to slide down causing lateral spreading of the foundation system. Indeed, in every port that suffered from lateral spreading there was liquefaction, but the opposite is not necessarily true. An example of lateral spreading is presented for the North Coronel pier in Figure 2.3, which was severely damaged in the approach zone. This zone is composed of a 30 cm thick RC deck supported on $\phi=46$ cm (18 in) (vertical) and $\phi=56$ cm (22 in) (battered) 9.5 mm thick steel piles. The forces induced by the displacement of the soil mass at the shore exceeded the support capacity and pushed the first four lines of piles by approximately 14 degrees. Ten millimeter steel plates welded to the web and flanges of the transverse beams, buckled and yielded. Welding at the pile caps of many piles fractured in shear, causing pile displacements of up to 3 m, and leaving a 22 m beam span unsupported.

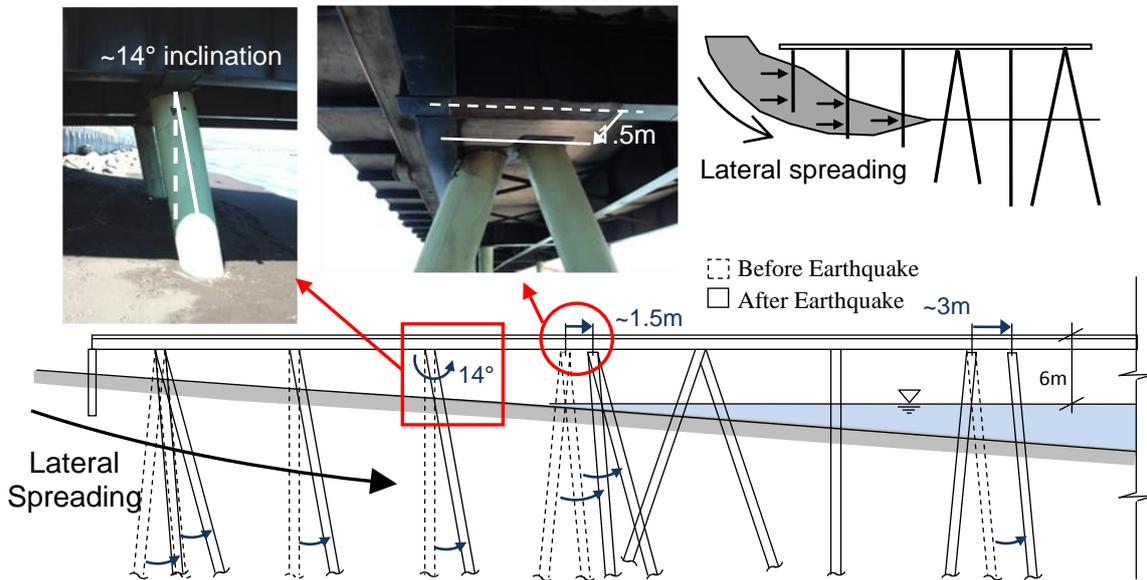
Figure 2.3. Inclination and shear damage of piles located in the approach zone in the North Coronel Pier

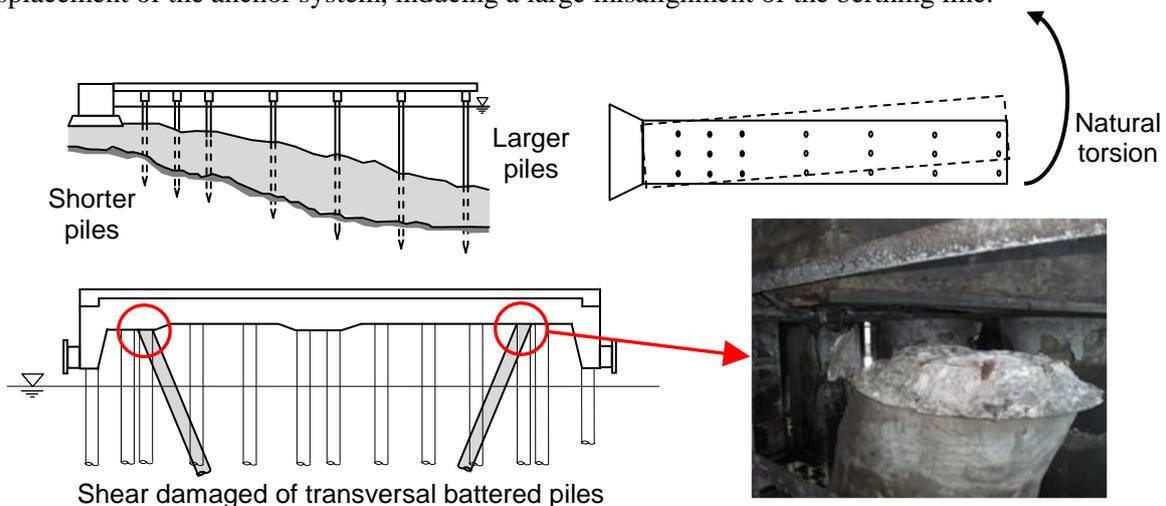
Damage in battered piles was also common in most of the observed piers. Since battered piles are intended for resisting lateral earthquake loads and mooring, berthing and crane operations, they are significantly stiffer laterally than vertical piles and, hence, attract larger earthquake forces. Therefore, ductility and displacement capacity are a main concern in the design of these RC piles (PIANC, 2001). Two other concepts are important in interpreting the pier damage in this earthquake: (i) the short pile effect; and (ii) natural torsion. Shorter piles are also stiffer and tend to attract considerably more lateral load than longer piles. As a result, stresses in the top pile-deck joints on the approach zone are generally large (Mondal & Rai, 2008). Because of this larger stiffness provided by the shorter piles, decks tend to rotate relative to the approach zone, increasing the ductility demands of the piles at the seaside edge (Figure 2.4). Battered piles in the transverse direction of the last 96 m of the Huachipato

pier were cut at the connection with the deck; however, no longitudinal battered or vertical piles had structural damage. One plausible explanation would be natural torsion as indicated above, in conjunction with a poor pile-deck connection design and/or implementation. In summary, the approach zone experiences larger force demands, while the berthing zone experiences larger displacement demands.

Figure 2.4. Shear damage in transversal battered piles due natural torsion at Huachipato Pier.
