# The August 23, 2011 Magnitude 5.8 Virginia Earthquake in the Eastern United States - An Engineering Perspective

## **SUMMARY:**

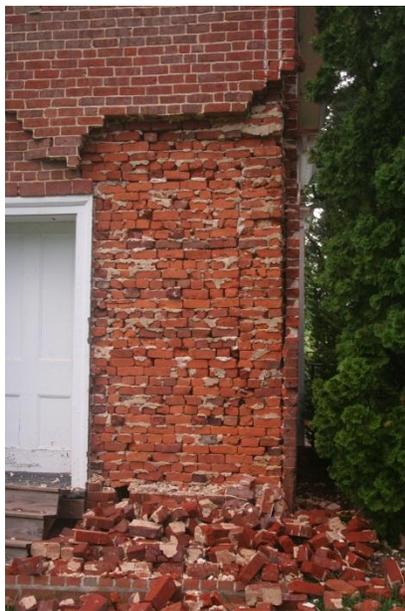
It is well known that URM buildings do not perform well during earthquakes. The 2011 Virginia Earthquake highlighted the fact that although URM buildings were no longer built in California after the 1933 and California enacted laws requiring retrofit of URM buildings in 1986, that in the central and eastern United States, URM buildings are not uncommon. Many commercial buildings in downtown Mineral, Virginia have URM storefronts and parapets that were damaged during the 2011 Virginia Earthquake. Two notable historic URM buildings in Louisa County were severely damaged including the Gilboa Christian Church (Figure 3.2a) which was built in 1857, and the Cuckoo House (Figure 3.2b) built in 1819. Initial estimates for repair costs are reported to be \$500,000 for the Gilboa Church as reported on their website. There were also numerous examples of collapsed URM chimneys throughout the epicentral region.

**a) Damage to Historic Church**

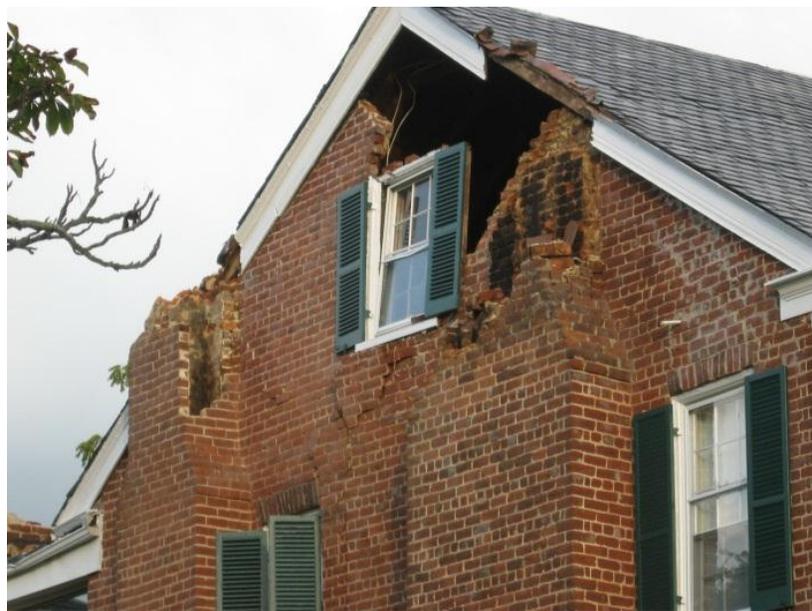
**b) Damage to Chimneys and Gable of Historic Home**

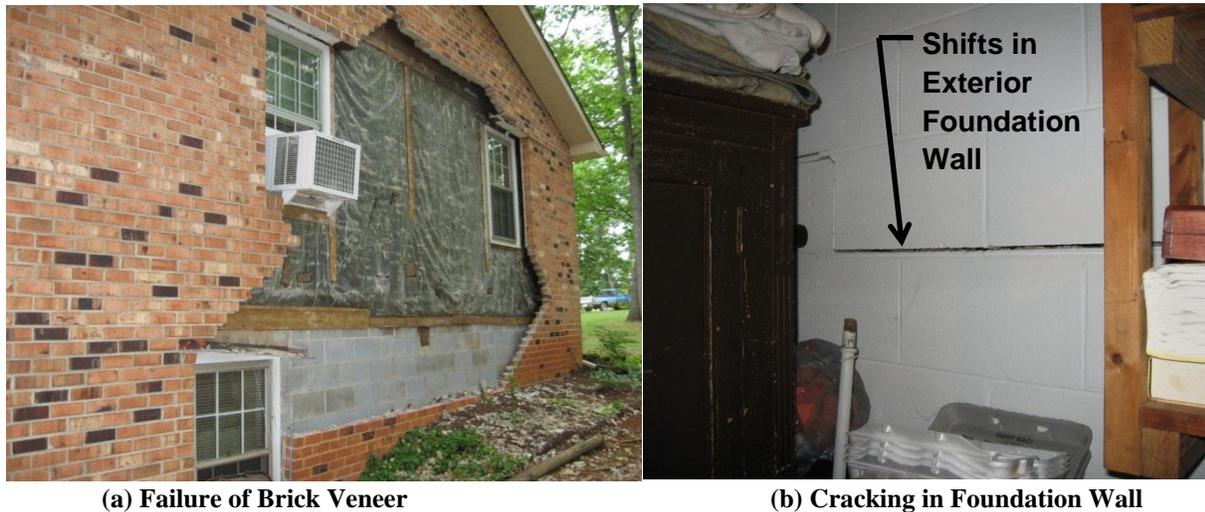
**Figure 3.3 – Examples of Damage to Residences in Epicentral Region**

Besides damage to URM structures, there was damage to many other types of structures as well. In the region marked on Figure 3.1 as having increased damage, there were many instances of failed brick veneer. Types of brick veneer ties that failed varied widely, from 16d nails driven into straight sheathing and set in mortar joints, to corrugated metal clips that were badly corroded in some cases, and failures in brick veneer that appeared to have been built in the past decade or two. 3.3a shows one example of failed brick veneer.

Other types of damage experienced in the epicentral region included cracked and shifted foundation walls (e.g. Figure 3.3b), collapsed carports (e.g. Figure 3.4), cracked infill walls, damaged hanging ceilings, and other nonstructural damage.

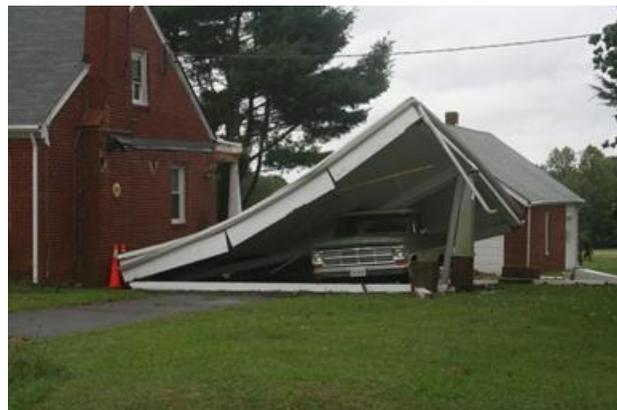
**Figure 3.4 – Collapsed Carport in Epicentral Region**

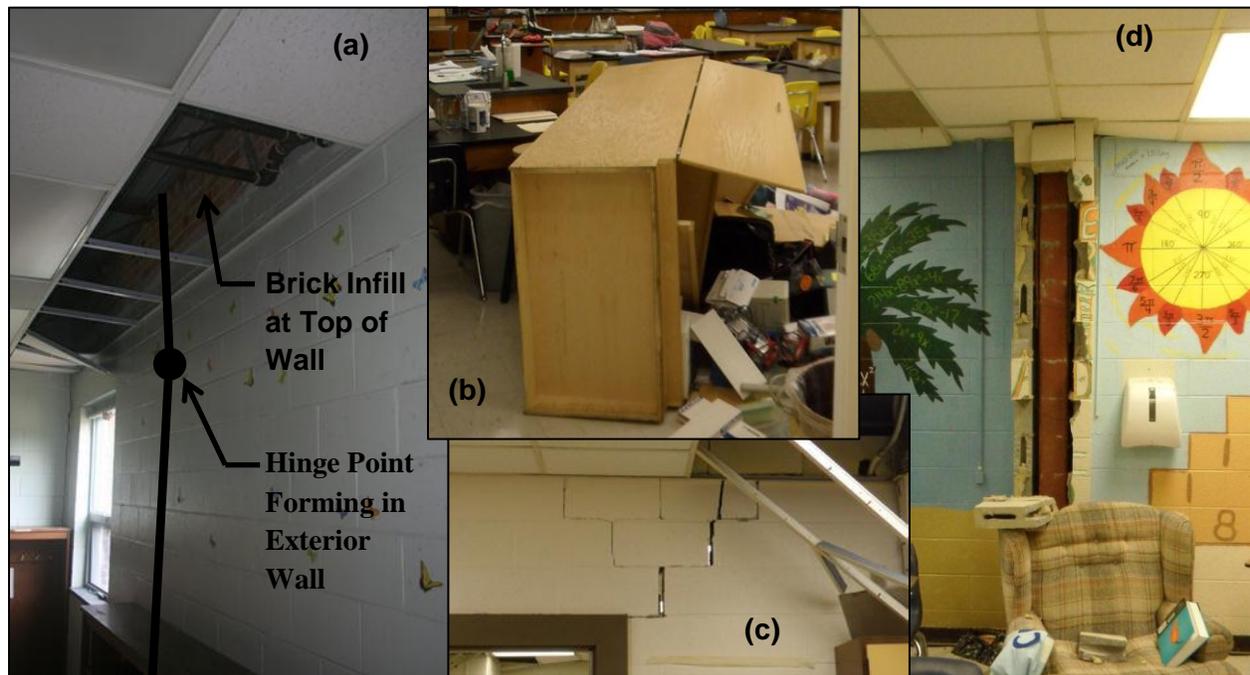
There are two middle schools and one high school in Louisa County. There was enough damage to one of the middle schools and the high school to require them to be shut down indefinitely. The Jefferson Middle School has steel roof joists bearing on masonry exterior walls. Even if lower CMU portions of the wall have reinforcing, the top of the walls were infilled with clay bricks above the ceiling line. Walls perpendicular to the roof framing were generally not well anchored into the roof structure and there were instances of fallen brick and masonry from the top of a wall. One wing of the structure experienced outward bowing of the bearing wall. As shown in Figure 3.5a, the exterior wall developed a hinge at the mortar line just above the window. The wall experienced residual displacement that was noticeable from the interior and exterior of the building.

The Louisa County High School had steel framing and unreinforced masonry infill. One of the few reported injuries occurred at the high school due to falling contents such as shown in Figure 3.5b. Similar damage as described above was observed for the unreinforced CMU infill walls such as cracking (shown in Figure 3.5c) and falling bricks. There was evidence of considerable movement of the steel framing relative to the CMU infill as the CMU surrounding the steel columns was commonly cracked and in some cases collapsed (Figure 3.5d). It was impossible for the Reconnaissance team to fully assess the damage to these buildings, but the estimate for repair of the high school was \$43 million (Kumar 2012).

**Figure 3.5 - Performance of Schools in the Epicentral Region (a) Jefferson Middle School, (b) Falling Contents at Louisa High School, (c) Unreinforced CMU Infill walls at Louisa High school, and (d) Differential Motion of Steel framing Relative to CMU Infill at Louisa High School. [Some photos Courtesy of R. Green]**

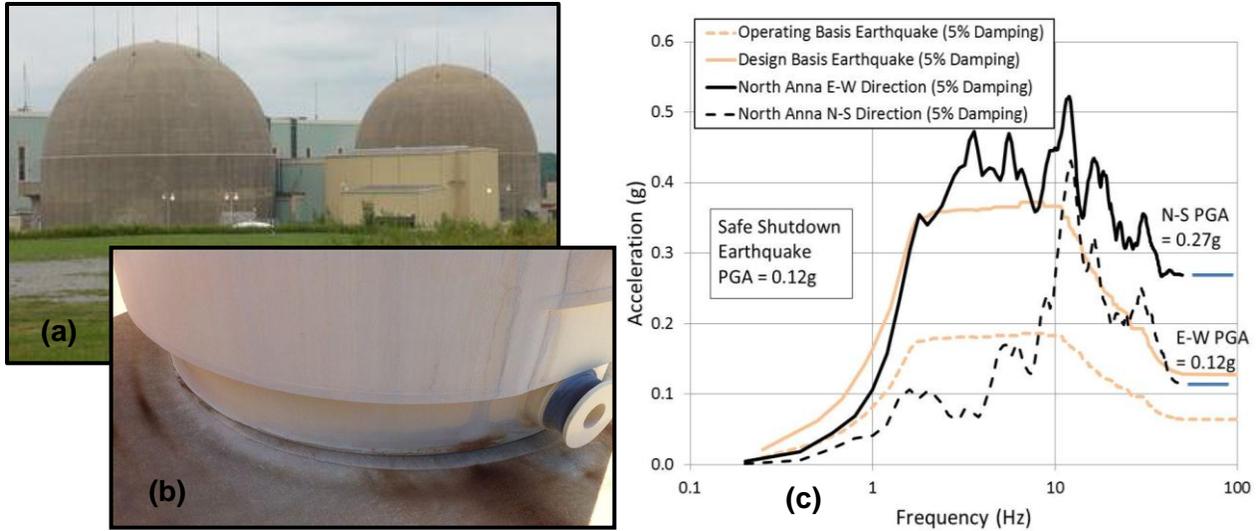
As shown in Figure 3.1, the North Anna Nuclear Power Plant was 18 km from the epicenter and in line with the directionality of the observed damage. The reactors underwent a safe shutdown procedure following the earthquake. The reactors' containment structures, Figure 3.6a, were designed to remain elastic for a peak ground acceleration of 0.12g and as shown in

Figure 3.6c, the measured PGA at the site was 0.27g. However, detailed inspections by Dominion Power, and Nuclear Regulatory Commission inspectors revealed no safety related damage (Bacque and Martz 2011, Dominion Power 2011). In November, the North Anna Nuclear Power Plant was cleared by the Nuclear Regulatory Commission to restart their reactors (Bacque and Martz 2011).

Two weeks after the earthquake, parts of the EERI and GEER reconnaissance teams were allowed to visit the North Anna Plant and investigate some of the noncritical structures. Minor damage was observed in a few of the noncritical facilities such as hairline diagonal cracking in some CMU walls. Cranes were functional in tall steel space frame buildings on the site implying negligible residual deformations. Nor was there any evidence of sliding of large water tanks. Twenty seven large storage casks, each weighing 520 kN were found to have shifted on their concrete slab. As shown in

Figure 3.6b, these casks used for dry storage of spent fuel rods slid as much as 114mm.

**Figure 3.6 – (a) North Anna Nuclear Power Plant, (b) Shifted Dry Storage Casks and (c) Recorded Ground Motions**

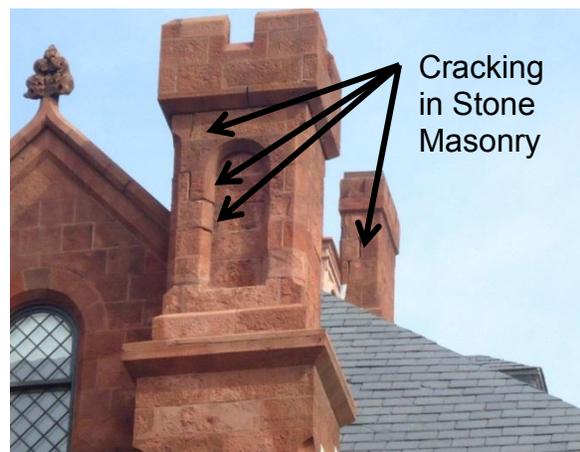
The Castle is a historic building built in the mid-1850s of unreinforced masonry and stone as shown in Figure 4.1. Large differential movement of stone elements can be seen in Figure 4.1. The Castle also experienced some other architectural damage of plaster cracking, and dislodged windows. The Castle was evacuated following the earthquake and was not reopened until complete safety inspections had occurred by the Smithsonian Institutes' Engineer of Record. Employees were allowed to return to work the following Monday, six days after the earthquake.

**Figure 4.1 - Cracked Chimneys at the Smithsonian Institute Castle**

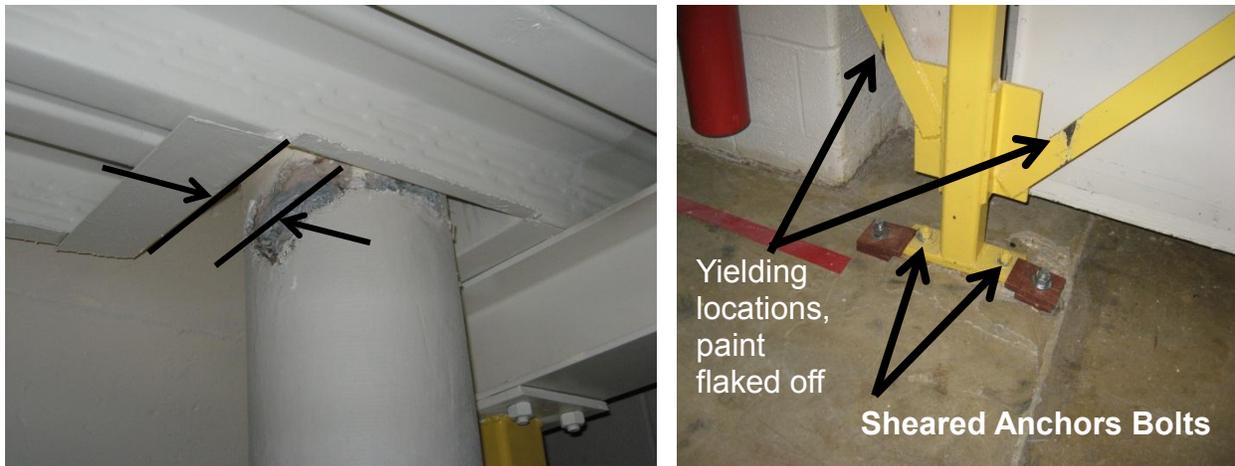
**Figure 4.2 – Typical Damage to Smithsonian Institute Pods**

cast concrete building only at the foundation, this construction can be summarized as a building within a building. The interior steel frame buildings are constructed of box columns with cross-bracing to support lateral loads. The Pods are warehouses where the non-displayed artifacts are stored. The Pods are pre-cast concrete buildings three stories tall with an interior steel frame building connected to the pre-cast concrete building only at the foundation, this construction can be summarized as a building within a building. The interior steel frame buildings are constructed of box columns with cross-bracing to support lateral loads. The floors are typical decking consisting of about four inches of concrete. The non-displayed exhibits are stored on all three floors in all four Pods. On inspection of the Pods it was evident that they each experience loads significantly beyond their design bases. However, when the Pods were built in the mid-1980s, there were no seismic design requirements in the Washington, D.C. area and the response of the steel frames and precast concrete buildings showed their weakness through differential displacements.

For example, at one location one can see as much as 15 cm of differential displacement as shown in Figure 4.2a. In addition, the lateral cross bracing between the steel columns yielded on all three floors and many steel column anchor bolts were sheared off as shown in Figure 4.2b.

a) Banging between floor and fire protection and piping, approximately 15 cm or more of movement      b) Anchor Bolt Shear and Yielding
