The Effects of Site and Soil Conditions To the Earthquake Damage: Oct, 23 2011 Van-Tabanlı Earthquake ($M_w=7.2$)

SUMMARY:

Keywords: Earthquake damage, local site conditions, strong motion data

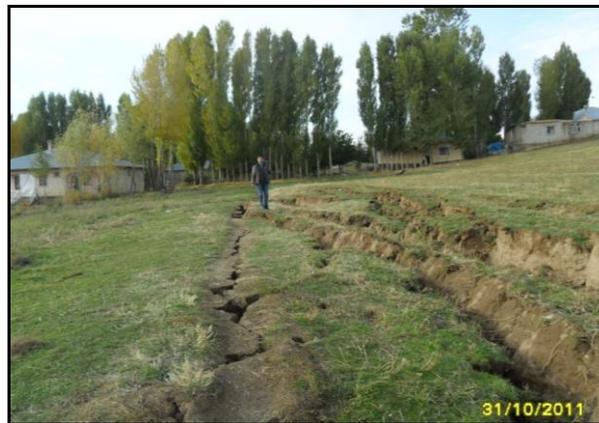
Significant landslides and settlements were mostly observed around Celebibag Village (Ercis) which is located on the upper-west of Lake Van. Soil cracks shown in Figure 4 can be characteristically assessed as the main scarps due to land sliding. Permanent ground deformations extended up to 50cm in the horizontal and vertical directions. Some numerous landslides were also observed along the Shore of Karasu River. During Van-Tabanlı earthquake, some slope instabilities have also been observed at highway embankments and artificial infills. A slope failure extending all the way through the Van-Ercis highway embankment was mapped as shown in Figure 5a. A maximum of ~40 cm vertical offset was also mapped along with lateral deformations exceeding 15 cm (Figure 5b). Rockfalls which can be defined as a massive rock of any size detached from a steep slope or cliff along a surface were observed along the highway. Approximate diameters of the rocks varied in the

Figure 4. Soil cracks due to landslides in Celebibag, Ercis

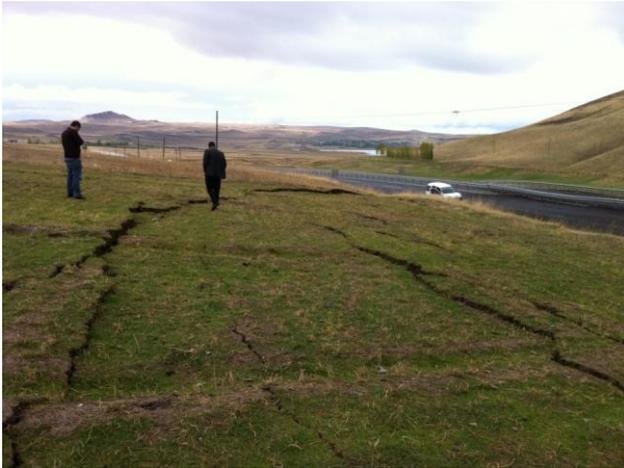
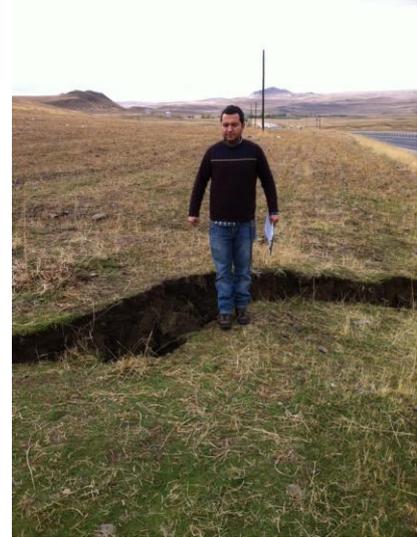
Figure 5. Slope instabilities: a. slope failure; b. ~40cm offset along Van-Ercis highway_

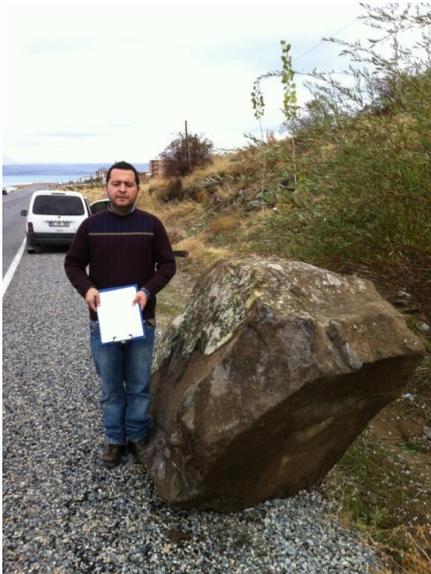
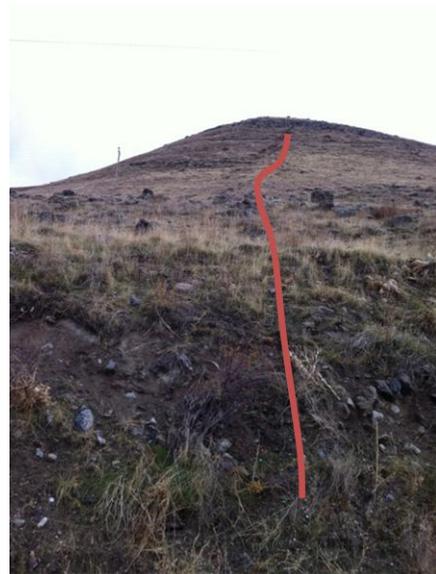
range of 1.0-1.3m (Figure 6a). The path of rolling can be seen in Figure 6b.

Figure 6. Rockfalls: a. the rock on the highway; b. the trace of the rockfall path_

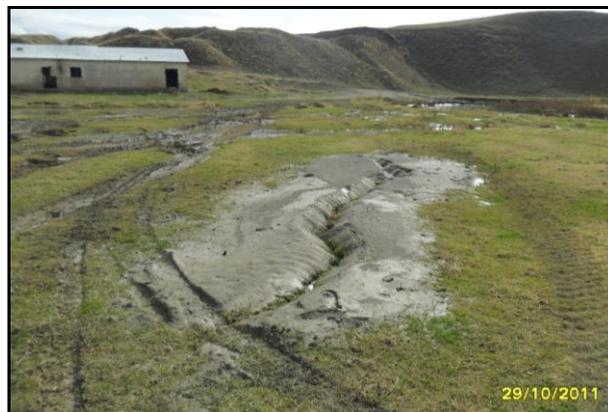
Some evidences of liquefaction and sand boils were observed at different locations near the shoreline of Lake Van and along the Karasu and Zilan Rivers during Van-Tabanlı earthquake. Extensive geotechnical hazard such as liquefaction, liquefaction-induced lateral spreading and settlements occurred in Celebibag located in western Ercis near the Ercis-Patnos highway and in the rural areas of North-western Van. Liquefaction induced lateral spreading and settlement and rockfalls happened nearby Topaktas village (15 km away from the Van city center), next to the river in Northern Van, 6 km to the north of the Van 100. Yil University (Figure 7). By the natural beach of Lake Van, significant seismically-induced lateral spreading and settlements were observed. Surface manifestation of soil liquefaction in the form of sand boils was widespread. The extent of lateral deformations was mapped as 22 cm along with 15-25 cm relative settlement (Figure 8a). Sieve analysis results performed on sampled sand boils are summarized in Figure 8b, indicating high-potential for liquefaction.

Figure 7. Sand boils due to liquefaction in Topaktas village, Van

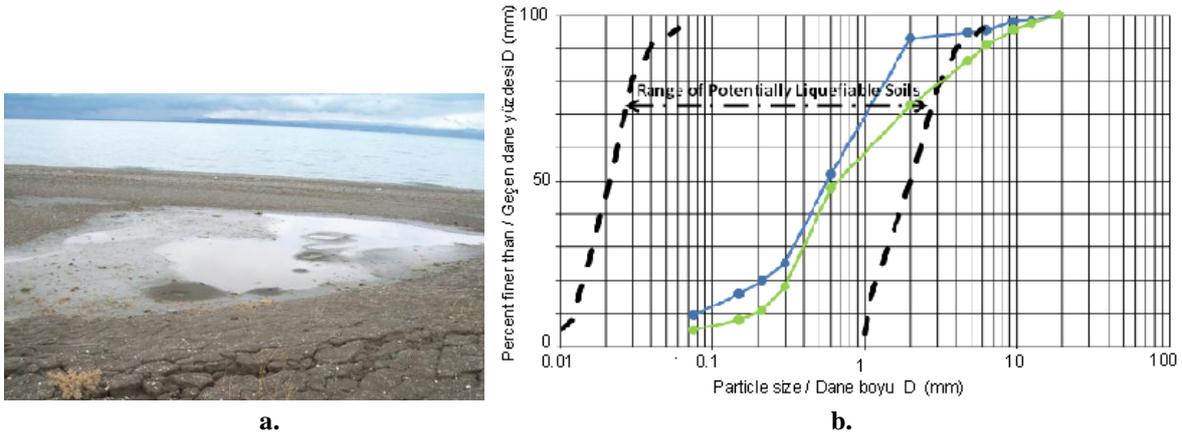
Figure 8. Lateral deformations: a. seismic soil liquefaction-induced sand boils and lateral spreading by Lake Van; b. sieve analysis

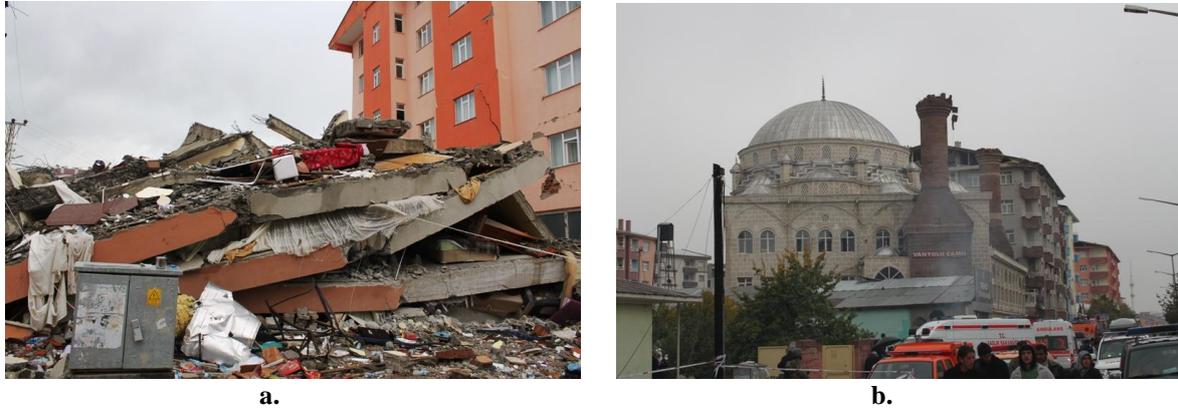
A wide range of structural damage was observed along Vanyolu Street as shown in Figure 11 and 12. Many buildings collapsed due to the soft story mechanism and inadequate confinement in beam-to-column joints. The minarets' of some Mosques also collapsed (Figure 11b). One of the major problems after the earthquake that local authorities faced was the rapid assessment of the buildings

Figure 11. Extent of structural damage along Vanyolu Street, Ercis: a. totally collapsed building due to soft story mechanism; b. collapsed minaret of Van Yolu Mosque (GIT-EQ, 2011)

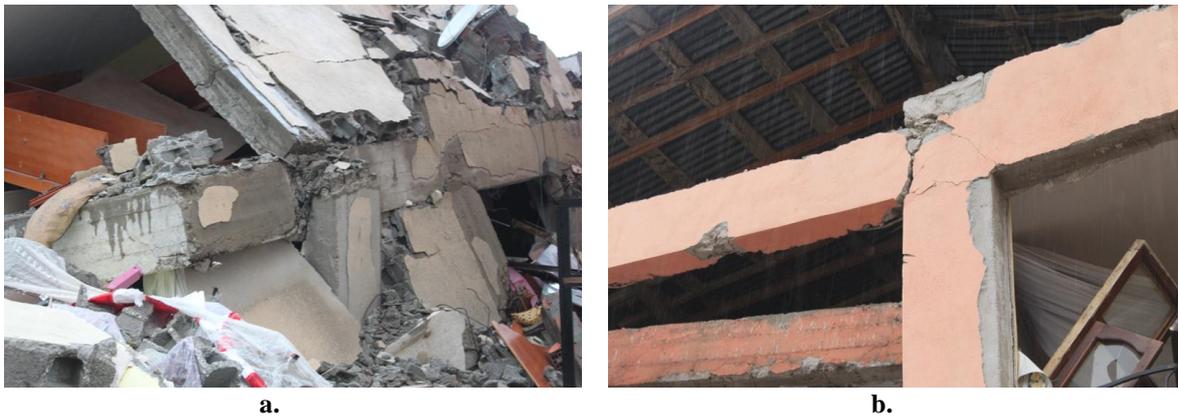
Figure 12. Beam-column joint failures in Ercis: a. failure in a beam-column joint due to inadequate confinement; b. brittle failure in a beam-column joint (GIT-EQ, 2011)
