# Investigation and Preliminary Analysis on Seismic Damage of Structures Subjected to Yushu Ms7.1 Earthquake

**Hongfu Chen, Junwu Dai, Baitao Sun, Sining Huang**

*Institute of Engineering Mechanics, China Earthquake Administration, Harbin 150080, China*

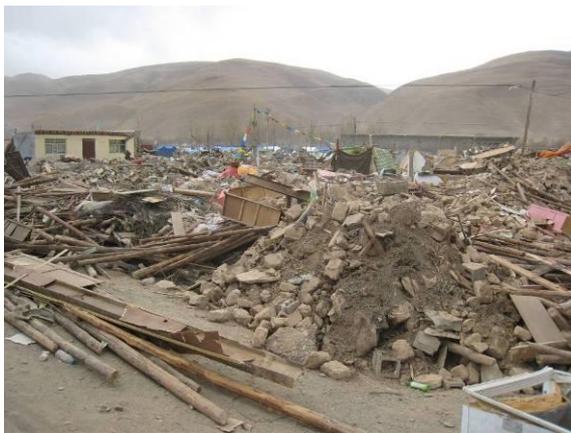
The adobe structures in hit area were mainly constructed by adobe and mortar, mostly single layered with wooden truss, which often exist in remote towns and villages. Such structures were built long ago, with lower strength of construction materials, weaker integrity, which led to poor collapse resistant capacity and resulted in a collapse ratio above 95%. For example, the adobe structures of epicenter Jiegu town (intensity IX) almost all collapsed, see Fig. 2.

**Fig. 2.** Collapsed Adobe Structure of Jiegu Town

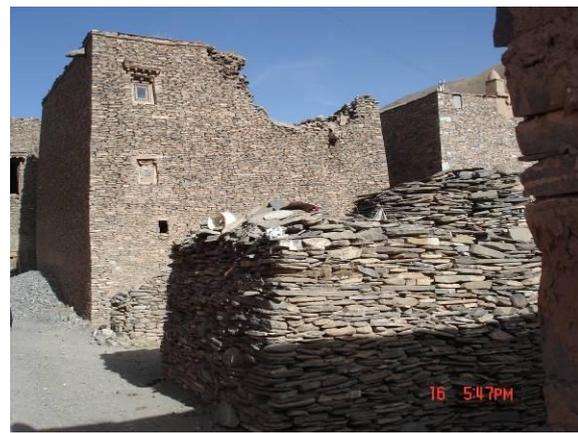
**Fig. 3.** Seismic Damage of Stone Structure

The stone structures of the disaster area were mainly constructed with stone and mud mortar, the floor slabs made of large pieces of stone lying on the wooden beam, most with one or two stories, wooden trussed. The stone structures were widely used in remote towns and rural areas, e.g. in Xiewu town, accounted for 95% of all the buildings. This kind of structure had weak bonding strength among stones, and bad integrity, therefore gotten partially collapsed in high intensity areas, which could be shown in Fig. 3. However, there were also some stone structures with high bricklaying quality, adopting ring beams and constructional columns, remained slight damage without collapsed.

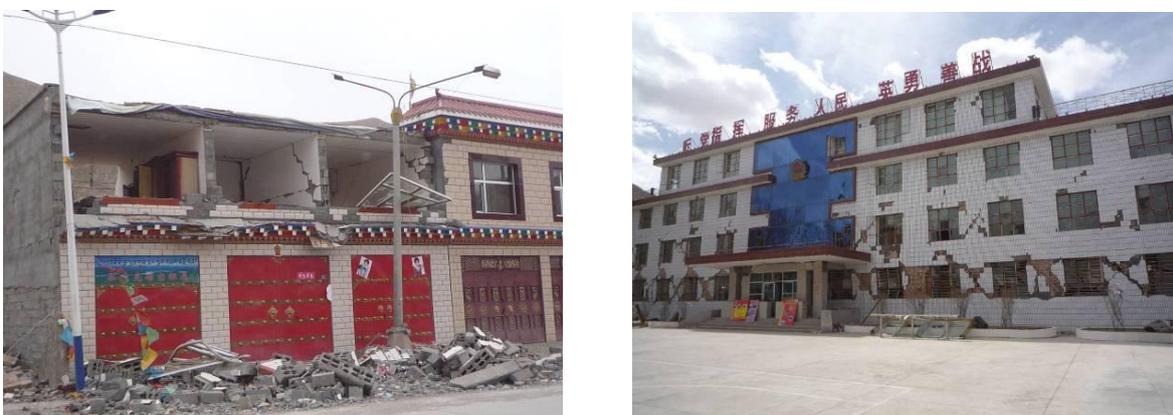
The masonry structures of Yushu region were mainly composed of concrete hollow block structures, brick masonry structures and masonry-timber structures. (1) Due to the natural limited conditions, clay bricks were hard to sinter and transportation expenses from other spaces were too high. Therefore, concrete hollow blocks were widely used. Concrete hollow block structures, mostly 2~4 stories took a proportion above 50% in local buildings. Most self-built masonry constructions of the disaster area were built of concrete hollow blocks mixed with mud. Because the mortar joints were relatively less than those of brick structures, and bonding between block and mortar were weaker, therefore buildings were damaged with step-cracks along mortar joint between block, even collapsed. Multi-storey masonry structures with seismic design were damaged with inclined or cross cracks on walls between windows or spandrel walls, and most of them did not collapse even in intensity IX area, which basically realized the requirements of ‘no collapse in rare earthquakes’ of the seismic design code (GB50011, 2001). (2) Brick masonry structures appeared to be relatively less used in residential buildings, but mainly be applied to schools, hospitals, hotels, office buildings for armed police and government, etc. Most of these buildings were seismic designed, with relatively better seismic measures and construction qualities, which led to better seismic performances (Sun and Chen, 2011; Chen and Sun, 2011). (3) Masonry-timber structures were mainly constructed by sintered clay bricks with mortar, wooden trussed, usually 1~2 stories. These types of buildings were not very common. Masonry-timber structures had a similar seismic damage performance with stone structures, whose roof truss were easily collapsed roof truss and staggered junctions between longitudinal walls and transverse walls were vulnerable. Therefore, concrete block buildings suffered heavier damage than brick masonry buildings, which is shown in Fig. 4.

Fig. 4. Seismic Damage of Masonry Structure (Intensity IX)

(3) Structures had very weak seismic fortification in the disaster area, especially adobe structures, which suffered severe damages. For the limited local economic conditions, adobe structures and masonry structures with concrete hollow brick were the most common constructions, which had poor seismic capacity and got disappointing damage ratio. It is strongly recommended that adobe structures should not be used in the rehabilitation, while masonry buildings with concrete hollow blocks should be adopted with ring beams, constructional columns, core columns according to the code, or be constructed as reinforced masonry structures.

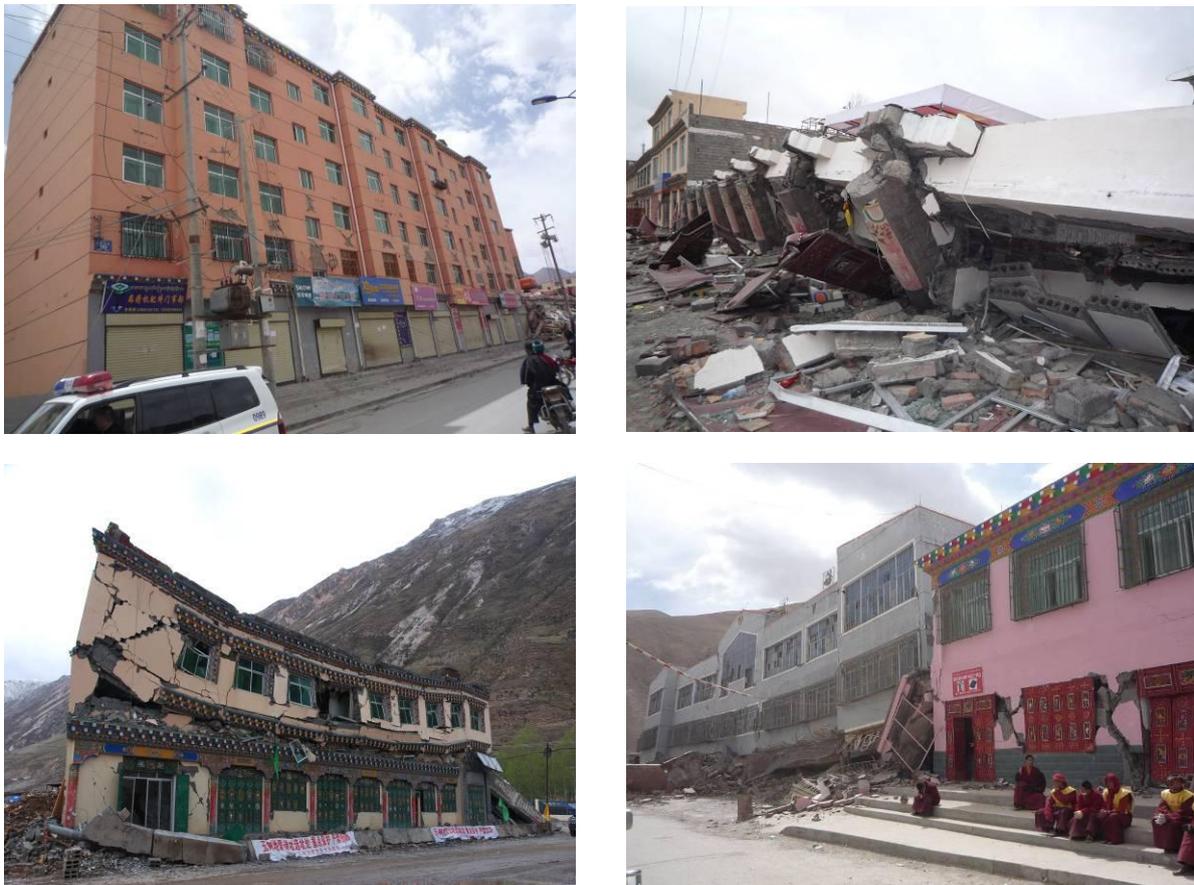
This type of structure was mainly occupied by shops along street, mostly 3~5 stories with reinforced concrete frame in the first floor, and masonry structure with concrete hollow brick in the upper structure. The investigation showed that there were lots of ‘semi-frame semi-masonry mixed structures’ with frame frontage and posterior longitudinal wall of masonry structure, which produced a confused condition of determining structure type and should be put into group of ‘masonry structures’. These buildings had a similar seismic damage with those in Wenchuan earthquake (Sun and Zhang, 2010). For instance, damages often appeared in the stiffness transferring story, with inclined or cross cracks in the wall between windows or spandrel wall. In addition, there were also some partial collapses or fallings due to large room in the bottom storey or middle stories, see Fig. 5.

**Fig. 5.** Seismic Damage of Masonry Structure with Bottom Frame (Intensity IX)

(4) Bottom frame structures had similar seismic damage characteristics with those in Wenchuan earthquake. In high intensity areas, despite of consideration of seismic fortification, this type of structures were damaged severely both in bottom and masonry superstructure. Therefore, appropriate stiffness ratio of bottom frame and upper masonry should be set.

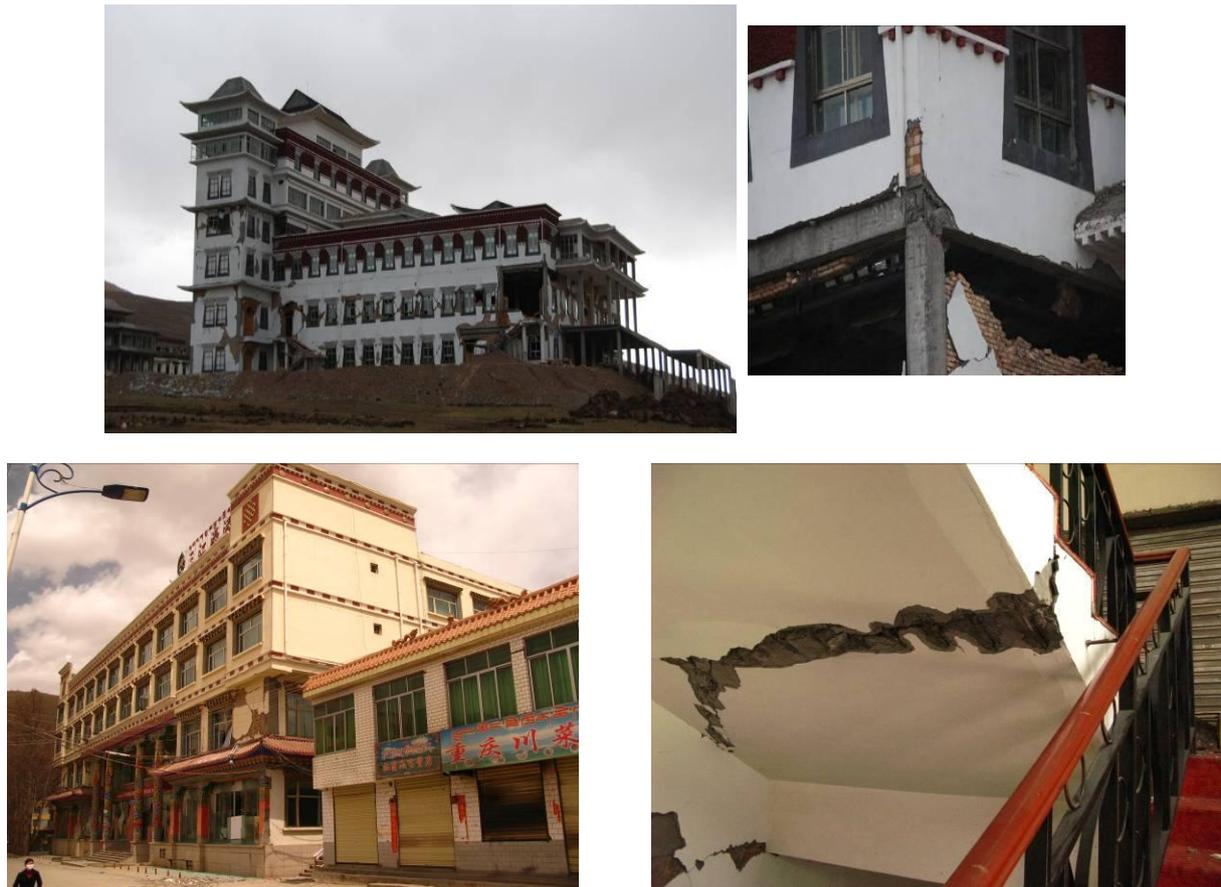
According to seismic design code of buildings (GB 50011, 2001), the local fortification intensity of Yushu is VII (or 0.15g). RC frame buildings, the infill walls of which were mainly composed of concrete hollow bricks, had a small amount in the disaster area, and mainly appeared in luxury hotels, new hospitals or temples. Frame structures suffered similar damages with those in Wenchuan earthquake, whose main damages were included as inclined cracks or ‘X’ shaped shearing cracks in

infill walls, concrete spalling of most construction columns end, reinforcement yielding, plastic hinge formation, damages of ‘strong beam and weak column’, collapse of staircase partition, collapse appearing in about one third away from the bottom of staircase for the ‘three-steps construction’, see Fig. 6. Some rare samples of ‘strong column and weak beam’ in the seismic design code were also found. For instance, formation of plastic hinges occurred in several platforms of staircase of the inpatient department of the people’s hospital (which was under construction) of Yushu. It can be shown in Fig. 6 that the frame structure under construction was basically intact, while the adjacent brick masonry construction got partially collapsed.

**Fig. 6.** Seismic Damage of Frame Structure (Intensity IX)

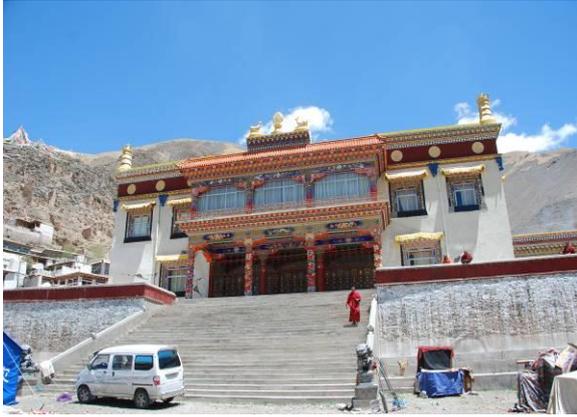
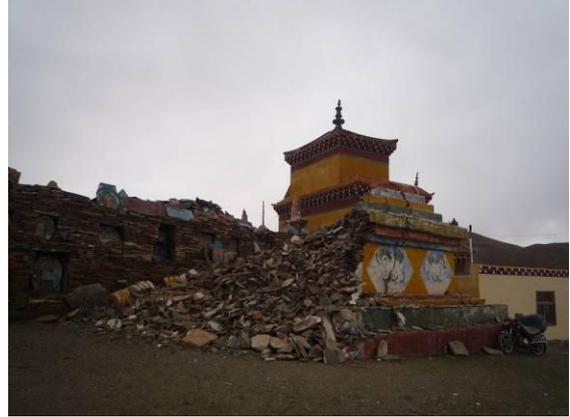
For the reason that most local residents believe in Tibetan Buddhism, a lot of religious buildings had been built, such as Buddhist institutes, shags, pagodas, Main Assembly Halls, etc. Because these temples had been built for a very long time, the constructions were mostly adobe structures, stone structures, or soil-stone wall structures with inner frame. The weak integrities and bad seismic performances of these buildings caused heavy seismic damages, which can be seen in Fig. 7.

**Fig. 7. Seismic Damage of Religious Building**

(5) For the reason that most local people believe in Tibetan Buddhism, religious buildings always had large populations inside. It's recommended that reinforced concrete frame structure and reinforced masonry structure should be adopted on such buildings afterwards.

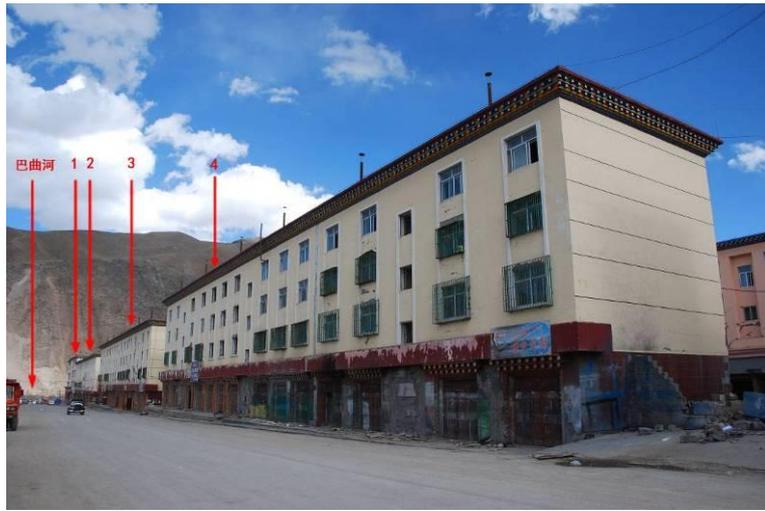
a) overall view

There were five buildings located in the commercial street perpendicular to the Shengli Road and Baqu River. Specific descriptions of these buildings are in Table 1. Fig. 8 and Table 1 shows that seismic damages of structure 1~4 were gradually reduced from the nearby Baqu River bank, which proved the significant influence of site effect.

**Fig. 8.** Seismic Damage Of Constructions in Commercial Street

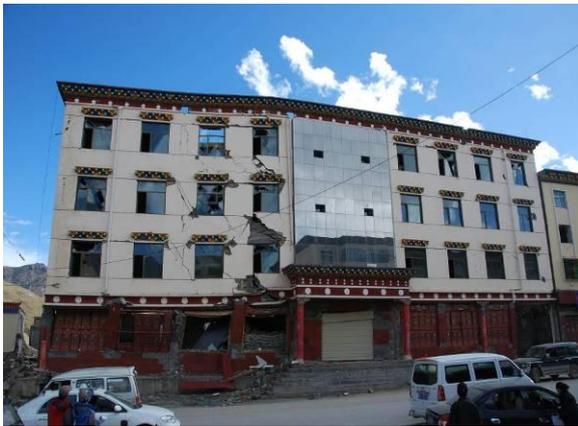
b) No.1 building

Building number	Structure type	Storey number	Damage grade	Descriptions of damage
1	RC Frame structure	4	severe damage	Most column ends of the first floor suffered lantern-type shear failure, which are typical 'strong beam and weak column' failure mechanism. Shear failure in the wall between windows and spandrel walls appeared above the second floor. In addition, several beam ends were damaged, and some stairs collapsed.
2	Masonry structure with bottom frame	4	Moderate/severe damage	Beam-column joints of the first floor remained intact, and penetrating cracks presented in infill walls. Decorative tiles dropped, crossed shear cracks existed in most spandrel walls of the second to fourth floor, and the infill walls of the staircase cracked.
3	Masonry structure with bottom frame	4	Moderate damage	Decorative tiles dropped, inclined shear cracks appeared in part of the spandrel walls of the second and fourth floor, the right side of the divider joint suffered heavier damage than the left one.

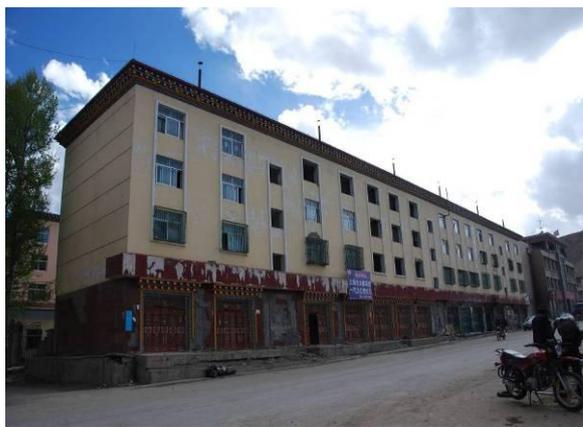
e) No.4 building

4	Masonry structure with bottom frame	4	Slight damage	Inclined cracks appeared in several spandrel walls.
