PERFORMANCE OF STEEL STRUCTURES DURING THE FEBRUARY 27, 2010, CHILE EARTHQUAKE

R. Herrera & J. F. Beltran

Universidad de Chile, Santiago, Chile

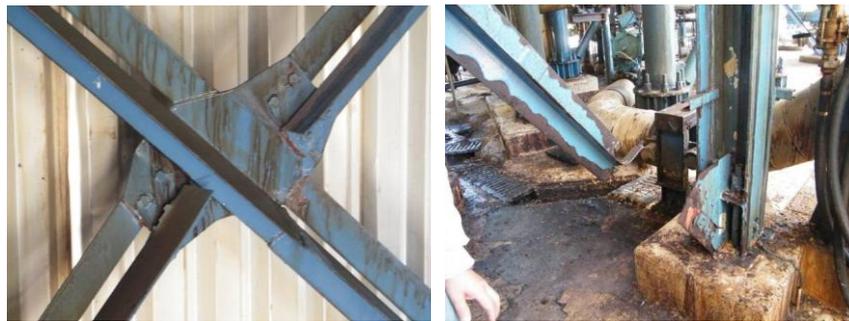
Figure 4: Brace failures

In general, no significant damage was observed in the structures. Most problems occurred in structures older than 20 years, where the structural members had very limited ductility. Typical damage observed was buckling of braces and fracture of gusset plates (Fig. 4). Some industrial buildings had permanent deformations due to the brace buckling and the lack of redundancy. Some failures of conveyor belts due to pedestal damage (Fig. 5) or partial collapse of an intermediate support structure were also observed. Fractured anchor rods could be observed at the base of columns and mechanical equipment, as well as the spalling or crushing of the leveling grout or the concrete underneath base plates. Other common damage observed was the buckling of shell structures, such as chimneys and tanks. However, most structures and building designed according to NCh2369 (INN, 2003) had light or no damage. The most significant structural damage occurred in a boiler building, where the seismic stoppers could not contain the displacement of the boiler, leading to the impact of the equipment with the structure.

(a) Brace buckling

(b) Brace-to-gusset connection fracture

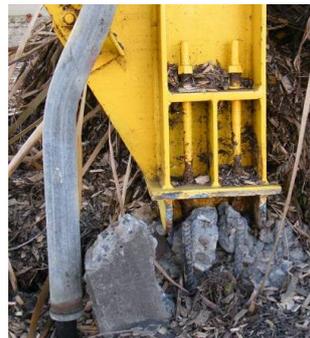
Figure 5: Stretching of anchor rods and pedestal failure

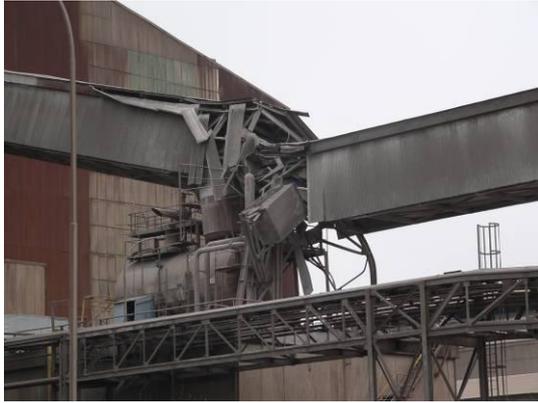
Localized severe damage was observed at the Huachipato steel mill, near Concepcion. Fig. 5 shows some of the problems on this industry, which was one of the most severely affected facilities. Nonetheless, in the analysis of the damage, consideration must be given to the fact that this installation is a very large, old facility with a large number of structures, located close to the epicenter and which has sustained events such as the 1960 earthquake of the South of Chile (Steinbrugge y Flores, 1963).

(a) Conveyor belt collapse

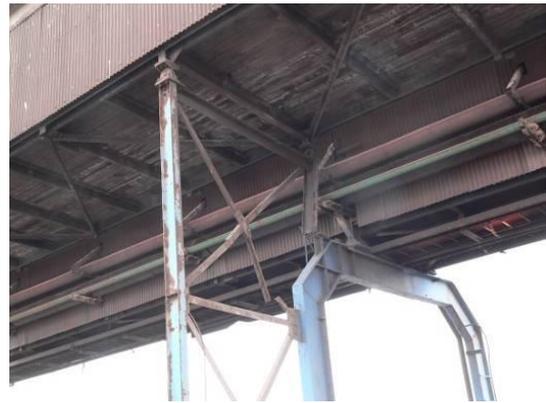
(b) Brace fracture

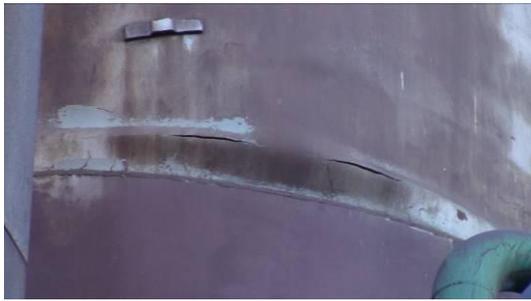
(c) Buckling of chimney wall

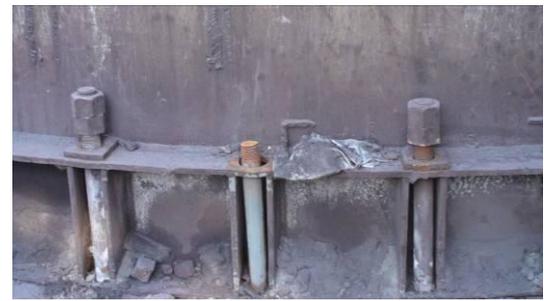
(d) Stretching and fracture of anchor rods

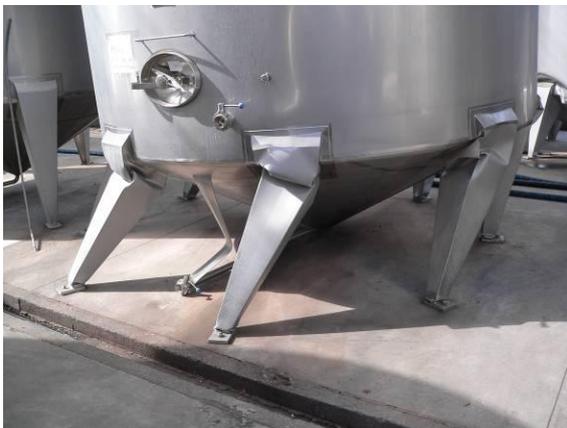
Stainless steel tanks were either supported on legs or on concrete footings. Legged tanks are usually used to store up to 50,000 l of the highest quality wines. Damage observed on these tanks is shown in Fig. 6 and includes: buckling of legs, buckling of tank wall around the leg, failure of the height regulation mechanism. When the legs were not anchored to the floor, normally the tank would topple over after one leg fell into a gutter or other floor irregularity.

(a) Leg instability

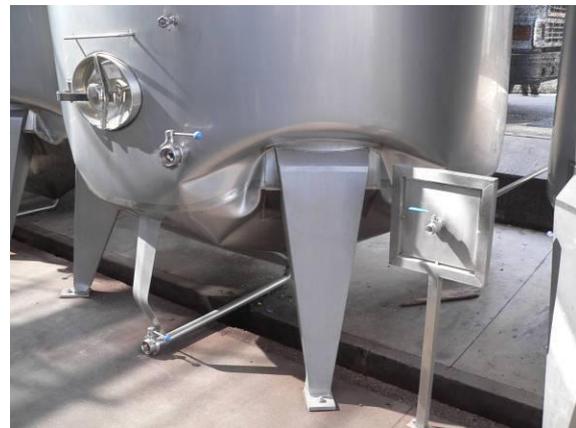
(b) Strong leg-weak wall failure

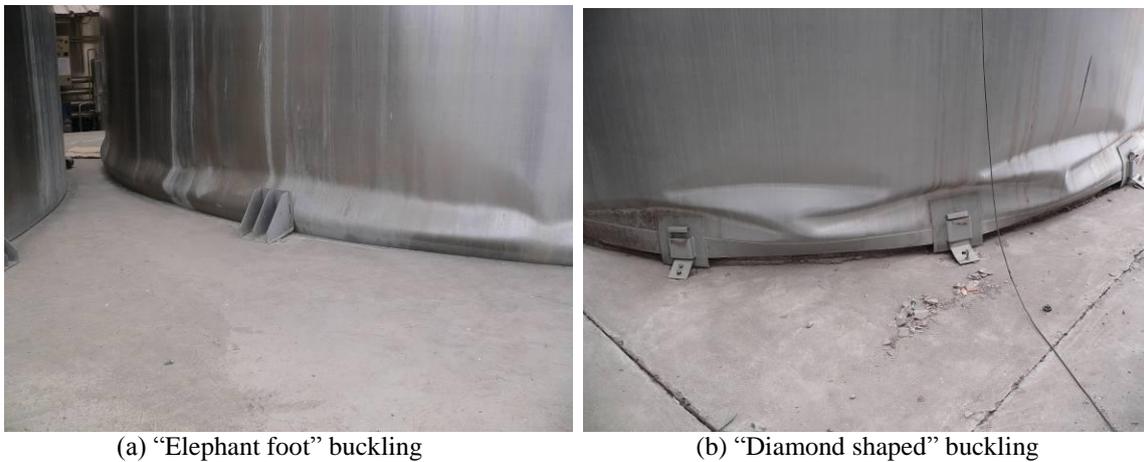
Tanks on grade are normally used for volumes over 50,000 l reaching capacities of over 650,000 l in some cases. The damage observed on these tanks includes: tank wall buckling (either “elephant foot” or “diamond shaped”, shown in Fig. 7), anchorage failure, separation of the bottom of the tank from the walls and fracture of valve and fitting connections to the tank wall.

Figure 7: Tank wall damage

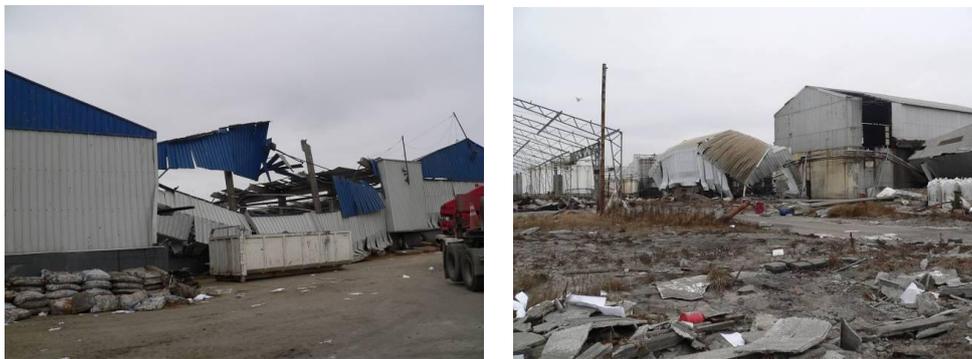
Most of these structures were made of cold formed light gauge steel, and despite the limited ductility of these elements, withstood successfully the ground shaking. Light steel structures, such as the fish processing facilities in Talcahuano shown in Fig. 8, were affected by the tsunami.

Figure 8: Damage on fish processing plants in Talcahuano.
