Regions Of Liquefaction Damage In Kaiapoi Following The Canterbury Earthquakes And Their Correlation With Former River Channels

L.M. Wotherspoon, M.J. Pender & R.P. Orense

The University of Auckland, Auckland, New Zealand

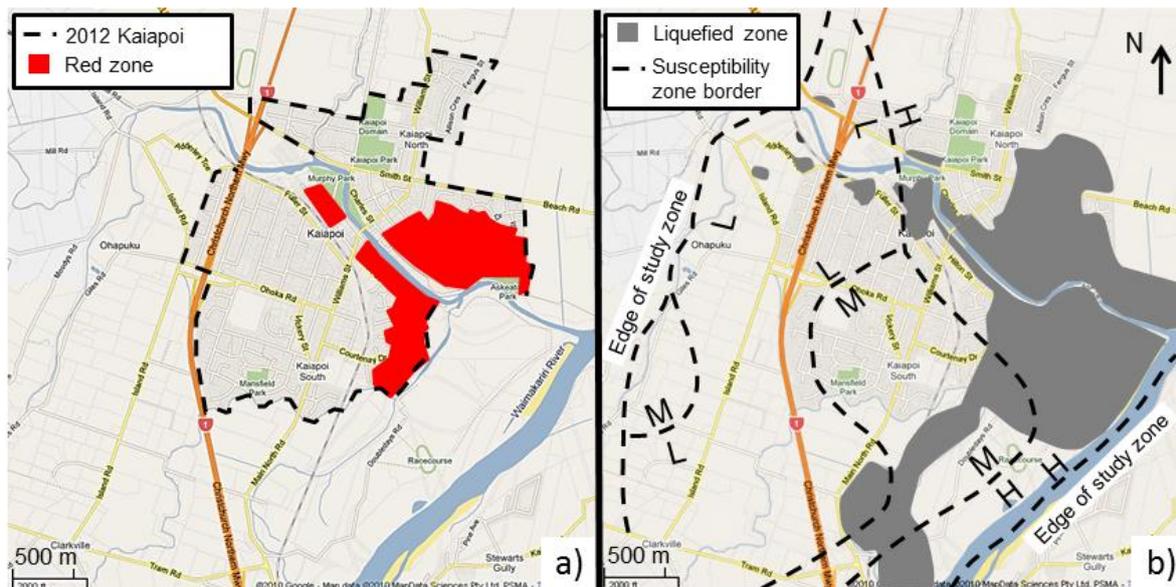
The Kaiapoi area was included as part of a liquefaction potential study of the eastern Waimakariri District in the early 2000's (Christensen 2001). The map of liquefaction susceptibility developed in this study for the area around Kaiapoi is summarised in Figure 3, with regions of high (H), medium (M), and low (L) susceptibility indicated. Liquefaction assessment used two earthquake scenarios, a $M7.2$ Southern Alps foothills earthquake with an epicentral distance of 50 km, and a $M8$ Alpine Fault earthquake with an epicentral distance of 150 km.

Figure 3. a) Kaiapoi town extents in 2012 and the red zoned residential areas b) Liquefaction susceptibility regions in Kaiapoi after Christensen (2001) and regions of liquefaction damage following the Darfield earthquake

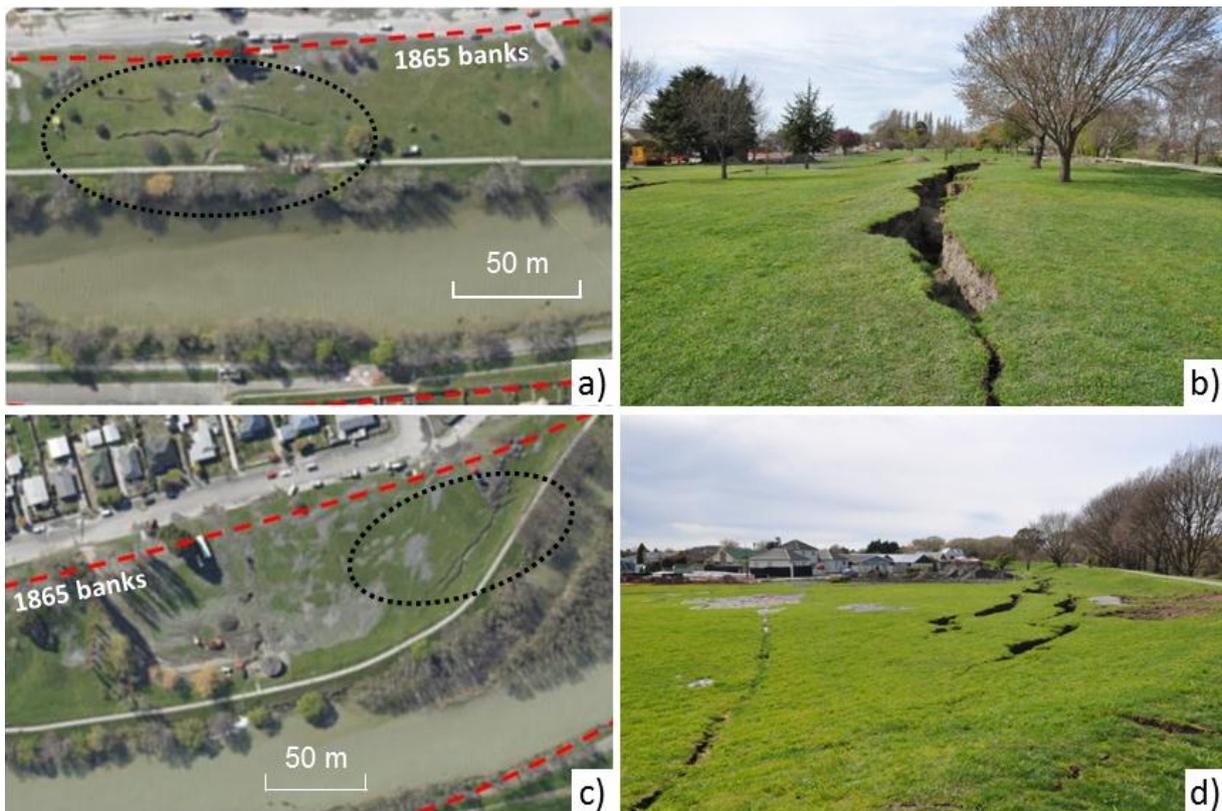
Figure 5. a) Aerial view of lateral spreading along Kaiapoi River indicating lateral spreading fissures (NZAM 2010); b) ground level view of dashed area in a); c) Aerial view of lateral spreading along Kaiapoi River indicating lateral spreading and large ejecta volumes (NZAM 2010); d) ground level view of dashed area in c)

These two areas and the rest of the land along the north banks of the Kaiapoi River were damaged by severe lateral spreading, impacting multiple structures situated adjacent to the river banks. Large fissures developed along this area of reclaimed land, indicated by the aerial view in Figure 5a. The circled area in Figure 5a is shown at ground level in Figure 5b. This was the most severe lateral

spreading fissure identified, with a width up to 1 m wide and a depth up to 2 m. These large fissures close to the river were free of ejecta, most likely due to their elevation in comparison to the water table. Cracks that opened up further back from the river were often filled with ejecta as these were at a lower elevation. Total lateral displacements of up to 3 m were recorded along this area (Robinson et al. 2011).

Large lateral spreading fissures were also evident in the region shown in Figure 5c, with a ground level view shown in Figure 5d. However, a much larger volume of ejecta, indicated by the grey areas in Figure 5c, was seen at the surface in this location. The most likely reason for this is the flat and low-lying characteristics in this area, meaning that the water table was closer to the ground surface in the grassed reserve area.

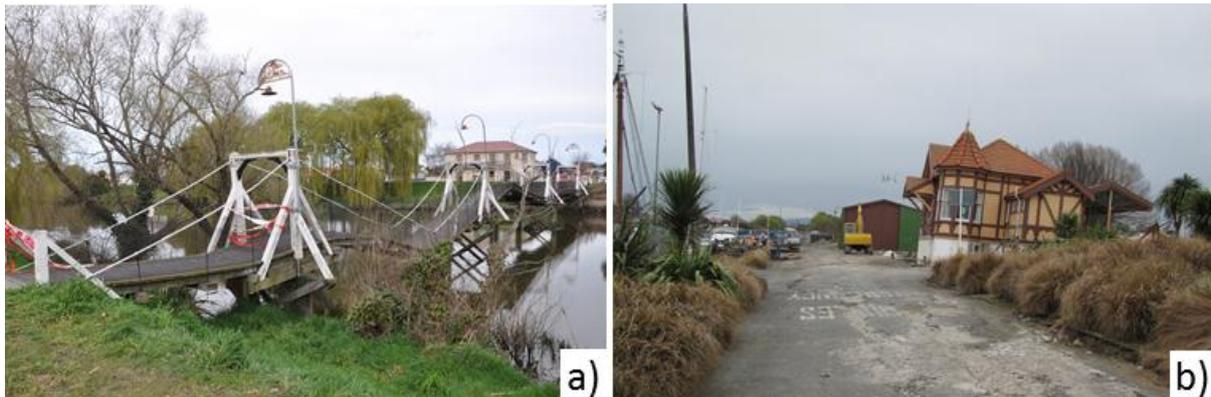
Figure 6. a) Damage to Mandeville footbridge; b) Back-rotation of the Kaiapoi Visitors Centre

Examples of the damage to structures along this area of reclaimed land are presented in Figure 6, the locations of which are indicated in Figure 4. The Mandeville footbridge, a wooden bridge spanning the Kaiapoi River built in 1874 and abutting an old reclaimed rubbish dump area, suffered severe buckling damage as a result of the compressive forces from lateral spreading of both riverbanks. The Kaiapoi Visitors centre, directly adjacent to the north bank of the Kaiapoi River, back-rotated approximately 5° away from the river as a result of lateral spreading.

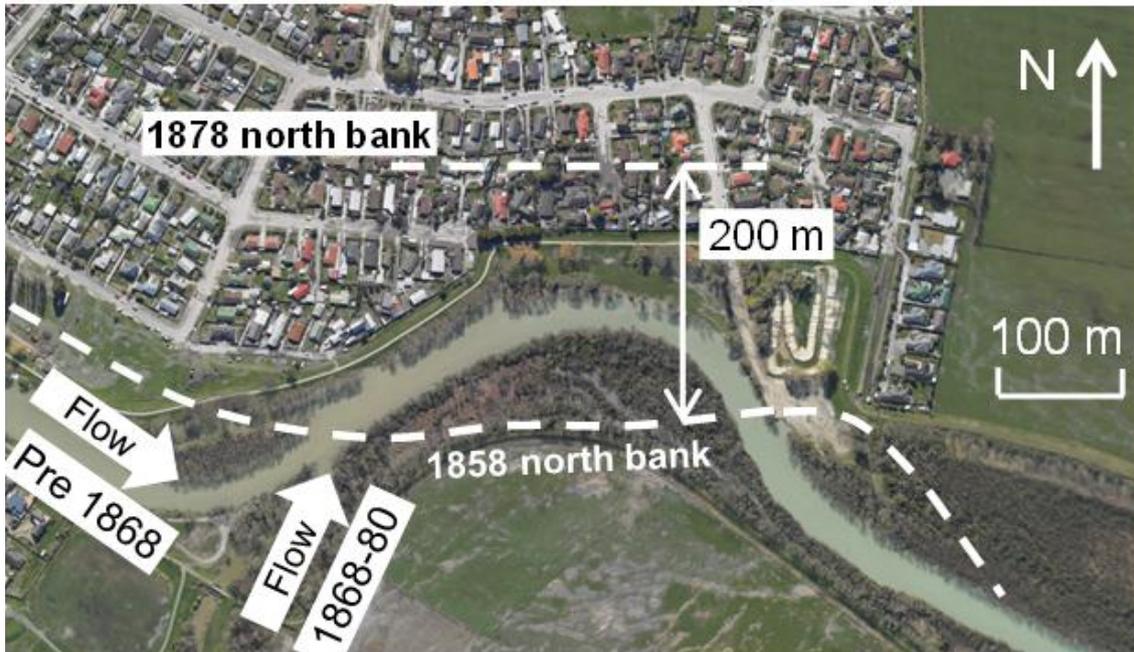
Figure 7. Aerial view of land damage in north-eastern Kaiapoi and the location of current and historic river channels (NZAM 2010)

A conservative indication of this extent of erosion is provided in Figure 7, using the location of the northern river banks from 1858 as the origin for the 200 m of river encroachment to the north due to the erosion processes. Surveyed plans for the streets in this area from 1858 show road locations cutting across the area that was eroded away during the 1868-1880 period (Wood 1993). Plans were developed to construct stopbanks to prevent further erosion north of this position. However, the main flow of the river shifted away from this location with the movement of the main channel of the Waimakariri further east of town in 1880, preventing any further erosion in this area. In fact, comparison between the 1878 and the current river banks shows that much of the eroded area was aggraded river sediments due to the reduced flow round the bend of the river.

All of the area shown in Figure 7 was affected by liquefaction, with the worst damage in the area between the current and 1878 river banks to the north of the current river bend. Significant lateral spreading fissures developed running parallel to the north banks of the river, impacting the area between the riverbank and the stopbanks set back from the river in this location. An aerial view of damage to a BMX park adjacent to the river bend is given in Figure 8a, with large lateral spreading fissures, surface ejecta and flooding. The residential buildings in this area were set back far enough from the river for lateral spreading to have little impact, however these were instead severely damaged as a result of settlement and large ejecta volumes. A close up aerial view of the cul-de-sac just to the north of the river bend in Figure 8b indicates that severe liquefaction in the resulted in extensive volumes of ejecta indicated by the dark grey areas. This was up to 400 mm thick in places, with a similar extent of settlement to some structures. This settlement also severely impacted the buried services and roadways.

Further settlement occurred in this area following both the 2011 Christchurch and 13 June 2011 earthquakes, with the severity of this and the ejected sands lessening for each event. This settlement resulted in flooding of the area just to the north of river bend following some high tide events. Many houses in this area were abandoned soon after the 2010 Darfield earthquake, with the all the residential area north of the river in Figure 6 designated as red zoned in 2011 (red zone location shown in Figure 3a).

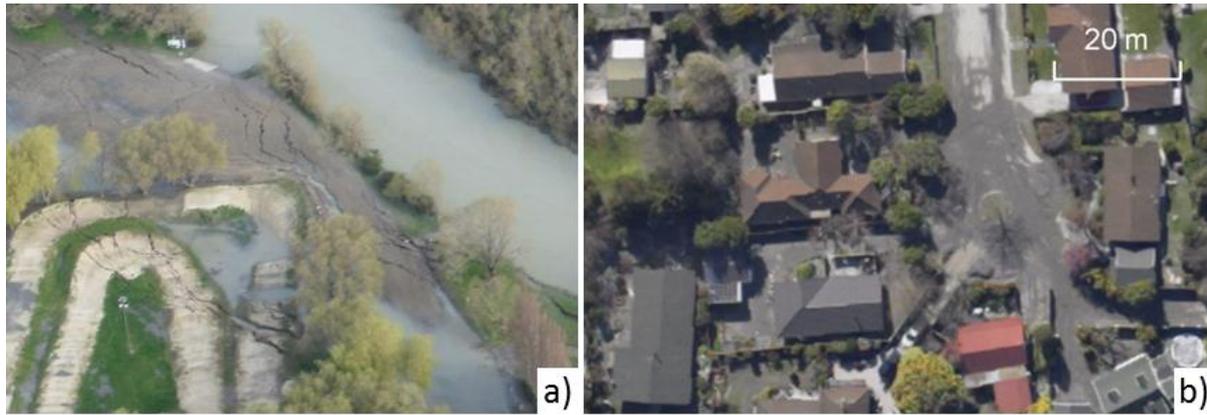
Figure 8. a) Aerial view indicating lateral spreading fissures and ejecta; b) aerial view of significant ejecta volumes north of river bend in Figure 6 (NZAM 2010)

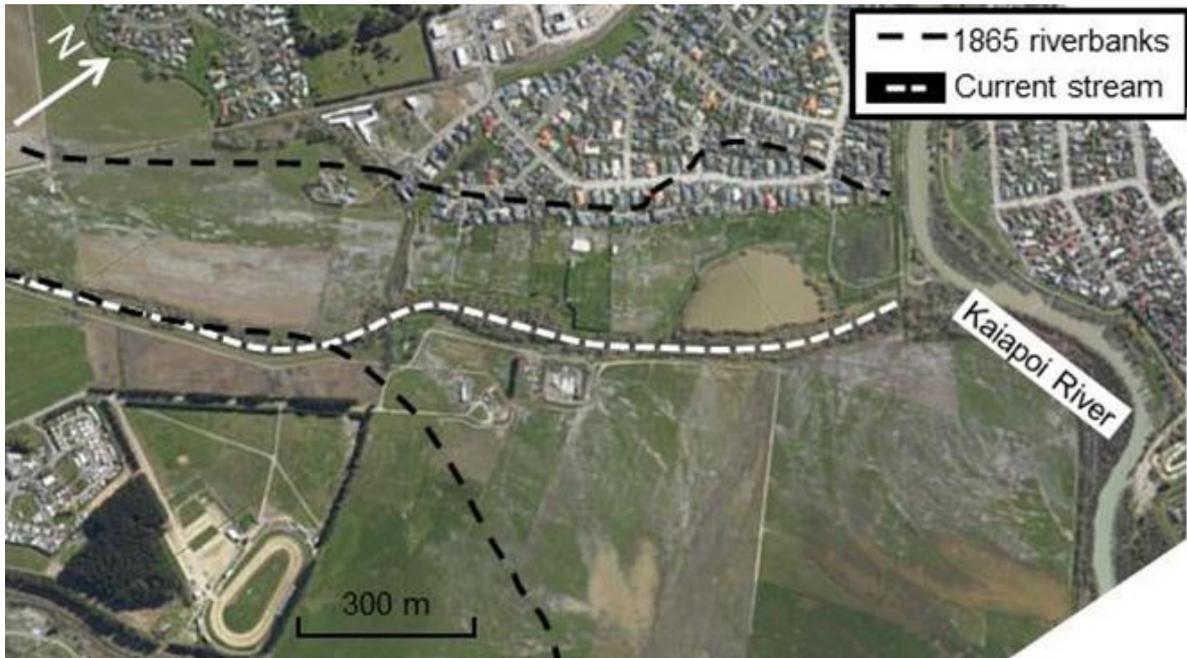
To the south-east of Kaiapoi, the surface manifestations of liquefaction following the Darfield earthquake were well bounded by the location of the southern branch of the Waimakariri River as it existed prior to 1880, also shown by the solid lines representing the confluence of the north and south branches in Figure 2. An aerial view of this south-eastern area after the Darfield earthquake is shown in Figure 9, with the black dashed lines showing the location of the river banks in 1865 (Ward & Reeves 1865, Cass 1864) and the grey areas within this evidence of ejecta and the surface. Outside these lines, there is little evidence of ejected material, and this was confirmed by ground based reconnaissance following the Darfield earthquake (Green et al. 2010). The white dashed line in this figure shows the location of a small stream, which is all that remains of the old southern branch following the river diversion in 1880.

The upper black dashed line in Figure 9 can be seen to pass through a residential area in south-eastern Kaiapoi. All of this area bounded by the old channel, part of a relatively new subdivision, suffered significant damage due to lateral spreading, settlement, and large volumes of ejected material. Large lateral spreading fissures up to 1.5 m in width ran through these residential properties and structures. Overall permanent displacements of up to 2.8 m were measured following the Darfield event as the land moved towards the present day stream shown in Figure 9 (Robinson et al. 2011). Ejecta up to half a metre deep was measured in the residential properties and roads in this region. This land damage caused a range of building damage including spreading, settlement, tilting, and foundation cracking. In many houses this cracking propagated up from the foundation slab into the structure and through the roofline. An example of the damage to residential buildings is shown in Figure 10a, where lateral spreading caused significant rotation of the structure and gaps between the house and the surrounds of over a metre.

These areas were further impacted following the 2011 Christchurch earthquake. There were again ejected sands evident throughout this area, and further lateral spreading affecting the residential buildings along the edge of the old channel. However, by this time many residents had already left their homes in the area due to the severity of the damage caused by the Darfield event. The severity of damage was again less following the 13 June 2011 earthquake, with some slight increases in lateral

spreading, and smaller volumes of ejected sands. All the area within the banks of the old river channel was designated as red zoned in 2011.

Figure 9. Aerial view of the surface manifestations of liquefaction in the south eastern region of Kaiapoi and the location of the old Waimakariri river channel (NZAM 2010)

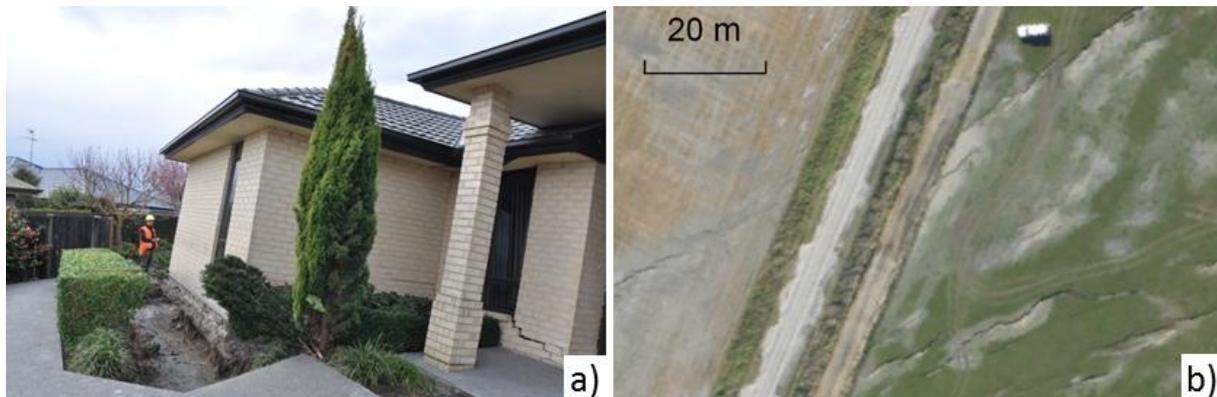
Train tracks suffered damage as they passed through the old channel in the top left corner of Figure 9. A close up aerial view of the damage is provided in Figure 10b, with significant volumes of ejecta and large lateral spreading fissures passing through the track location. The white rectangle at the top of the figure to the right of the tracks is a truck, which provides a good indication of the scale of this lateral spreading. The horizontal movements and settlement in the area meant significant remediation of the tracks was required soon after the earthquake. The race track and structures at the bottom left corner of Figure 9 were unaffected by liquefaction as they were located outside the old river channel.

Figure 10. a) Lateral movement and tilting of house in residential area overlapping the old river channel in Figure 6; b) lateral spreading and ejecta across rail tracks (NZAM 2010)
