# Practical Lessons for Concrete Wall Design, Based on Studies of the 2010 Chile Earthquake

**K. Telleen & J. Maffei**

*Rutherford & Chekene Consulting Engineers, San Francisco, CA, USA*

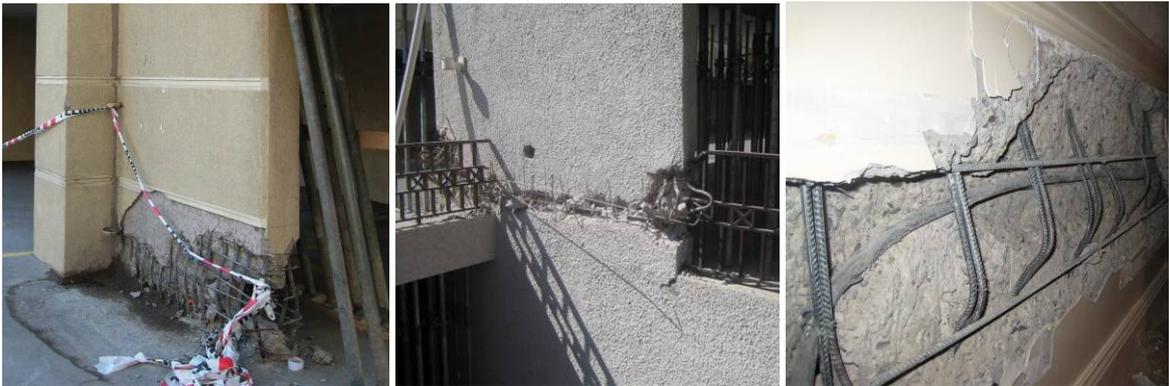
**Figure 1.1.** Damage to wall boundaries: longitudinal bar buckling and concrete crushing.

Much of the damage observed in concrete walls of mid-rise and high-rise buildings in the Chile earthquake consisted of buckling of longitudinal (vertical) reinforcing bars and crushing of concrete near the base of the walls. This type of failure was most severe at wall boundaries, but damage also tended to propagate over much of the length of the wall as shown in Figure 1.1 and Figure 1.2c. It is an undesirable failure mode because it can lead to strength degradation and irreparable damage. Such damage may have contributed to the total collapse of one building in Chile.

Several instances of damage to wall boundaries occurred in walls with flanged cross-sections such as T-shapes and L-shapes (Figure 1.1a, Figure 3.1a). In such configurations, the neutral axis depth is different depending on the direction of bending (Figure 4.3c). Paulay and Priestley (1992) discuss this effect in more detail, noting that a large neutral axis depth can lead to limited curvature ductility unless adequate confining reinforcement is provided in the critical compression regions of the wall. When the

flange is in compression, the neutral axis depth is shallow, and much of the web reinforcement is strained in tension. When the direction of shaking reverses so that the flange is in tension, the neutral axis depth is deep, imposing large compressive strains at the extreme fiber of the web and with compression extending a significant distance along the length of the wall. This type of behavior is consistent with damage such as that in Figure 1.1c, where vertical bars exhibit buckling along much of the length of the wall.

The ATC-94 project includes analyses of damaged and undamaged walls from several different Chilean buildings in an attempt to determine which scenario most accurately describes the observed damage in Chile and in experimental tests. Both interpretations lead to a conclusion that inadequate ties in the boundary zones make a wall more likely to experience damage of this type. The implications of the spalling-first scenario would lead to requirements for a greater area of confinement ties in the compression boundaries. The implications of the buckling-first scenario would lead to close spacing of ties (not necessarily greater tie area) and would possibly imply ties further into the section; the emphasis of design for flexural walls such as those in Chile would focus on restraining bars from buckling, because if this is done the questions of strain demand and strain capacity may be less critical.

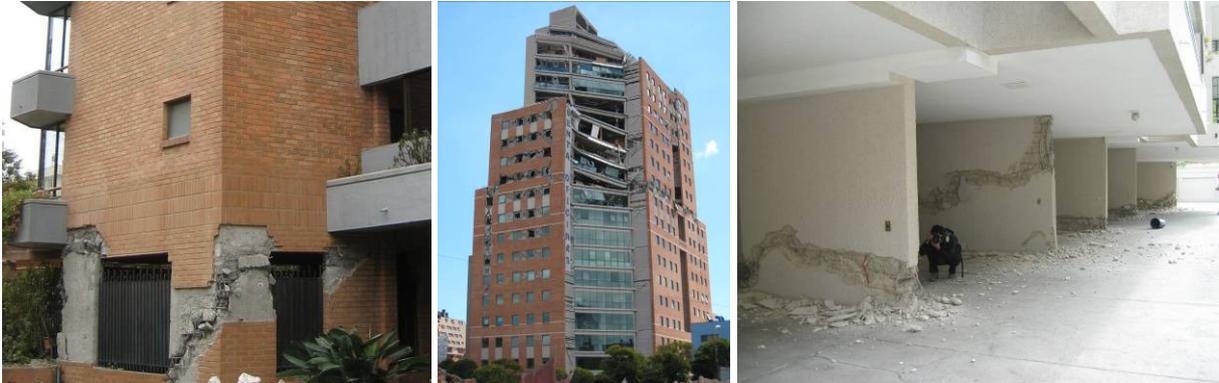
**Figure 1.2.** Damage concentrated at discontinuities (photo (c) by Professor Patricio Bonelli)

Abrupt changes in wall length led to damage in cases where shorter walls occurred above longer walls (Figure 1.2b), and also where longer walls occurred above shorter walls (Figure 1.2a and 1.2c). In the example of Figure 1.2b, decreased wall length also coincides with a decrease in wall thickness and reinforcement. This discontinuity and the presence of weak shear-critical wall piers contributed to a partial story collapse at that level. In examples such as Figure 1.2c, wall length decreases at lower levels to accommodate drive-aisles and parking constraints, while apartments above extend toward the property line. Figure 4.1 describes observed damage and associated design characteristics in this type of building configuration.

Possible recommendations for improving design practice could include avoiding vertical discontinuities near the intended plastic hinge region of walls, adjusting analysis assumptions or limits on concrete compression strain, using special detailing requirements to improve compression and cyclic behavior of wall boundaries, and providing reinforcement to rationally resolve forces at discontinuities.

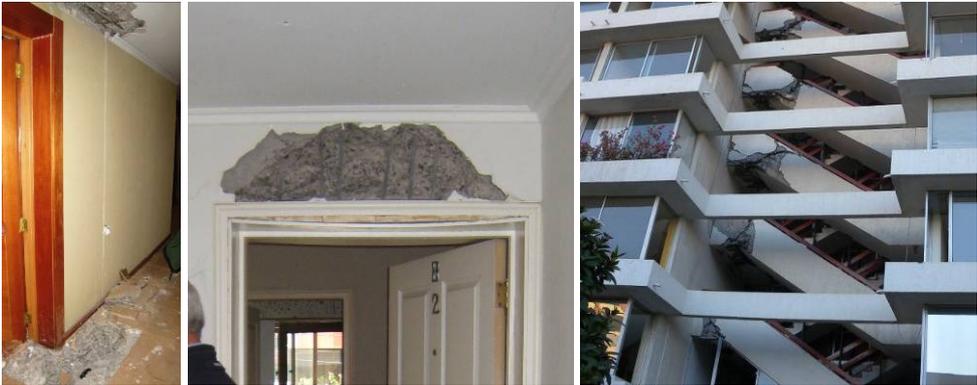
**Figure 1.3.** Damage to coupling elements (a) slabs (b) beams (c) stairs.

Damage was observed from coupling due to slabs, beams, spandrels, and stairs transmitting forces between distinct structural walls (Figure 1.3). Where coupling is the intended mechanism of response and walls and coupling beams are detailed accordingly, coupling beams can be an effective means for dissipating energy. However, if coupling effects are not explicitly accounted for in design, unintended behavior may occur in the coupling elements, or the coupling can increase the shear demand and neutral axis depth of coupled walls beyond that provided for in the design. This can potentially lead to the wall boundary damage discussed previously.

Potential improvements to design practice include explicitly accounting for the coupling elements in the seismic analysis and design, or detailing them to minimize interaction with the designated seismic force-resisting elements.

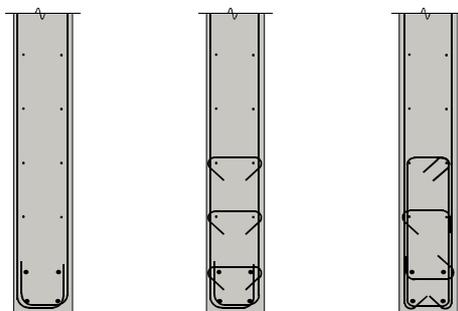
Some evidence from the Chile earthquake indicates that bar buckling was a key cause of damage. For example, all of the serious flexural damage to walls reported has included buckled bars. The authors are not aware of reports of spalling without buckled vertical bars. Also, all of the damaged walls reported had inadequate transverse reinforcement, similar to Figure 2.1a. Some engineers in Chile state that they do use well-detailed transverse reinforcement and that such walls did not suffer any damage. In the spalling-first scenario one would expect some damage even to well-detailed walls.

**Figure 2.1.** Wall boundary detailing (plan sections): (a) No hoops or cross-ties; typical of walls with observed damaged in the 2010 Chile Earthquake. (b) Cross-ties with 135-degree hooks; authors are not aware of any damage observed to walls with this type of detailing in the Chile Earthquake. (c) Hoops and cross-ties with 90-degree and 135-degree hooks; satisfying current ACI 318 detailing requirements.

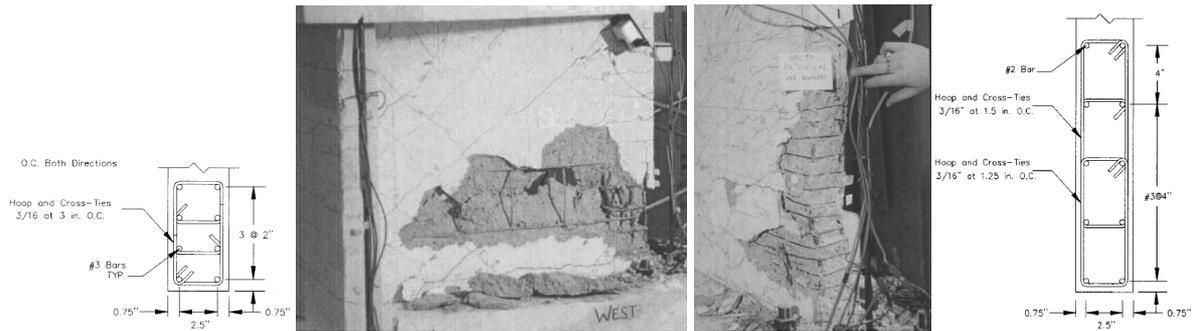
The buckling-first interpretation is also consistent with behavior observed in the test specimens by Thomsen and Wallace (2004), shown in Figure 2.2. T-shaped wall specimens with different amounts of wall boundary ties were subjected to cyclic static loading with increasing displacement. The specimen in Figure 2.2a, with widely-spaced hoops and cross-ties extending only a short distance into the wall web, showed bar buckling occurring suddenly at 1.25% drift, without significant prior spalling. The specimen in Figure 2.2b, with more closely-spaced hoops and cross-ties extending further into the wall web, showed more ductile response, achieving 2.5% drift before the wall web began to buckle out-of-plane.

**Figure 2.2.** Test specimens from Thomsen and Wallace (2004): (a) Hoops and cross-ties spaced at  $8d_b$ , extending  $0.15L_w$  into wall web. (b) Hoops and cross-ties spaced at  $4d_b$ , extending  $0.35L_w$  into wall web.

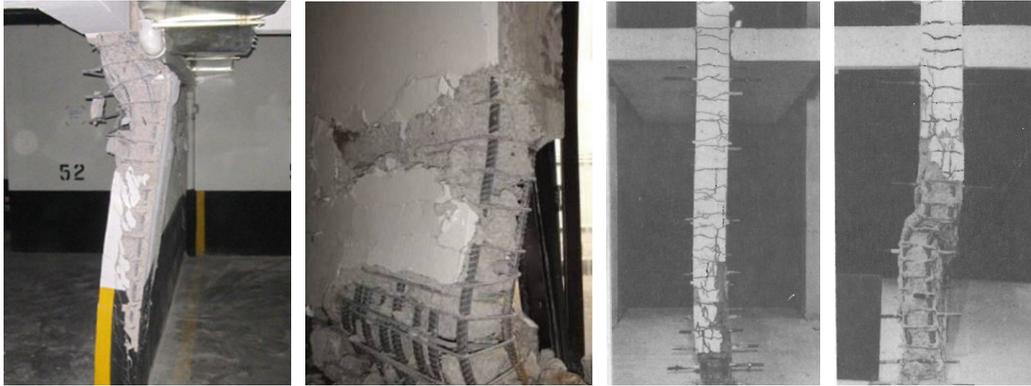
Prior to the 2010 Chile Earthquake, this phenomenon had been observed in experimental tests (Figure 3.1c,d), but the authors are not aware of any reports of this behavior in an actual earthquake. Relative to other types of observed wall damage in the Chile Earthquake, the number of instances of overall wall buckling is relatively few (Figure 3.1a), and some engineers question whether or not this behavior is distinguishable from concrete crushing in certain instances. These instances were often associated with significant residual drift in the building. This behavior was also observed in the 2011 Christchurch, New Zealand, Earthquake (Figure 3.1b).

A notable feature of the examples shown in Figure 3.1 is that the buckling length of the wall is less than the clear story height. Also, the wall in Figure 3.1b is relatively thick, apparently satisfying the criteria listed above from the Uniform Building Code. These observations indicate that other factors, besides the thickness and clear height of the wall, can be influential. Tension strain has been suggested as an important factor because this causes concrete cracking and, upon load reversal, requires vertical bars to carry compression loads. One curtain of reinforcement will inevitably yield before the other, which could lead to wall buckling if cracks are large enough relative to the thickness of the wall.

**Figure 3.1.** Examples of overall wall buckling: (a) 2010 Chile Earthquake (photo by Professor Jack Moehle) (b) 2011 Christchurch Earthquake (Kam et al 2011) (c, d) Tests by Goodsir (1985)

To improve performance, potential modifications to design practice could include providing a minimum wall thickness at the compression boundary of a wall, as a function of the unsupported wall height and/or tensile strain demand in the region of potential plastic hinging. The thickness requirement could also depend on other variables such as unbraced wall length, axial load, or neutral axis depth. The ATC-94 project includes studies of experimental tests and the damaged buildings shown in Figure 3.1 to verify the causes and identify design limitations to avoid this behavior.

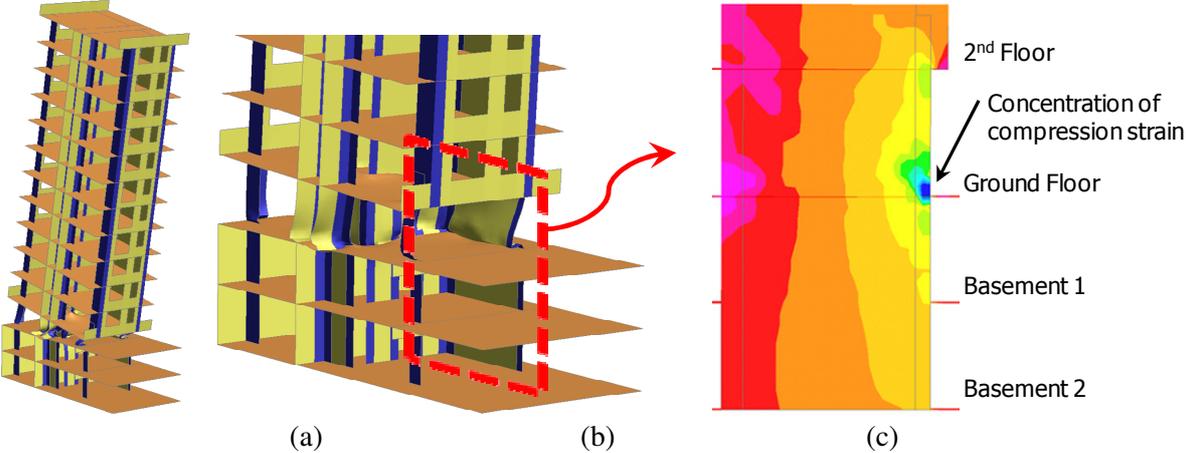
The nonlinear finite element model shown in Figure 4.2 was developed by working groups on the ATC-94 project to analytically capture behavior of an example building that includes the configuration issues described in Figure 4.1 and that suffered damage in the Chile Earthquake. When subjected to

recorded earthquake motions, the model predicts concrete crushing failure, initiated in the extreme fiber of the wall at ground level (Figure 4.2c). The strain distribution along the base of the wall is not linear; compression strains are much greater near the end of the wall. With successive cycles, the failure spreads along the length of the wall, with little vertical distribution of strain. After several cycles, vertical-load-carrying capacity is lost along much of the wall length and the building collapses. More details of the analysis are provided by Telleen et al (2012).

Figure 4.2. Analysis of wall with vertical discontinuity (a) model deformed shape at failure (b) close-up of lower stories (c) partial wall elevation showing vertical strain concentration at ground floor. (models and figures by Yuli Huang and Michael Willford)

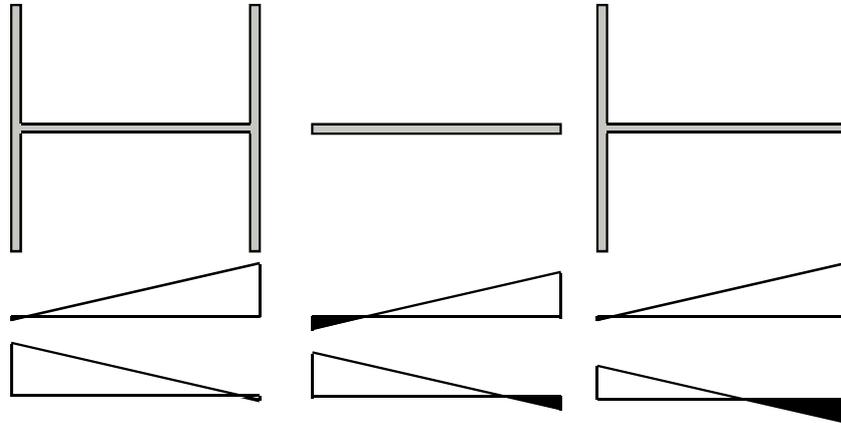
**Figure 4.3.** Neutral axis depth for wall sections (assumes  $P = 0.1A_g f'_c$ ,  $\rho = 0.0025$ ):  
 (a) I-shaped  $0.02L_w$  (b) rectangular  $0.2L_w$  (c) T-shaped  $0.4L_w$

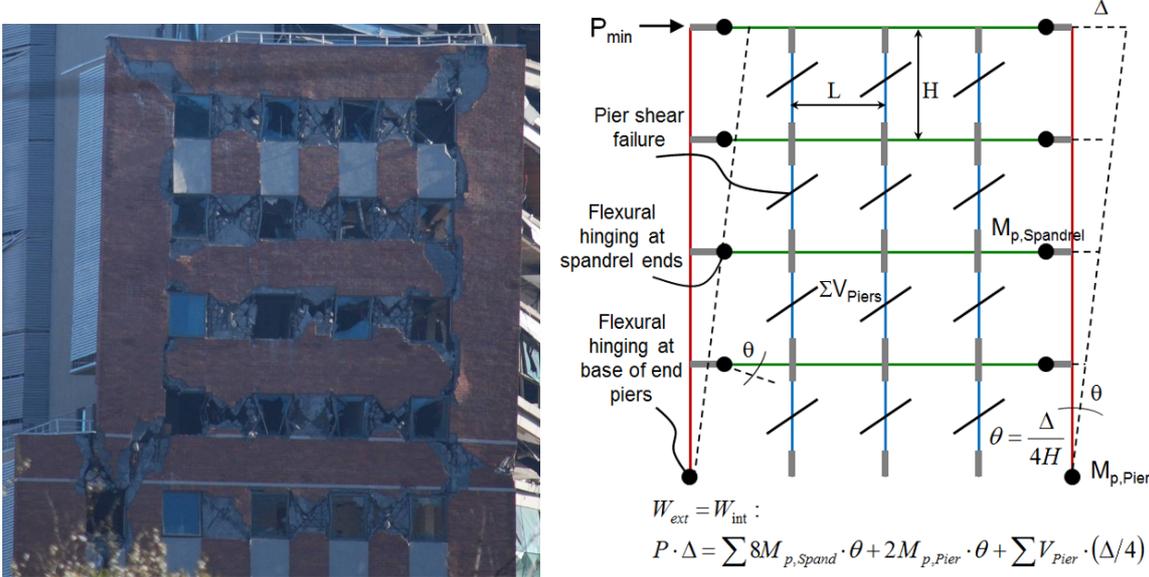
The pier-spandrel system shown in Figure 5.1a is a portion of a high rise building (Figure 1.2b) that suffered severe damage and partial collapse in the Chile Earthquake. On the elevation shown (which did not collapse) the wall piers suffered severe shear damage when constrained between deep spandrels, while the spandrels suffered flexural damage at the ends where they connect to heavier piers of the end bays. Hand calculations, described in more detail in Telleen et al (2012), confirm that piers are shear-governed, and that the governing plastic mechanism for the system is as shown in Figure 5.1b. These calculations determine the expected behavior mode of each pier and spandrel by comparing their flexural and shear strength, and then considering several potential plastic mechanisms for the system and identifying the mechanism corresponding to the least lateral resistance.

**Figure 5.1.** Pier-spandrel system: (a) observed damage (photo from EERI team) (b) plastic mechanism observed and validated by calculation (figure by Ady Aviram and Dominic Kelly).

Given that this behavior mode and mechanism are reasonably predictable by straightforward engineering calculations, the question can be considered whether design codes should require engineers to identify the governing behavior mode and mechanism, using capacity design principles. An additional issue is that US and Chilean codes currently make only a small distinction (via the strength reduction factor) in the assumed ductility capacity between shear versus flexural behavior. (For flexure, ACI 318 applies a strength reduction factor of 0.65 to 0.9, depending on whether the section is tension-controlled or compression-controlled. For shear, the strength reduction factor is 0.6

or 0.75, depending on whether the member is flexure-controlled or shear-controlled.) Shear failure of walls and wall piers is generally less-desirable than flexural yielding because shear failure tends to exhibit less ductility and can be associated with a concentration of lateral deformation and damage. For wall piers with slender aspect ratio, ACI 318-11 includes some new requirements similar to column design provisions. FEMA 306 (ATC 1999) and Maffei et al (2000) outline a more general process for identifying the governing mechanism of lateral deformation of various building configurations, similar to the example described above.
