Seismic Monitoring of Reinforced Concrete Buildings Following the Mw 8.8 Feb 27th, 2010 Offshore Maule Earthquake in Chile

Following the February 27, 2010 Mw 8.8 earthquake impacting central Chile, a team of U.S. researchers, professionals, and local collaborators instrumented several reinforced concrete buildings in Santiago, Chile, to measure aftershock response data. The selected buildings, designed according to ACI 318-95, represent typical construction, e.g. moderate to high rise office buildings with large office space and inner core shear walls and mid-rise residential shear wall buildings. Instrumentation consisted mainly of accelerometers as well as some displacement transducers with data recorded using digitizers. Several aftershocks were captured over a period of one month. Data collected were processed and system identification algorithms were used to determine modeling parameters (e.g. building periods, acceleration amplification, inter-story drifts). Investigations included analyses to assess building rocking and torsion, and assessment of diaphragm in-plane rigidity. An overview of the instrumented buildings, recorded data, and analytical results will be presented,

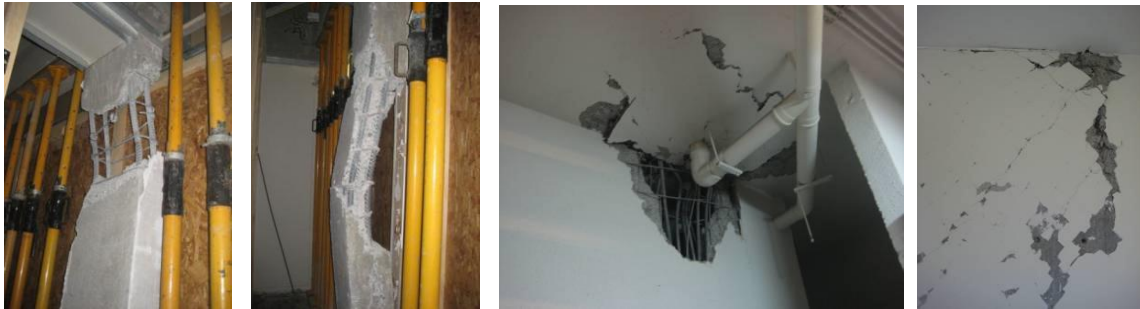
Figure 2.2 a-d(left to right): Structural damage in building 2. From left to right: (a&b) column damage on the ground level floor, (c) wall damage at the underground parking levels, (d) Shear wall damage at ground level

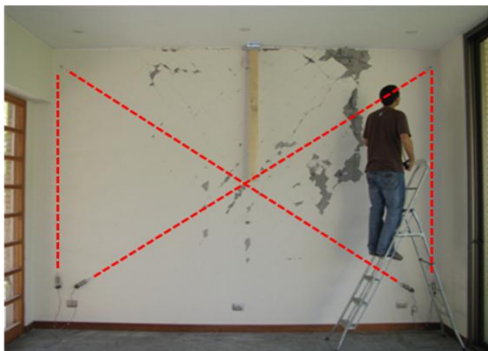
The instrumentation in *Building B* included the installation of linear voltage differential transducers (LVDTs) across a damaged shear wall on the first floor of the building. A photograph of the wall and the sensor instrumentation is shown in Figure 3.14. One pair of LVDTs was installed in diagonal configuration to enable the calculation of shear deformations during the aftershock. Another pair of vertical LVDTs was placed at both ends of the wall, spanning over the entire story height to determine the rotation due to flexural deformations. Since deformations are small, the diagonal sensors allowed for estimating the shear component of the first story lateral deformations in the wall plane. The flexural component was estimated by assuming a concentration of such deformation at wall base and that overall deformations in the wall are dominated by shear.

A time history of shear and flexure displacements during the March 25 aftershock is presented in Figure 3.15. The results indicate that the deformations are dominated by the shear component reaching about 0.2mm of lateral deformation, whereas the flexural component reaches about 0.04mm, which is only 20% of the shear component.

Figure 3.14 Instrumentation of damaged wall in Building B.

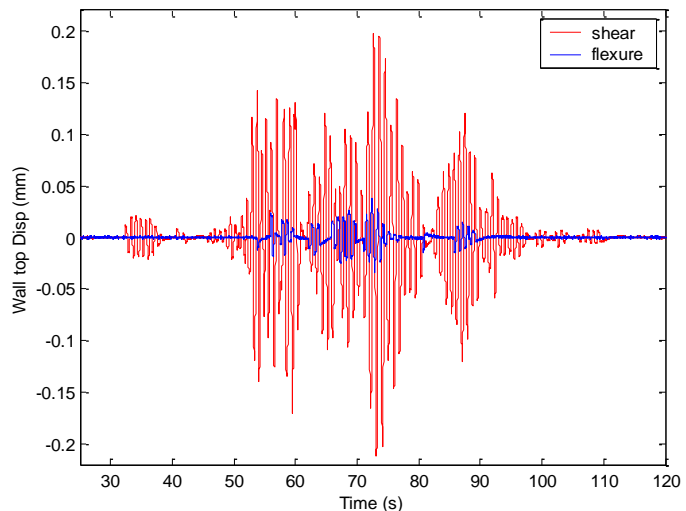
Figure 3.15 Shear and flexural components of wall shear displacement
