THE EARTHQUAKE OF 28 JULY 1957 IN MEXICO CITY
by Emilio Rosenblueth*

Introduction

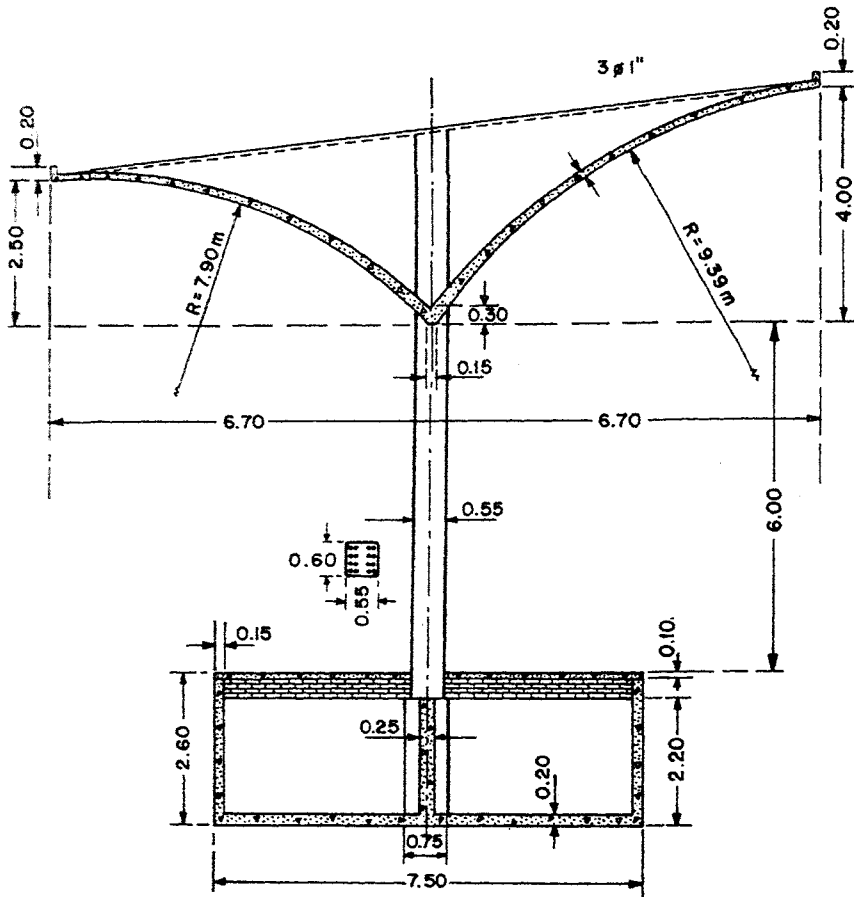
The structure for the market place (part of which is shown schematically in Fig. 12) was designed by ultimate-load theory to resist 0.1 g at failure. It was excellently built. Failure occurred by fracture of the column bases. Damage was more severe in parts built on virgin ground (former streets) than on preconsolidated soil and more in the recently poured concrete than in that which was a few weeks or months old. Foundation compliance under the relatively small footings may have added in bringing about the resonant condition.

FIG. 12. SECTIONAL VIEW OF THE LATERAL SHELL IN LA MERCED MARKET

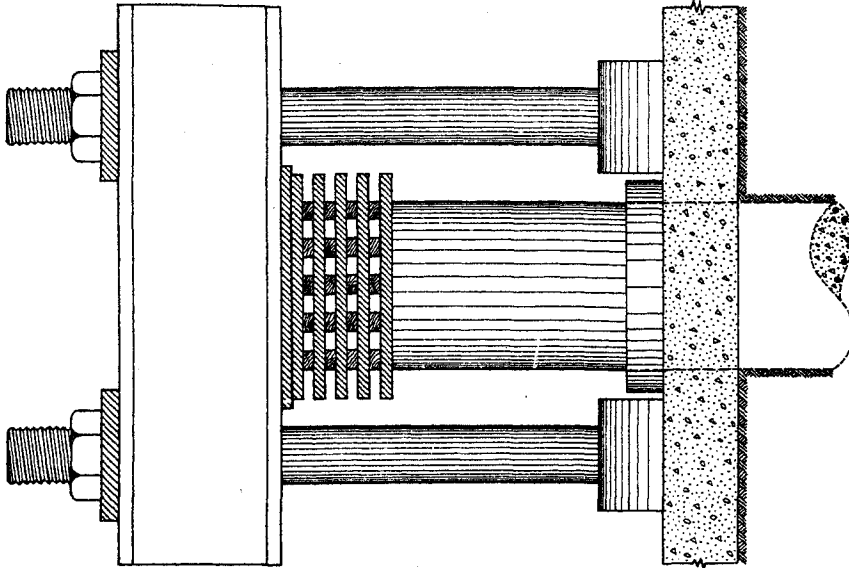
Behavior of patented control cells in some piles affords an exception that may be classed as foundation failure. The cells are wood cubes whose stress-strain curve in compression is relatively flat although quite sensitive to the rate of loading. (28) The cells are placed between steel plates as shown in Fig. 16. The club sandwich thus formed transmits pile loads to a pair of I beams or channel sections. These in turn are held down by two bolts anchored to the foundation slab. Usually 25 cells are placed in each layer. Plastic behavior of the wood insures that the load transferred from the building to the pile (of the order of 60 metric tons (132 kips)) remains almost constant despite subsidence of the city and gradual emergence of the piles. The bolts allow occasional adjustments and cutting off of short lengths of pile.

This system is ideal for carrying vertical loads but is not very stable under earthquakes, for the dynamic increment in load alters suddenly the distribution of loads taken between piles and soil. This will cause sudden tilting of the bolts when they were not strictly centered and plumb at the outset of the motion. Several such instances occurred in July 1957, bringing about local settlements and tilting of some buildings. The structures were easily straightened, however, and the system has since been improved by the addition of concrete pedestals that insure its stability.

FIG. 16. PILE WITH LOAD CONTROLLING MECHANISM

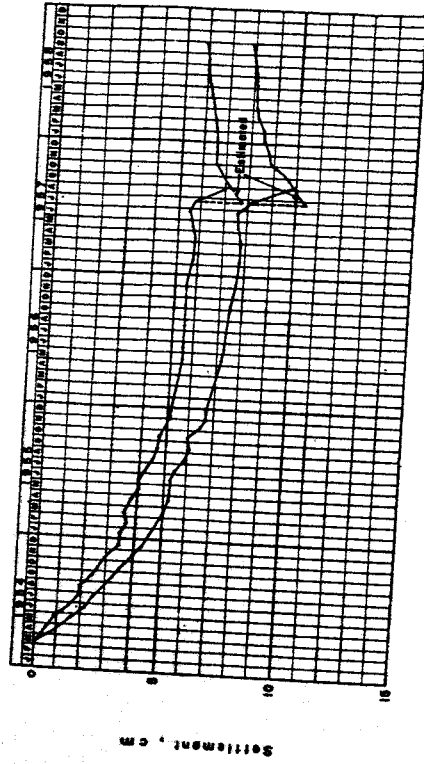
FIG. 15. TYPICAL TIME - SETTLEMENT CURVES
