NIIGATA EARTHQUAKE OF 1964

Japan National Committee on Earthquake Engineering

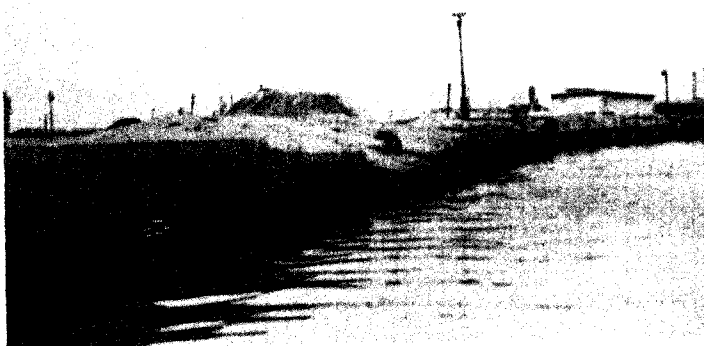
Landing piers built on well foundation showed marked forward tilting and settlement owing to inadequate bearing capacity during the earthquake. The pile-supported portion of the pier between the well foundations also showed some forward tilting and settlement, which, however, seemed to be caused indirectly by the failure of the well foundations rather than of the piles. The apparent superiority of the piles may be attributed to their greater depth of penetration which was an important factor in the stability of this type of soil. This argument is supported by the fact that, of the quaywalls of the same type, the ones with shallower water suffered heavier damage. This is being incorporated into the basic policy for rehabilitation of Niigata Harbor.

Plate 3-1. Damage to Pier D at Niigata Harbor. Severe tilting occurred at well foundations.

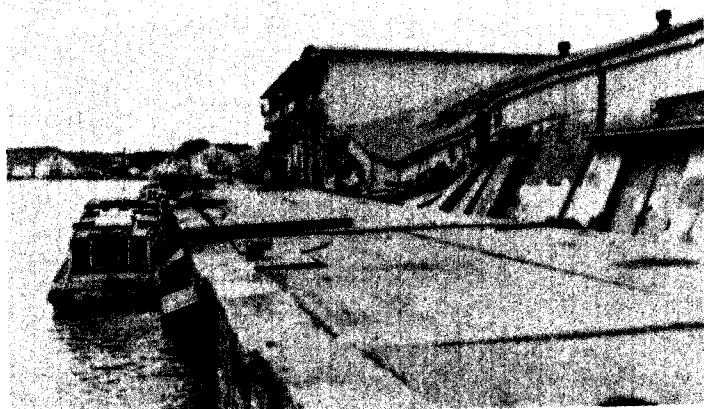
Quaywalls and bulkheads, mostly of sheet-pile construction, suffered the worst damage of all the port and harbor facilities. Typical failure modes were the settlement of the wall and forward movement of the wall line. Forward tilting was more frequent than failures due to inadequate depth of penetration. Many cases of damage were caused by inadequate counterfort. Only light damage was noted in new quaywalls which had been designed according to the current specifications which called for adequate counterfort resistance. Broken tie-rods were noticed at some low quaywalls and bulkheads.

Plate 3-2. Damage to quaywalls and sheds at East Pier. The sheet pile quaywall settled 20cm (max.) at the top and moved 3.00m (max.) towards the water.

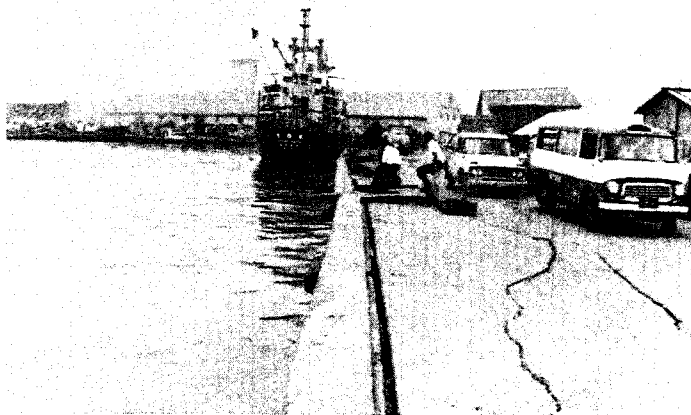
Plate 3-3. Damage to sheetpile quaywall at South Pier. Maximum settlement: 35cm; maximum translation: 2m.

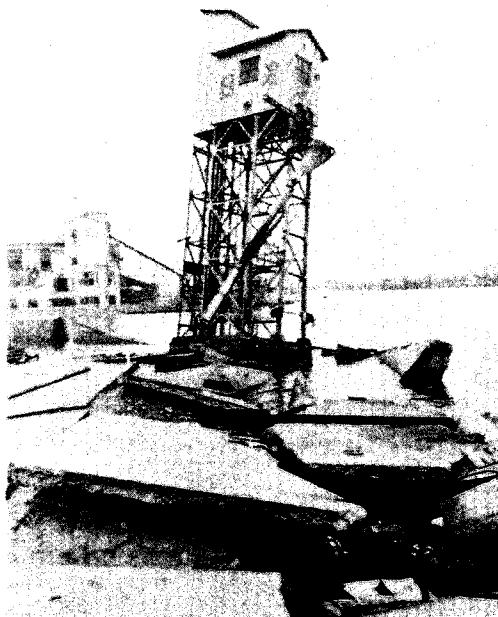
Plate 3-4. Damage at corner of South Landing Pier (concrete blocks) and South Pier (sheetpile).

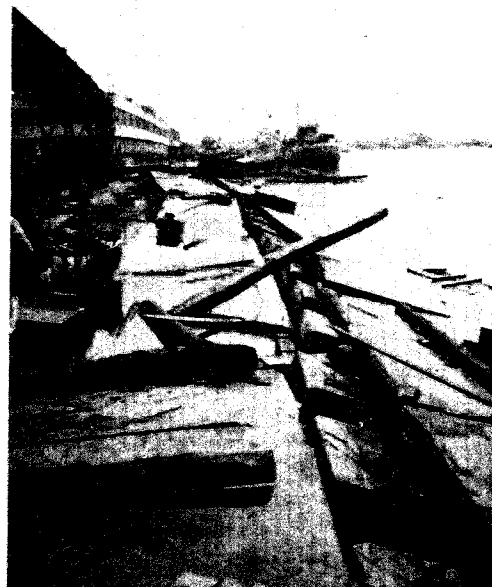
Plate 3-5. Damage to sheetpile quaywall reaching a depth of 4.0m.

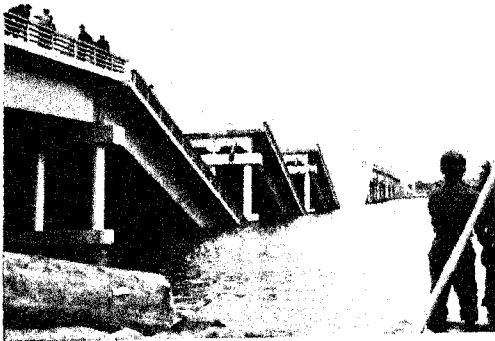
Bridge superstructures fell off piers at Showa Bridge in Niigata City (Figs. 3-1, 3-2, and Plate 3-6), at an overbridge east of Niigata Railroad Station (with a 26.6 m main span of built-up steel girders and timber pile foundation), and at Shin-Matsushima Bridge on the estuary of the Agano River (under construction). The following two bridges suffered extensive damage due to lateral movement of the river banks towards the center of the river: Yachiyo Bridge located downstream from Showa Bridge (Fig. 3-3, Plates 3-7 and 3-8) and Bandai Bridge (with six 40 m main spans of concrete arches and 14.88 m side spans of two-hinged arches). The damage to the side spans is shown in Plate 3-9.

Plate 3-6. Showa Bridge
viewed from the left bank
upstream.

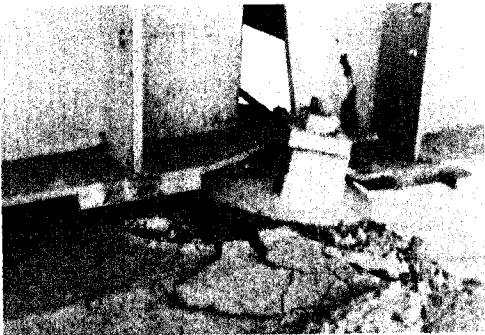
Plate 3-8. Damage to a
support at Yachiyo Bridge.
(A roller support on the
left side)

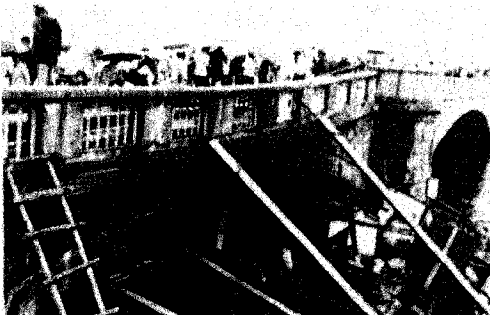
Plate 3-9. Deformed arch span
at Bandai Bridge, viewed
from the upstream side.

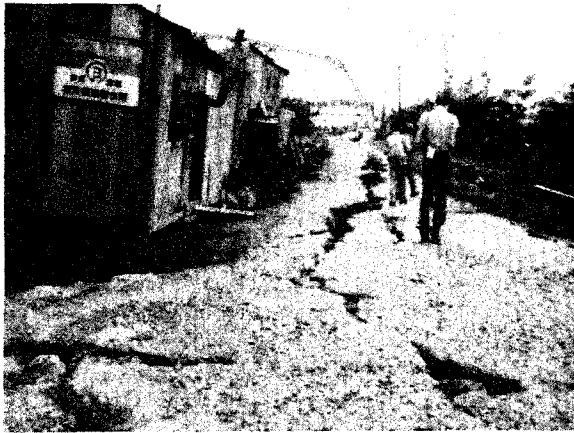
Plate 3-10. Longitudinal cracks in a levee.

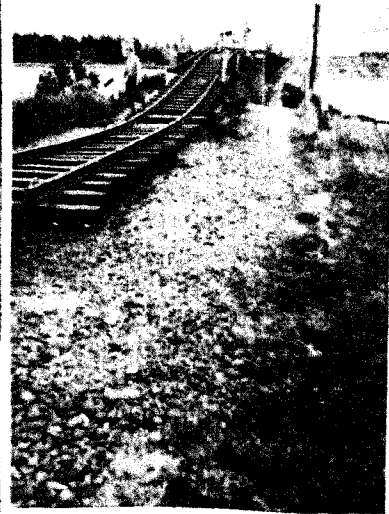
Plate 3-11. General subsidence of railroad embankment on old riverbed.

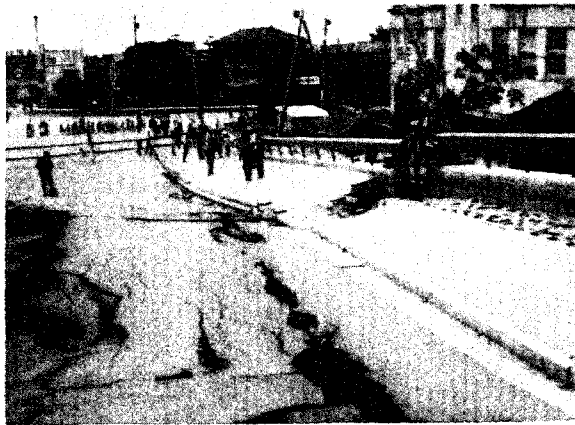
At boundaries between embankments and rigid structures such as bridges, sluice gates, and culverts, the embankments were likely to settle or crack due to discontinuity in vibration characteristics.

Plate 3-12. Subsidence of embankment at a bridge approach.

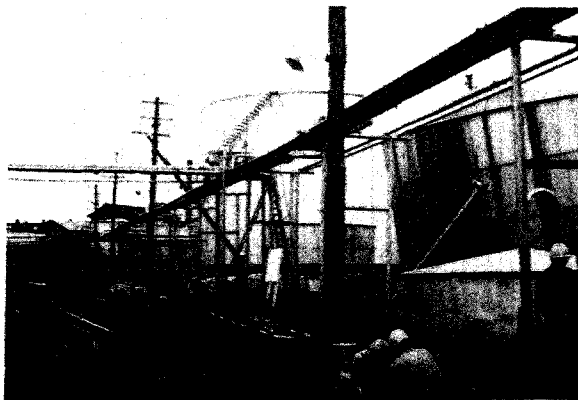
It is interesting to note that some oil tanks founded on loose sand experienced different degrees of damage depending on whether or not the sand had been mechanically stabilized. For example, sandy ground whose natural N-values ranged from 1 to 15 over a depth of 8 m was densified by vibrofloatation using 17 % filler so that the N-values increased to a range between 5 and 25. An oil tank weighing 15 t/m^2 built on this stabilized ground settled only 2 to 3 cm due to the earthquake, whereas another tank of a smaller load built on untreated soil nearby suffered marked differential settlement. In this case the vibrofloatation process probably contributed to improving the uniformity of soil properties as well as increasing the average soil density. Plate 3-13.

Plate 3-13. The far tank was built on soil stabilized by vibrofloatation. The tank in the foreground was built on untreated soil.

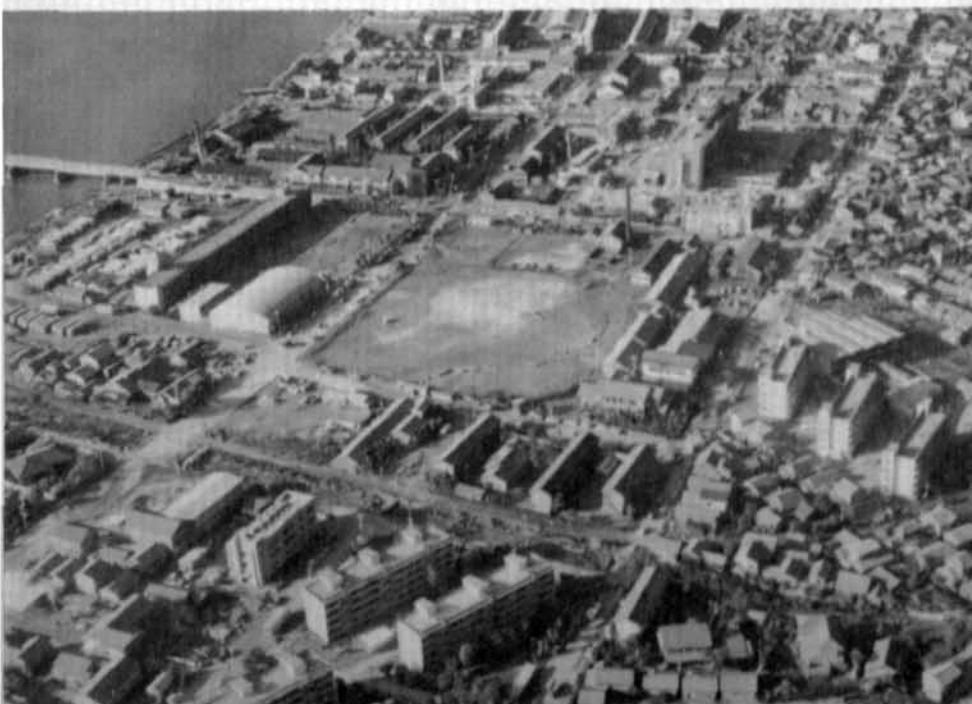
Plate 4-2. Near Yachiyo Bridge, Niigata. Note cracks and craters in the ground.

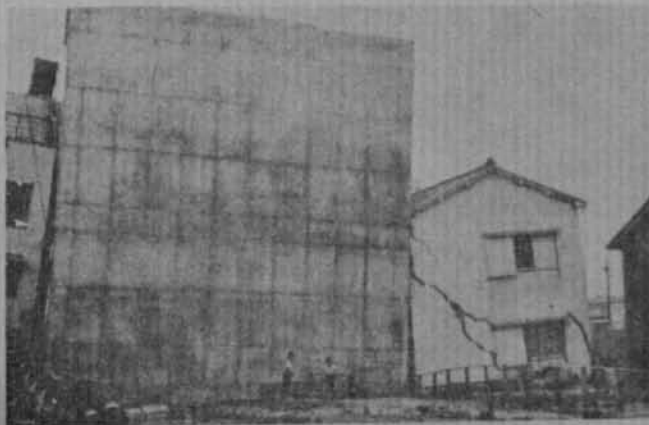
Plate 4-4. At Higashi-
machi, Niigata. Cracks
in the right building
were caused by settle-
ment of the reinforced
concrete building on
the left.

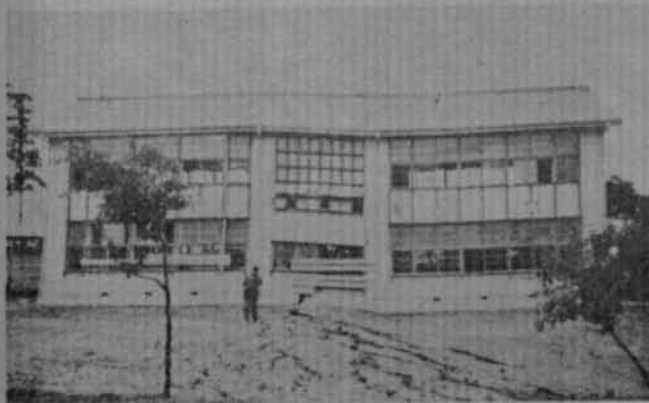
Plate 4-5. A wooden
school building. The
stairs in the center
settled.

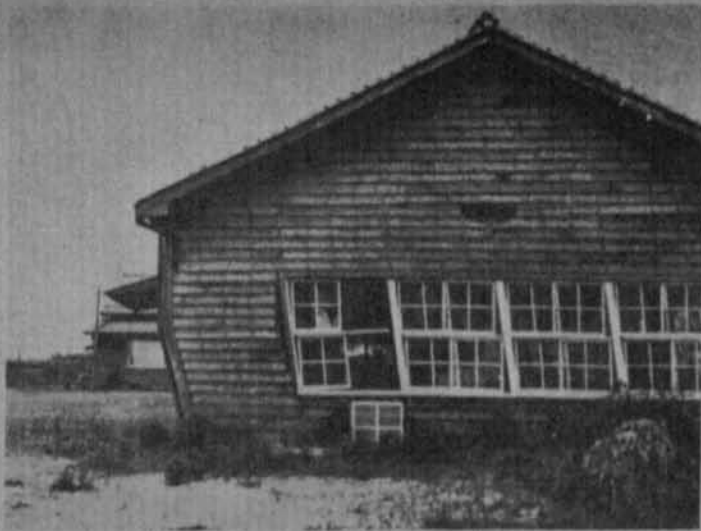
Plate 4-6. A warehouse.
Columns were broken at
braces.

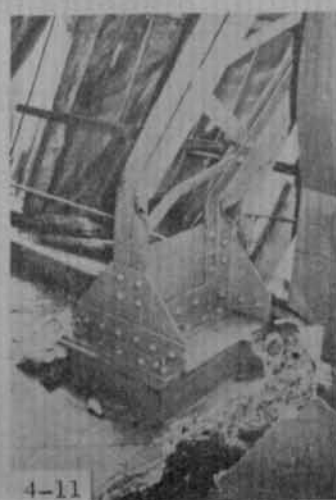
Plate 4-11. Flexural failure of a column of the building of Plate 4-10.

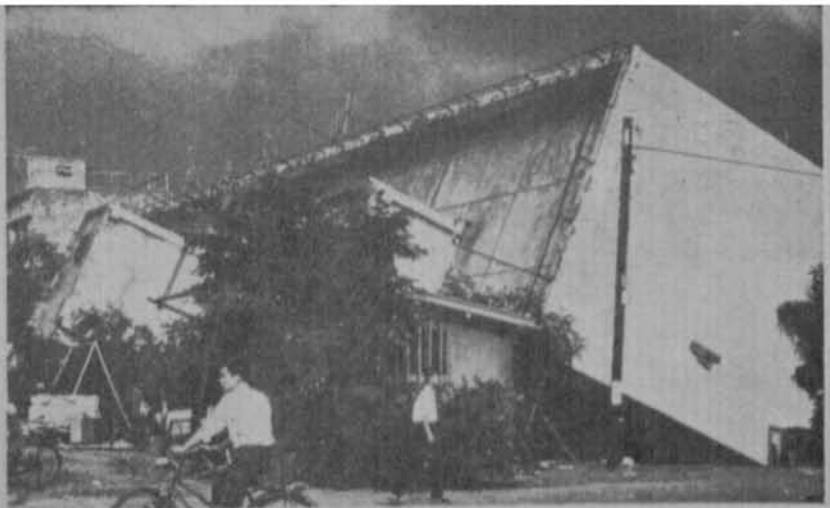
Plate 4-14. Large settlement (max. 2 m) and tilting (140/1000) of a building on 6-m timber piles designed to carry 6 t per pile.

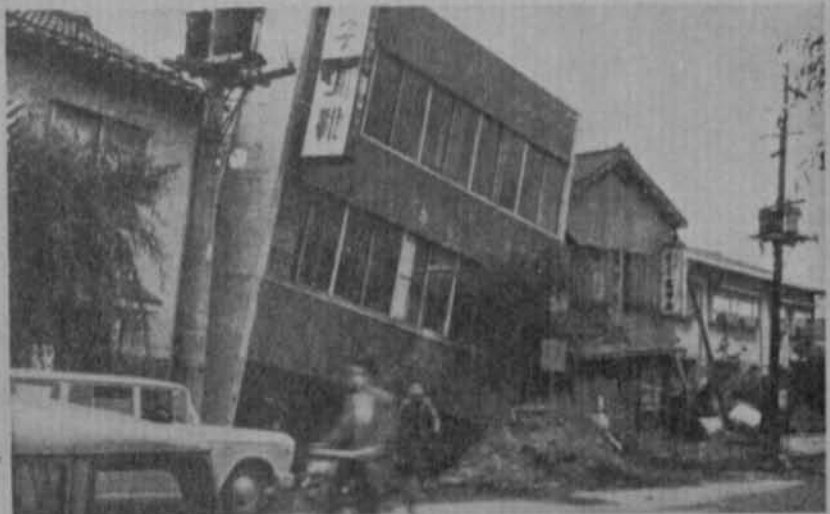
Plate 4-15. A large amount of tilting toward the heavier side of the building.

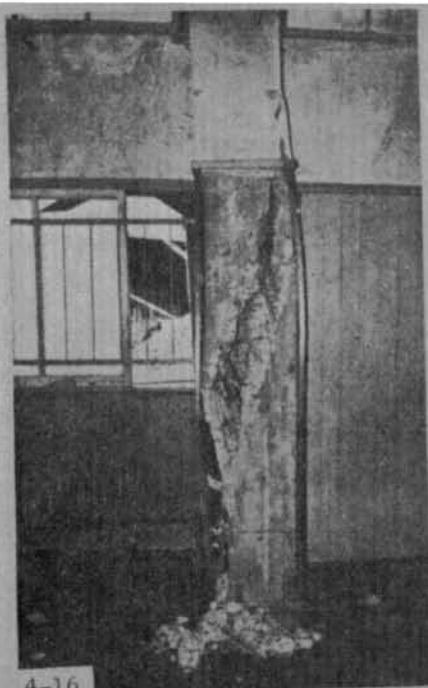
4-16

Plate 4-16. A school gymnasium of reinforced concrete one story structure with partial second floor. A ground crack nearby caused this shear failure of the column.

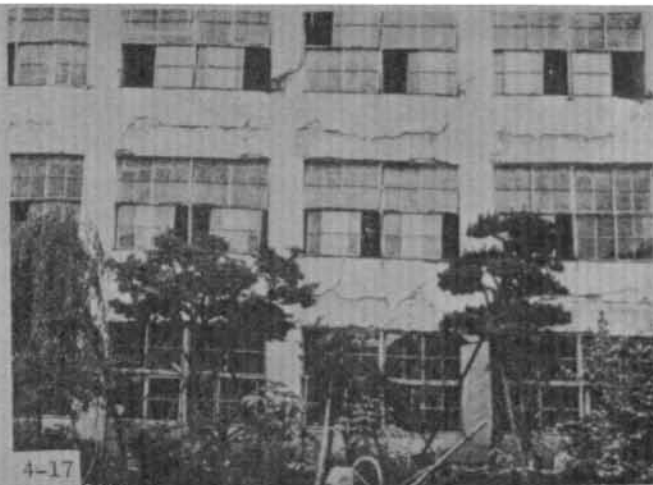
4-17

Plate 4-17. A 3-story reinforced concrete school building on 6-m timber piles. A ground crack ran across this 45-m long building causing the third point to settle 40 to 60 cm.

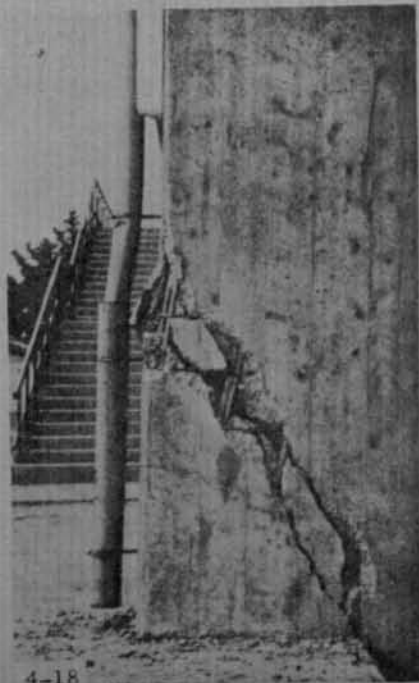
4-18

Plate 4-18. A crack in a column caused by a ground crack which ran below the building.

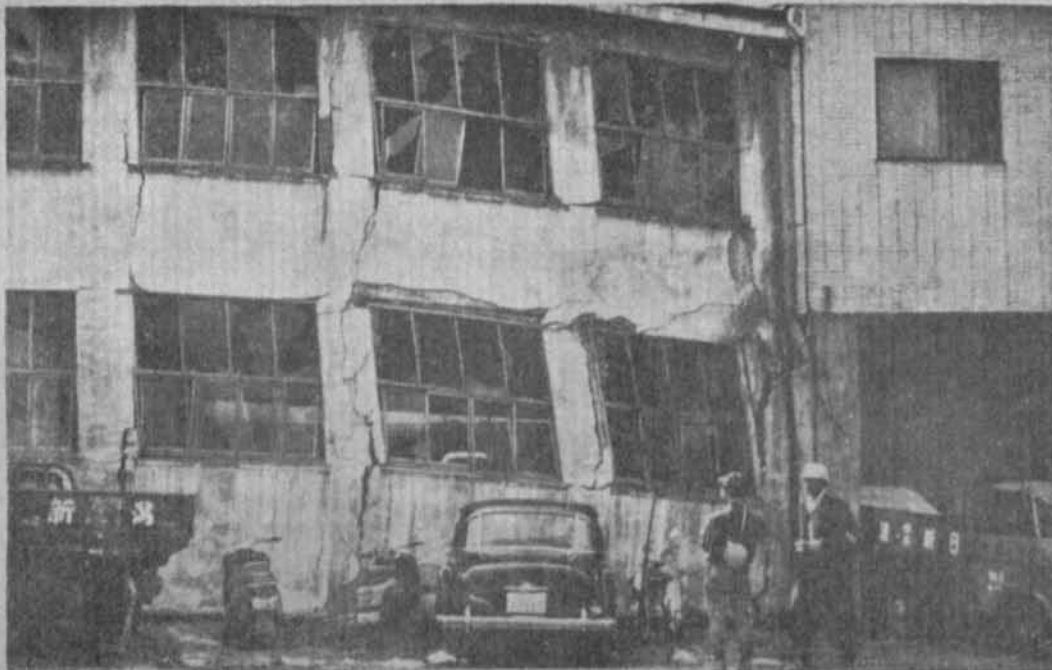
Plate 4-20. Failure near the junction between a two-story reinforced concrete building (on the left) and a three-story reinforced concrete addition.

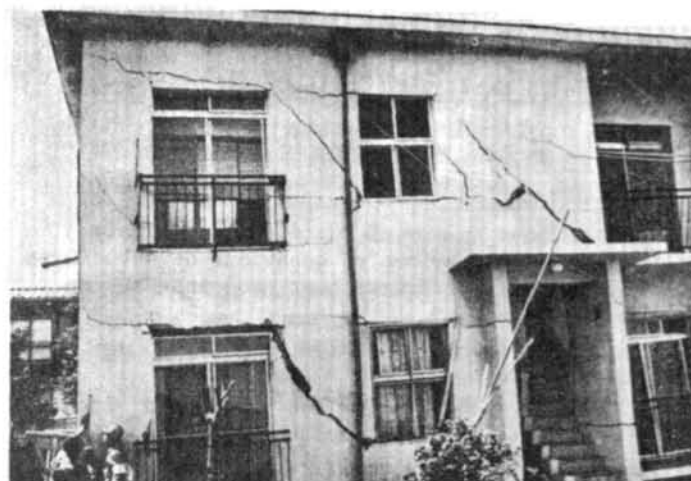
Concrete block buildings suffered the same type of damage as the reinforced concrete buildings, i.e., settlement and tilting en masse, or cracked walls due to differential settlements.

Plate 4-23. Cracks in this concrete block building were caused by differential settlement.
