# The Effect of the December 2004 Great Sumatra Earthquake and Indian Ocean Tsunami on Transportation Systems in India's Andaman and Nicobar Islands

Durgesh C. Rai,<sup>a)</sup> M.EERI, C. V. R. Murty,<sup>a)</sup> M.EERI, Sudhir K. Jain,<sup>a)</sup> M.EERI, Hemant B. Kaushik,<sup>a)</sup> Goutam Mondal,<sup>a)</sup> Suresh R. Dash,<sup>a)</sup> Alex Tang,<sup>b)</sup> M.EERI, Mark Yashinsky,<sup>c)</sup> M.EERI, and Martin Eskijian,<sup>d)</sup> M.EERI

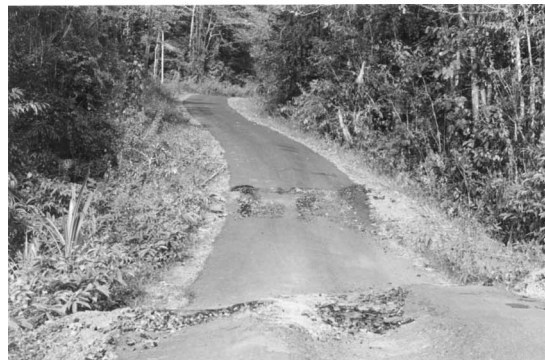
Widespread lateral spreading in the Andaman Islands led to significant damage to pavement and drainage structures of the ATR and other link roads (Figure 1).

**Figure 1.** (a) Subsidence of a stretch of road connecting Baratang town to Jarawa Creek on Middle Andaman Island led to the closing of the road to traffic (photo: G. Mondal). (b) and (c) Longitudinal and transverse ground deformation at Mohanpur village in North Andaman Island (photos: D. Rai).

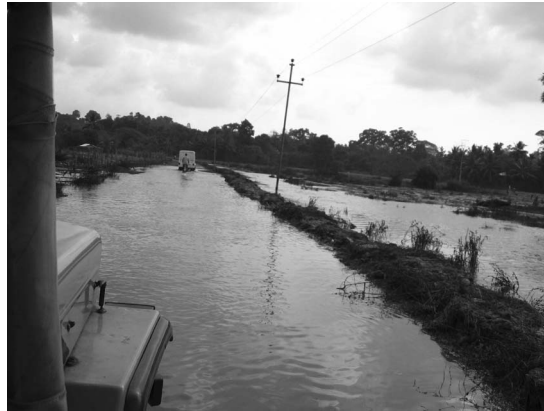
The tectonics-induced subsidence of the land has led to submergence of roads in some areas, particularly in the low-lying areas neighboring Port Blair (Figure 2).

**Figure 2.** Seawater flooded the ATR in the Sippyghat area near Port Blair during high tide (photo: G. Mondal).

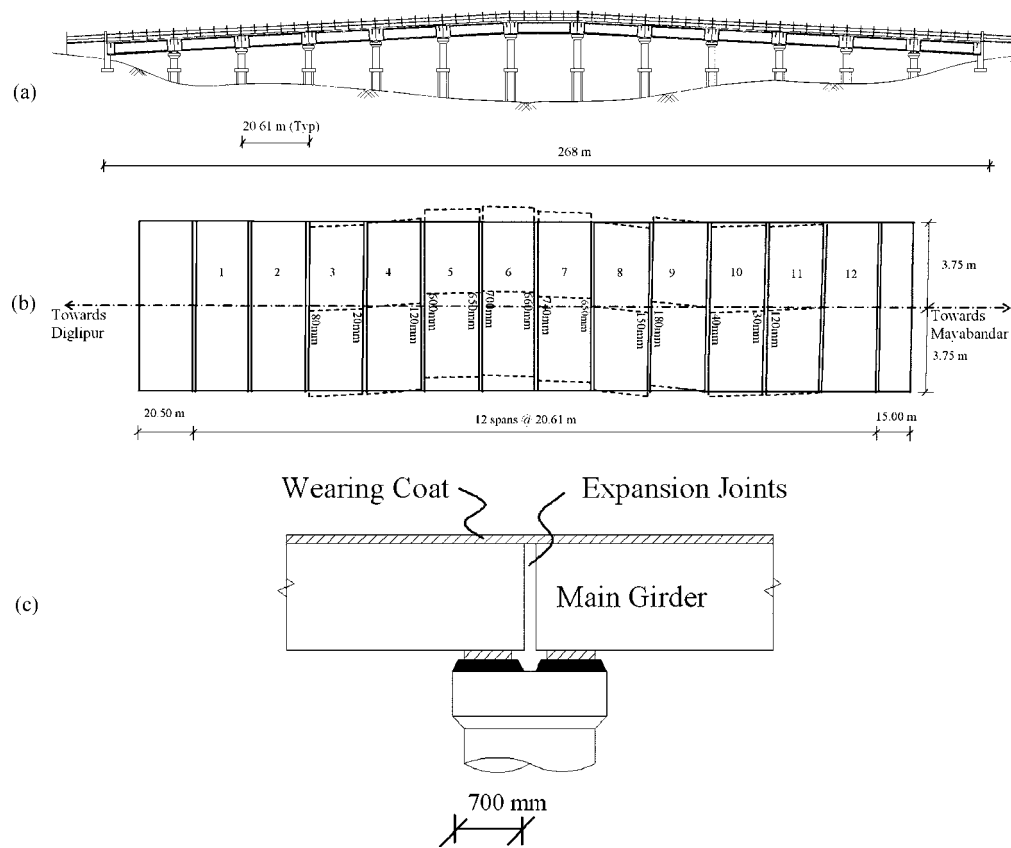
The largest bridge in the A&N islands is over the Austen Strait, which connects the North and Middle Andaman islands on the ATR. This is a newly constructed 268-m-long 7.5-m carriageway RC bridge (Figure 3). Two of the authors had visited this region two years ago after an  $M_w=6.5$  earthquake on 14 September 2002 and had expressed the following concerns about this bridge in published reports (Rai and Murty 2003, 2005):

*“Inadequate seating of bridge deck over piers and abutments is a serious concern for its safety during a stronger earthquake in future. The bearings are simple neoprene pads which are far from satisfactory for a bridge located in seismic zone V. Bridge deck restrainers are the minimum that need to be provided to ensure that the spans are not dislodged from the piers in future earthquakes.”*

Damage to the bridge during the 26 December earthquake was in line with the above observation and could have been far worse in the event of stronger shaking. The fifth, sixth, and seventh spans from the Diglipur side were displaced by about 700 mm horizontally and by about 220 mm vertically from their original position and fell off the bearings. Other spans, including the third, fourth, eighth, ninth, tenth, and eleventh spans

from the Diglipur side, moved by about 20–150 mm horizontally. As a result, the bridge had to be closed even for the light vehicles that were used immediately after the earthquake, particularly when the bridge was needed for facilitating postearthquake emergency services across the islands. Fortunately, the shaking at the site was rather low (VI–VII on the MSK intensity scale), and the span did not fall off the piers. Hence, in the present instance, it was relatively easy to restore the bridge. Because of the remote location of the bridge and the absence of large contracting firms in the islands, the bridge remained out of operation for more than six months.

**Figure 3.** (a) Elevation of the Chengappa Bridge over the Austen Strait at Mayabandar, (b) alignment of the bridge after the 26 December 2004 earthquake, and (c) seating details of the bridge girder.

- The use of conventional neoprene pad bearings in bridges must be thoroughly reviewed before such bearings are used in new construction. The addition of a few really simple earthquake-resistant features in bridges, such as lateral restrainers for bridge decks, can be critically useful in the event of strong shaking.

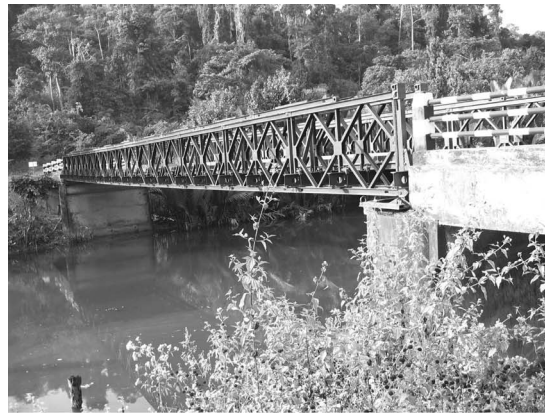
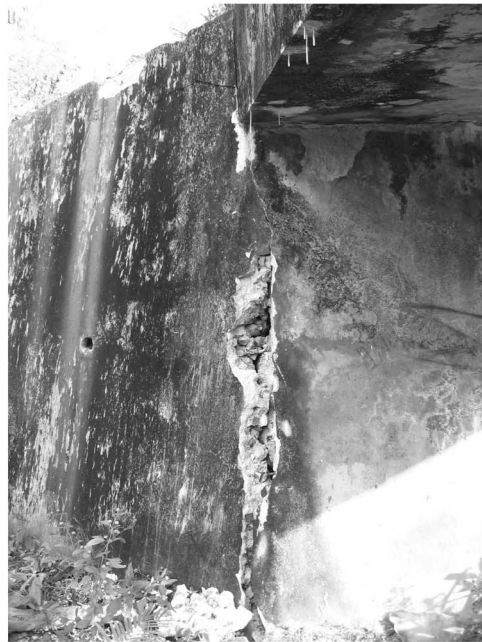
Wing walls of a small bridge near Port Blair were cracked and displaced by several centimeters. The CD Nala/BD Nala Bridge along the ATR, about 88 km north of Port Blair and 19 km south of Baratang, sustained minor damage. It is a three-span bridge consisting of a 31.5-m-long steel Bailey bridge span in the middle and 3-m-long concrete spans at each side (Figure 4). Separation took place at the joint of the concrete wing wall and the abutment at both sides of the bridge, while the Bailey bridge portion performed well. Cracks in the floor slab were noticed in a box culvert 8 km south of Gandhighat.

**Figure 4.** (a) CD Nala/BD Nala Bridge on the ATR in South Andaman Island, and (b) cracks and separation at the joint of the wing wall and the abutment (photos: D. Rai).

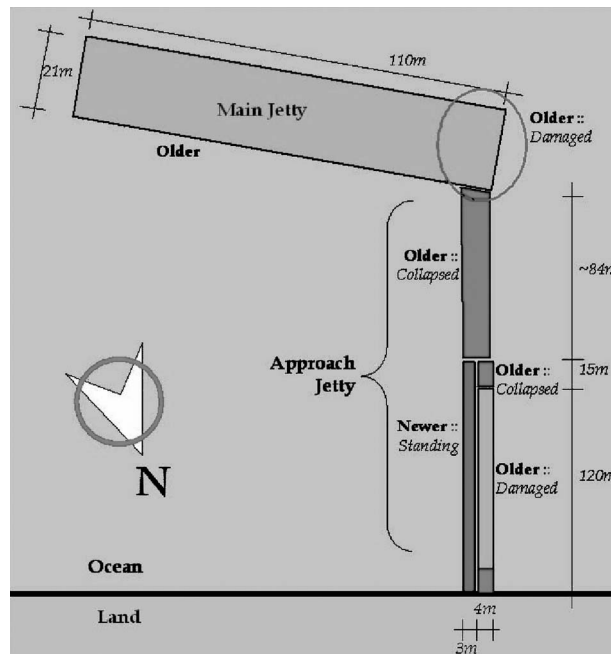
**Figure 6.** The layout of the inter-island passenger ship jetty at Campbell Bay consists of older and newer segments; the former were severely damaged, and some of them collapsed.

A number of shorefront structures and jetties suffered damage or collapse during the earthquake shaking and the tsunami waves that followed. For example, collapse of the inter-island passenger ship jetty at Campbell Bay in Great Nicobar Island collapsed, thereby hampering relief efforts. This jetty originally consisted of a 220-m-long approach jetty and a main jetty about 110 m long in a re-entrant corner configuration. The jetties were all supported on 300-m square piles (Figure 6). The approach jetty was later widened to 7 m for a distance of  $\sim 115$  m on the landward side. During the earthquake, the 80-m segment of the approach jetty connecting the two re-entrant arms collapsed (Figure 7). The existing segments of the jetty show shear failure at the top of the piles underneath.

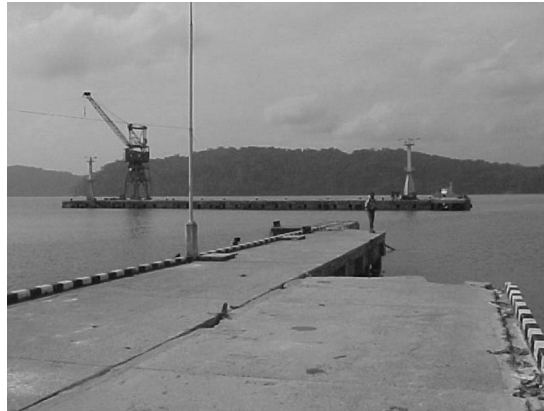
**Figure 7.** An 80-m segment of the RC approach jetty at the inter-island passenger ship jetty at Campbell Bay was washed away (photo: C. Murty).

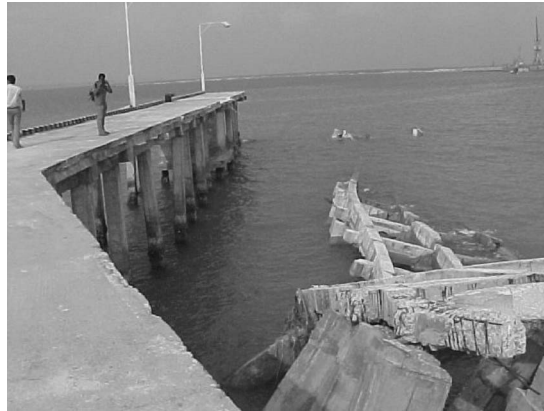
Similarly, the collapsed jetty in Car Nicobar Island, and the breaching of one breakwater-cum-approach jetty and collapse of another approach jetty at Hut Bay in Little Andaman Island (Figure 8), also hampered the relief efforts. At Hut Bay, an RC jetty 32 m wide and 240 m long sustained pounding damage between the old segments (four subsegments of 40 m each) and new segments (two subsegments of 40 m each) of its vierendel-type deck. Furthermore, the 300-mm square RC piles underneath the new

**Figure 8.** An RC jetty at Hut Bay in Little Andaman Island. The jetty collapsed, which hampered relief work (photo: C. Murty).

segment sustained shear failure at their junction with the deck; this may have led to the 150-mm horizontal separation between the two segments. Jetty structures also collapsed elsewhere in the Nicobar Islands, namely, Kamorta and Katchal islands. In Port Blair, the Janglighat jetty collapsed (Figure 9). In North Andaman Island, jetties at Sagar Dweep and Arial Bay were damaged due to ground shaking (Figure 10). Also, in North Andaman Island, the berthing jetty and a portion of the approach jetty at Gandhinagar

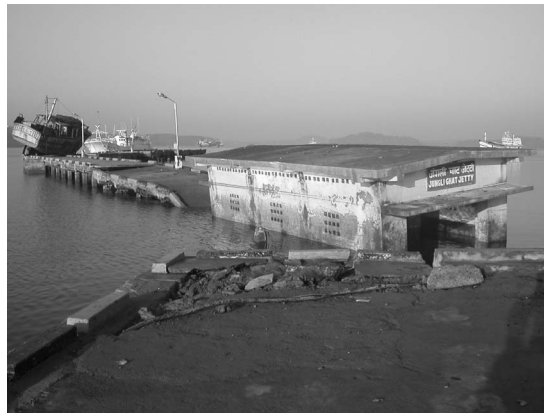
**Figure 9.** The Janglighat jetty in Port Blair has a sudden change of orientation in its plan geometry. Also, there was additional mass in the form of a passenger verification building at that vulnerable location, and the supporting piles underneath were poorly designed. For these reasons, the jetty partially collapsed due to earthquake shaking (photo: C. Murty).

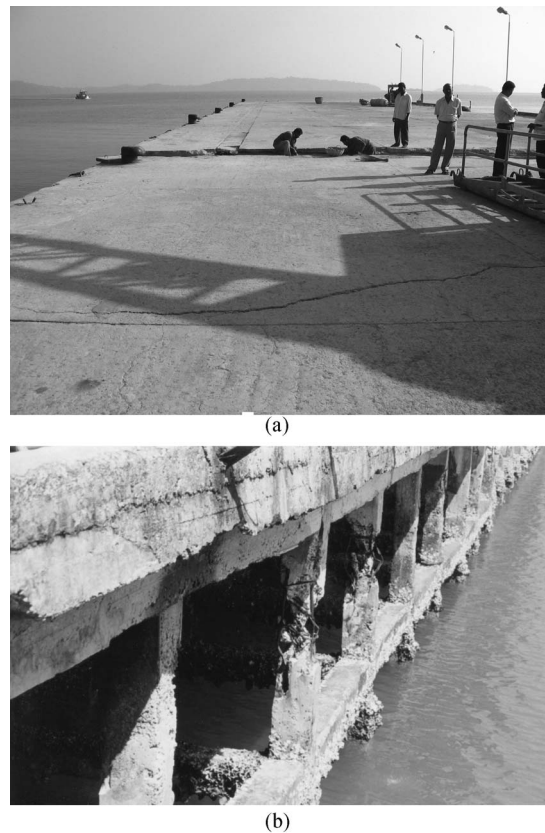
**Figure 10.** (a) A portion of the berthing jetty at Diglipur Harbor sank due to the failure of piles (photo: D. Rai). (b) Severe corrosion led to damage of the columns of the approach jetty at Rangat Bay Harbor in Middle Andaman Island (photo: G. Mondal).

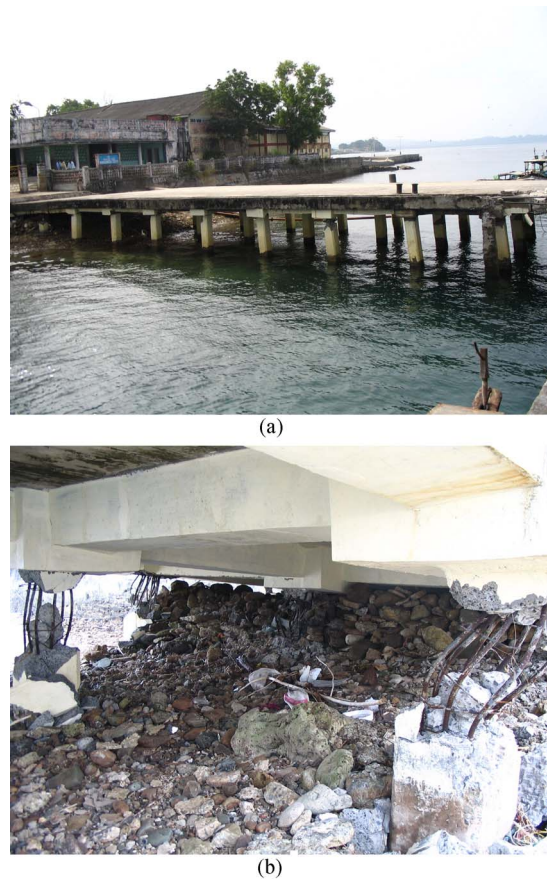
collapsed. At Mayabandar and Rangat in Middle Andaman Island, several piles supporting the jetty superstructure were damaged (Figure 11). Pounding damage at several sections of jetties was observed.

**Figure 11.** (a) Approach jetty at Mayabandar in Middle Andaman Island. (b) Close-up of the shear failure of short piles close to the shore where the approach jetty begins (photos: D. Rai).

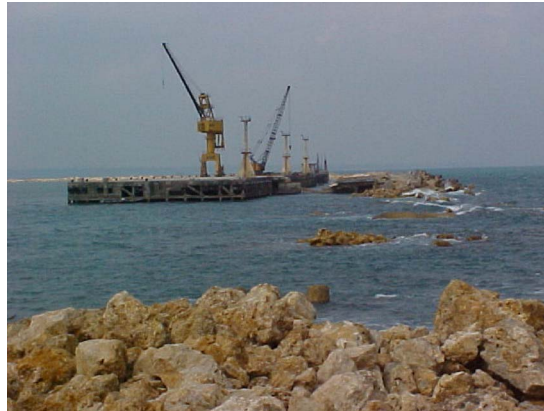
tion material. The reuse of the low-quality material in any future construction needs thorough examination. On this occasion, even the RC jetty structure sustained shear failure of the 300-mm square piles on which it rested.

**Figure 12.** A shortage of appropriate construction material led to the use of porous coral stones from local quarries to construct the breakwaters. The stones were easily uplifted by the tsunami waves, and the waves breached over 100 m of a segment of the approach breakwaters of the RC jetty at Hut Bay in Little Andaman Island (photo: C. Murty).

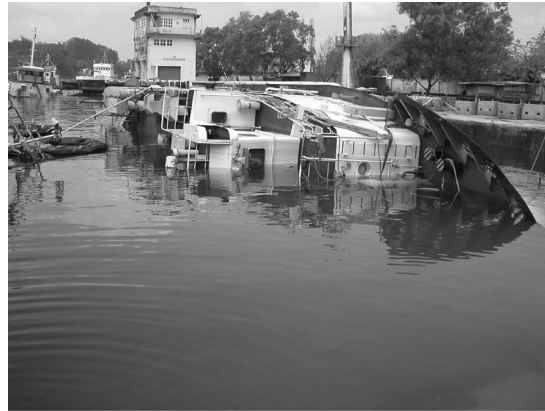
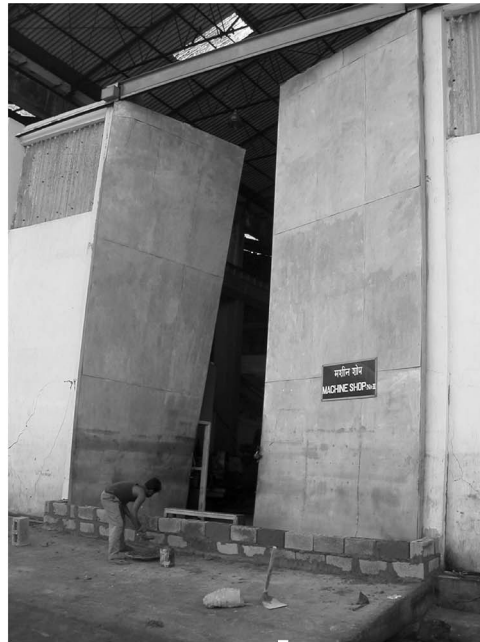
the machine room and damaging the steel equipment and tools. In some instances, masonry walls were raised to prevent the ingress of seawater and protect the contents of the workplace (Figure 13b).

**Figure 13.** (a) Inundation of the marine jetty dry dock complex in Port Blair. (b) The steel gates of the machine shops at the marine jetty dry dock complex were bent by the giant tsunami waves; a 300-mm-high masonry wall was constructed in front of the shops to prevent seawater from entering them during high tide (photos: H. Kaushik).

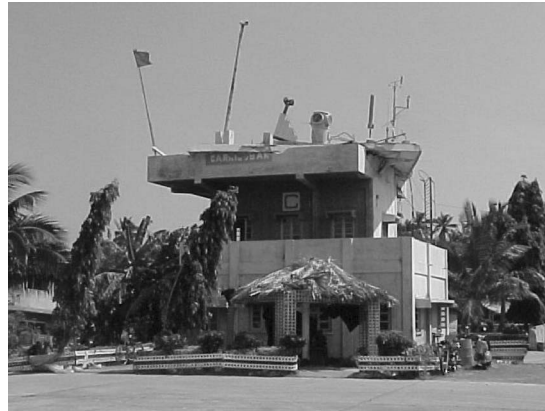
**Figure 14.** Partial collapse of the upper story of the ATC tower in Car Nicobar Island (photo: C. Murty).

Lifeline facilities such as seaport and airport control towers collapsed due to shaking and/or waves. For instance, the airport traffic control (ATC) tower at Car Nicobar collapsed due to earthquake shaking alone (Figure 14). This RC-frame, three-story square-plan structure with masonry infills had only four corner columns, and hence it had limited redundancy. As per functional requirements, the top story had a glass facade all around and was inclined downward to allow the viewing of aircraft in the airspace of the airport without reflecting glare to the aircraft. However, the RC columns were also bent outward along the slope of the glass. During the shaking, the upper story collapsed due to its flexible nature and brittle columns. Such type-designs (i.e., generic designs that are not earthquake-resistant) of the ATC towers are being used elsewhere in the country, particularly in the severe seismic zones; this aspect requires urgent corrective action to strengthen the towers to resist seismic shaking and/or wave loading.

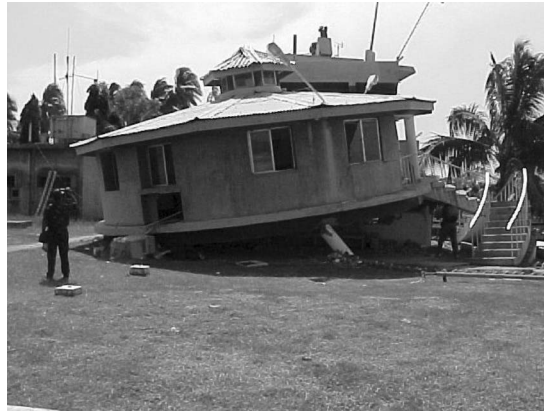
The two-story, circular RC-frame Courier Point Building at Car Nicobar Airport collapsed due to ground shaking. It had an octagonally shaped roof, and the frame building had no infills in the first story, so it can be classified as a “building on stilts.” The building is situated at an elevation where the tsunami waves did not reach. The building was irregular due to a number of architectural features, including an asymmetric staircase (Figure 15). The columns in the first story were of 330-mm diameter with eight 16-mm-diameter high-yield-strength deformed bars as longitudinal steel and 6-mm mild steel ties at 150-mm centers as transverse steel. The building suffered large asymmetric torsional deformation, causing total crushing of columns in the first story.

**Figure 15.** Collapsed two-story RC-frame Courier Point Building at Car Nicobar Airport (photo: C. Murty)

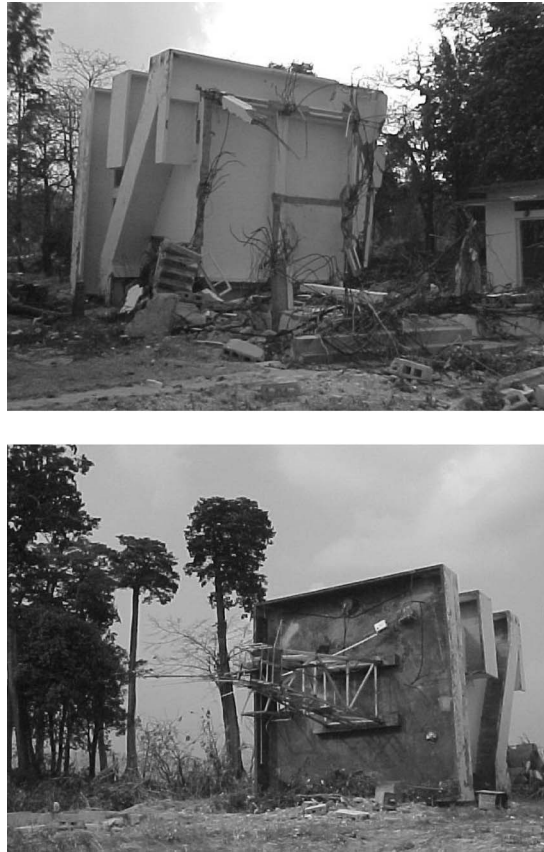
The seaport traffic control (STC) tower at Hut Bay on the east coast of Little Andaman Island also collapsed due to tsunami-induced damage (Figure 16). This RC-frame, square-plan three-story building with masonry infills had limited redundancy, with only eight perimeter columns. The large positive pressure created by the giant tsunami waves toppled the building. As in the case of the ATC towers, such type-designs of STC towers are also being used elsewhere in the country, particularly in the severe seismic zones; this aspect requires urgent corrective action by the authorities to strengthen and/or modify the towers to resist wave loading.

**Figure 16.** Laterally toppled three-story STC tower at Hut Bay in Little Andaman Island (photos: S. Dash).

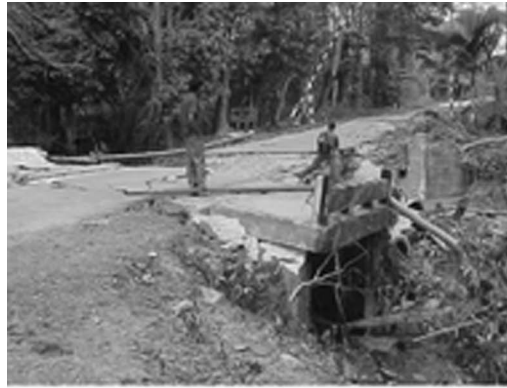
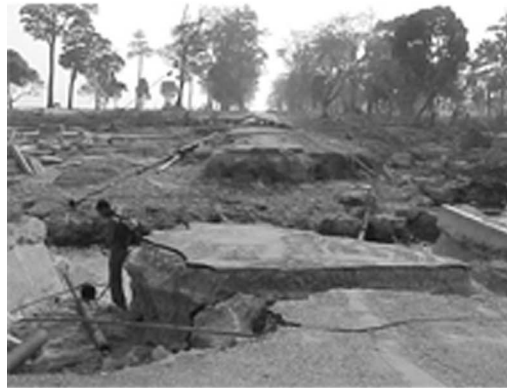
with no connection with the RC vertical walls or RC pipes on which they rest. When the water rose above the culvert level, the RC slabs became afloat; where RC pipes were used, they were displaced but not completely uplifted, but the bitumen topping over them was washed away (Figure 17).

**Figure 17.** Small culverts along roads were washed away under the tsunami water surge in Little Andaman Island. (a) seven 1.5-m-diameter, 100-mm-thick RC pipe culverts lost bitumen topping. (b) an entire pipe culvert was washed away (photos: C. Murty).
