## **EXPERIMENTAL PROGRAM AND PROPOSED DESIGN METHOD FOR THE RETROFIT OF STEEL MOMENT CONNECTIONS**

### **SUMMARY**

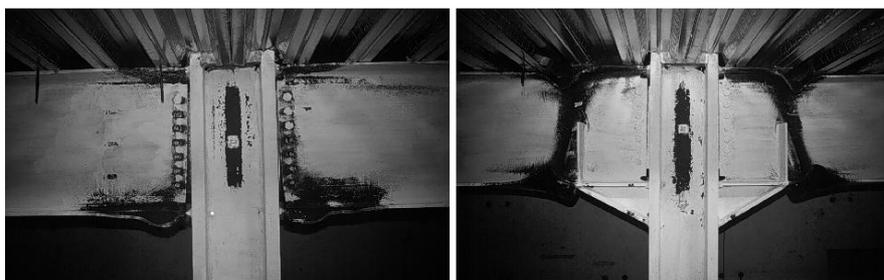
Figure 3: Specimens After Testing

The composite bottom flange RBS (DB2) exhibited a marked improvement over specimen DB1, achieving beam plastic rotations of 0.020 radian. Both connections, however, still failed by fracture of the bottom flange groove welds. During the 120 mm (4.80 in.) load cycles, fractures initiated at the bottom cope holes and propagated along the bottom edge of the beam web with each cycle. This was followed during the next cycle at 120 mm (4.80 in.) by the fracture of the bottom flange groove weld in both beams. The fractures initiated at the center of the beam flanges, near the beam web cope. Inspection of the weld fracture surfaces revealed some rather large slag inclusions not detected by ultrasonic testing which may have contributed to the weld failures. Specimen DB2 sustained much higher levels of plastic rotation than DB1, likely due to a substantial benefit from the higher toughness weld metal (composite slab effects were also involved.) Once the bottom flange welds of DB2 failed, the behavior was extremely poor and degraded substantially during later load cycles. Although the specimen obtained beam plastic rotations meeting or exceeding the 0.020 radian of plastic rotation acceptance criteria, the weld fractures occurred at levels very close to this acceptance criteria. Variations in slab details, such as stronger concrete, more reinforcing steel, or steel decking oriented in the other direction, may cause earlier fractures. Therefore, the connection detail tested must be viewed with caution.

With the addition of a composite floor slab (specimens HCH2 and HCH4) the connection behavior was excellent. All four connection beam flexural capacities deteriorated gradually due to local and lateral buckling of the beams. The top weld fractures of specimens HCH1 and HCH3 were prevented. Testing of both specimens was stopped due to testing limitations, with total plastic rotations of 0.028 to 0.055 radians.
