AN ANALYSIS OF DAMAGE TO HANSHIN ELEVATED EXPRESSWAY DURING 1995 KOBE EARTHQUAKE

Satoko ABE, Yozo FUJINO, Masato ABE

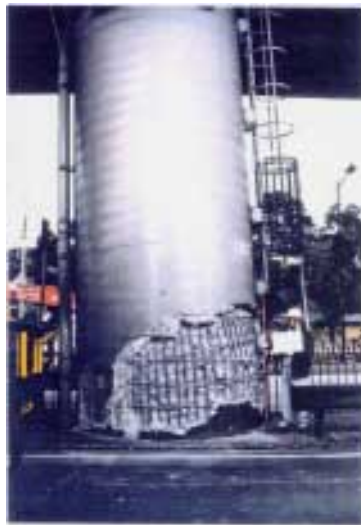
(a) P48

Although damage level of many piers was generally very high in the Kobe Route, it is also true that damage to many piers judged by visual inspection were moderate or mild. Fig.2 shows the photographs of two adjacent piers after the earthquake. Whereas (a)P48 is severely damaged, (b)P49 in only 35m west of P48 seems to be non-damaged.

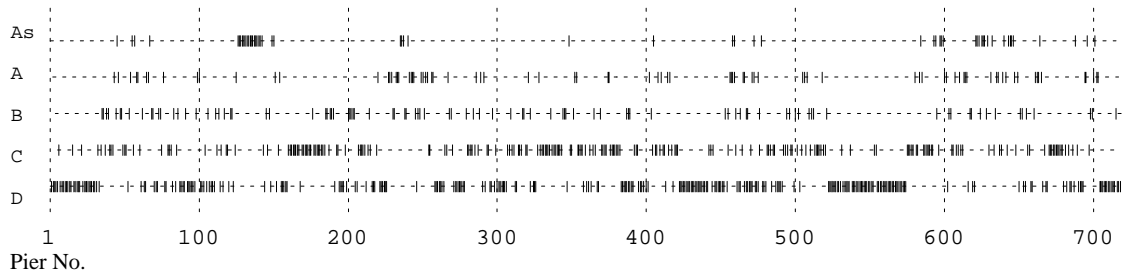
Figure4: Visually-judged damage level of the piers

Fig.4,5 and 6 shows the damage level of the piers, bearing, girders along the route respectively. The damage level was basically based on the appearance of the above-ground damage: 'As' = collapsed, 'A' = near collapsed, 'B' = severe, 'C' = mild, and 'D' = no damage. The damage level shows that the spatial variation of the damage level is rather random along the route and no consistent trend can be found.

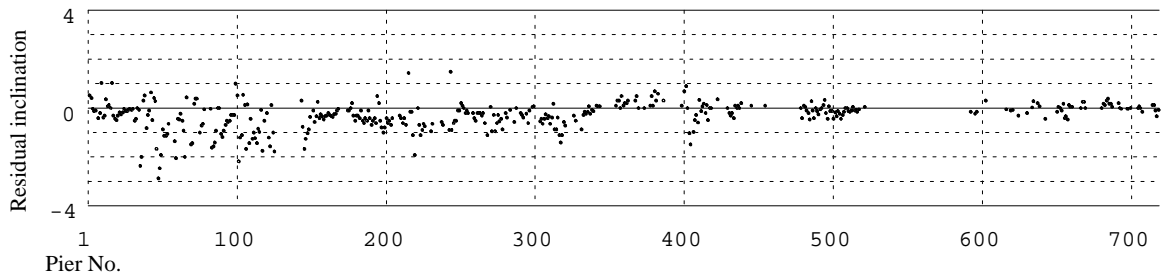
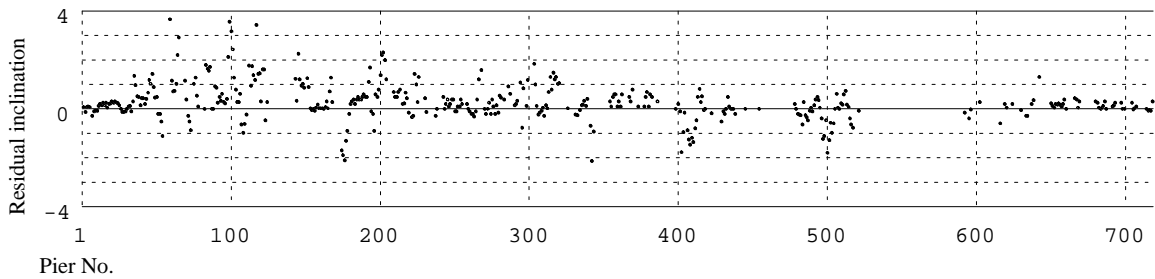
Figure7: Residual inclination of RC single piers (°)

Right after the earthquake, reconstruction and repair of the bridge structures for restoration of the Kobe Route started. One of the measurements was the level of the inclination of the piers. Fig.7 shows the residual inclination of RC single piers. Large residual inclination of piers causes the difficulty of placing girders and visual uneasiness. Hence, piers with the inclination larger than 1° were demolished even if their visually-judged damages were mild. Indeed, 88 piers were removed simply because of large inclination.

It is interesting to note that the large inclination occurred from P50 to P300 (east part of Kobe Route). Although the piers in the west was closer to the epicenter, the inclination in the west part was smaller. Correlation between the damage level (Fig.4) and the residual inclination of the RC single piers (Fig.7) is seemingly not high.

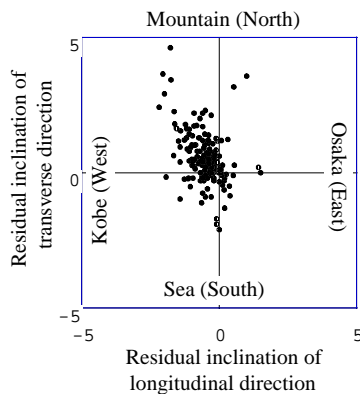
Figure8: Direction of Residual inclination of RC single piers (P50 – P300)

Fig8 shows the direction of the residual inclination of the RC single piers from P50 to P300, while Fig.9 shows the orbit of the horizontal ground motion measured. It is clear that the dominant direction of the residual inclination is similar to the dominant direction of the ground motion.

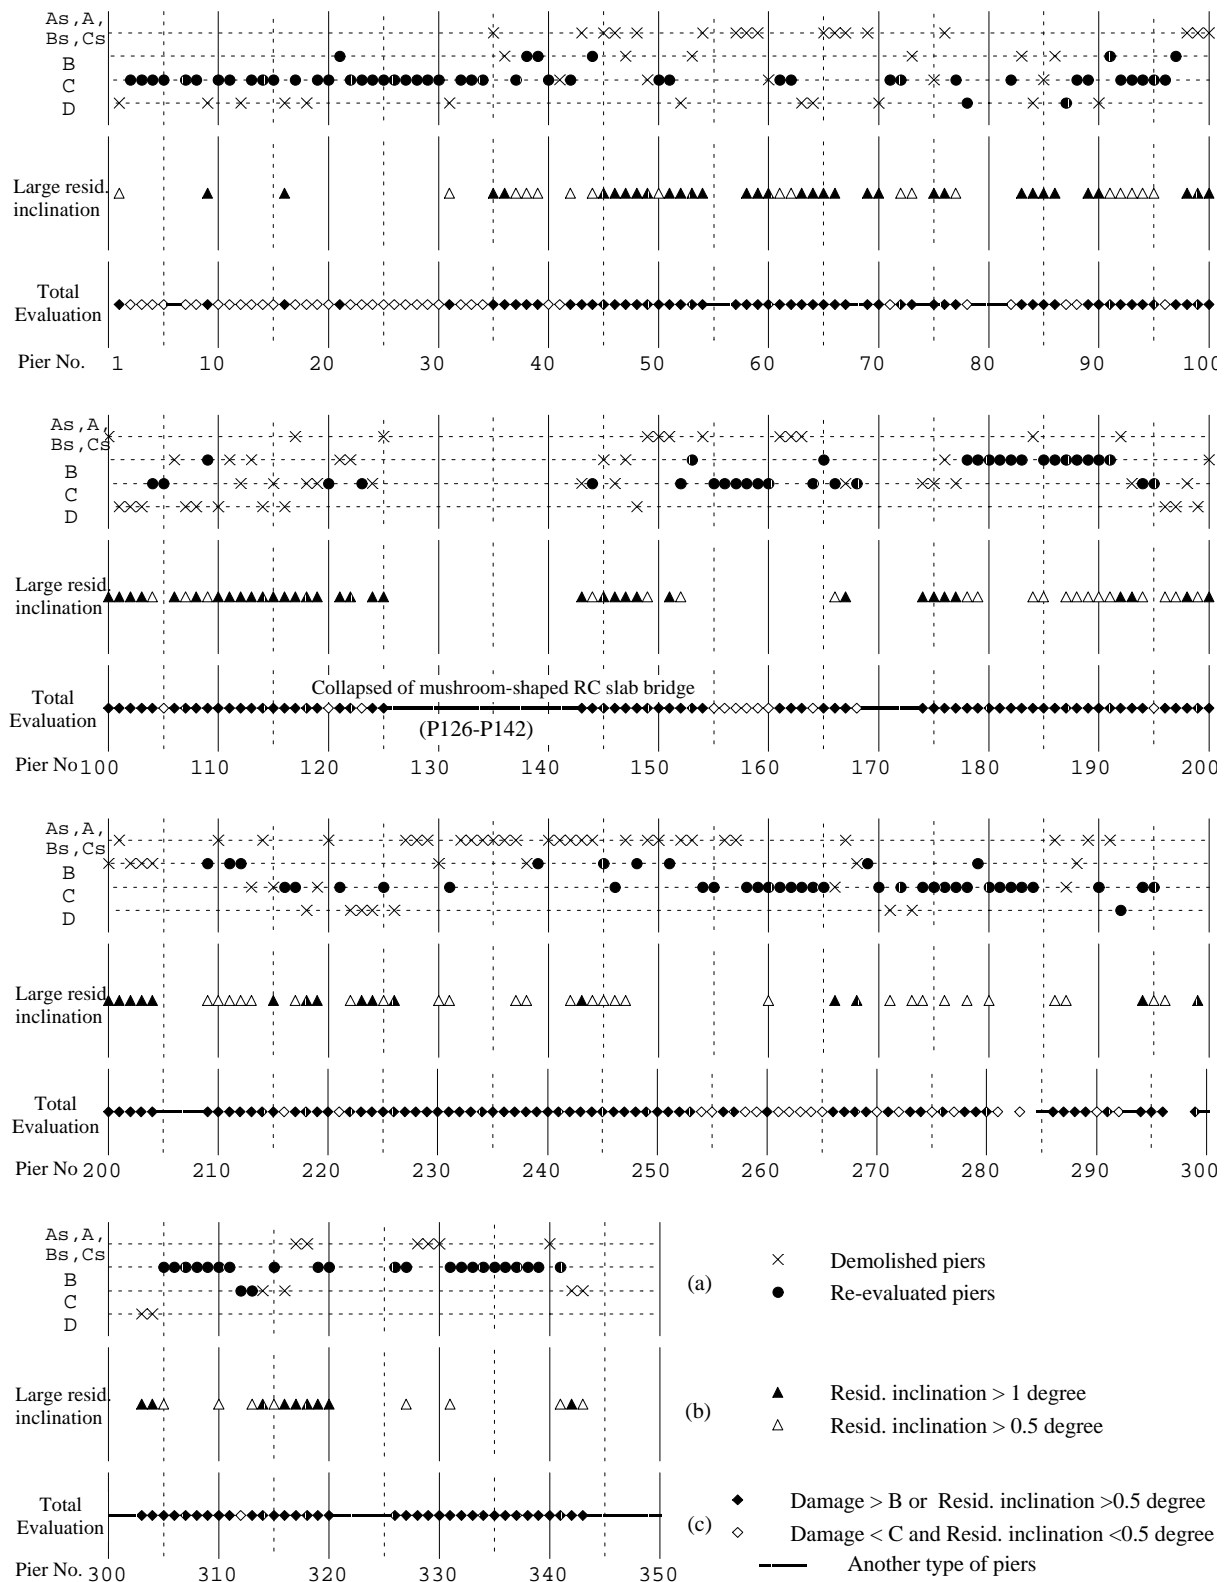
Figure10: Damage of RC single piers from P1 to P350

Fig10(a) shows the damage level of RC single piers from P1 to P350. Damage level (As, A, B, C, D) was basically based on the above-ground damage. But in the stage of restoration, the damage level was re-evaluated including the damage of under-ground piers. Bs (or Cs) means that the damage level in the underground was

found to be very severe during the restoration although the damage seen above the ground level was judged to B (or C). 'x' signs indicate the demolished piers. 'x' sign in the first line (As, A, Bs, Cs) means that the piers were demolished because of the serious damage. On the other hand, 'x' sign in B, C, D's line means that the piers were

demolished because of large residual inclination. In Fig.10(a), the damage level is very much scattered and no consistent trend can be found. This fact is rather difficult to accept because the type of the bridge structures in this section was very similar to each other.

Fig10(b) shows the piers with residual inclination larger than 0.5° . Comparing Fig.10(a) and (b), it is clear that large residual inclination occurred in many piers without serious appearance damage.

According to Ref.1, the inclination angle 0.5° corresponds roughly to the ductility factor 2.5, and ductility factor of maximum response is estimated to be 5.0. This implies that the piers with residual inclination $>0.5^\circ$ suffered the damage at least B. Hence, the overall damage is defined to be either (As, A, Bs, Cs, B) or the residual inclination $> 0.5^\circ$ here. In Fig10(c), the piers of damage level As, A, Bs, Cs, B and with the residual inclination $> 0.5^\circ$ plotted as \blacklozenge signs, and others, \blacklozenge signs. It is clear that in the section from P1 to P34, almost all the pier are plotted as \blacklozenge sign (light damage), and in the section from P35 to P350, \blacklozenge sign (severe damage). This result implies that the earthquake level would have changed around the P35.

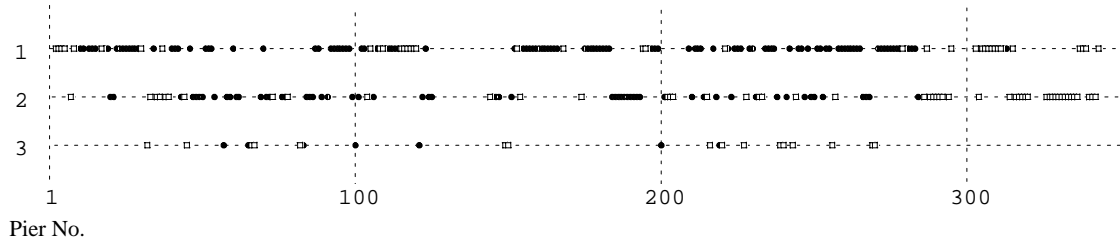
Figure11: Visually-judged damage mode of RC single piers
 (1: flexure, 2: flexure - shear, 3: shear) (shapes of cross sections ●: circular, □: rectangular)

As well known, the damage mode of RC single piers under horizontal seismic force can be classified roughly into three: either flexure, shear or their combination. Among these, the shear mode failure is non-ductile and to be avoided. Fig.11 shows the observed damage mode of RC single piers from P1 to P350. In many piers, the damage mode was flexure. Shear failure occurred, however, in some piers, which are rectangular section.

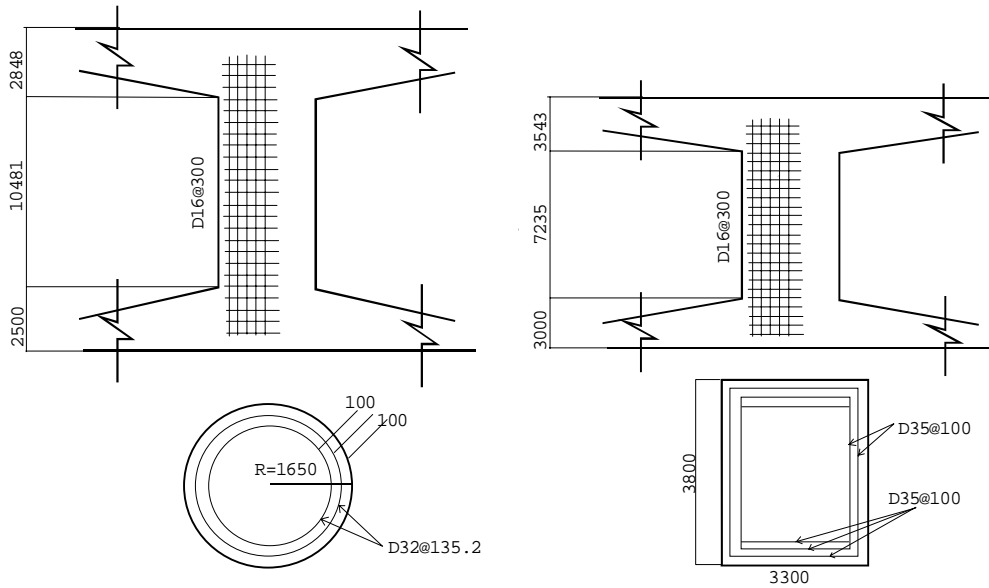
Figure12: Arrangement of reinforcing steel in typical cross sections

Generally the rectangular piers carried long span girders in Hanshin expressway. Fig.12 shows the typical case of reinforcing in circular and rectangular cross sections. In rectangular cross section, longitudinal reinforcements was increased to meet large bending moment due to large weight of the long span whereas the transverse reinforcement was not proportionally increased. The seismic design code employed at 1960's overestimated the shear capacity carried by concrete, and did not require adequate transverse reinforcement for shear seismic design of the piers, resulting in low shear capacity.

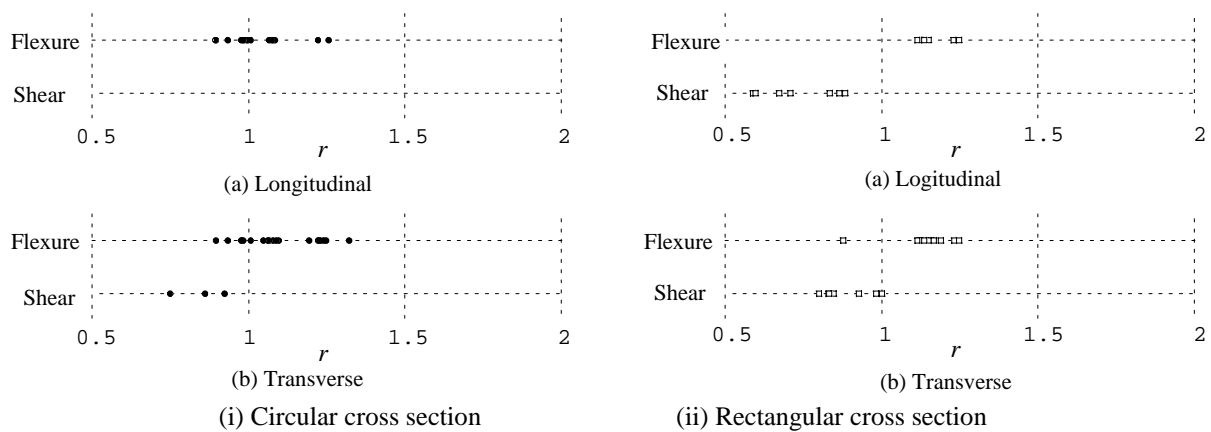
Fig.14 Damage mode and the ratio, r of flexure to shear capacity in severely damaged (>B) piers

Fig.14 shows the relationship between r and the observed failure mode. This plot is made only for severely damaged piers (damage level > B). In all the piers of $r > 1.0$ occurred flexure type failure, and in almost all the piers of $r < 1.0$ occurred shear type failure. Only in 8 piers, the failure mode was flexure in spite of the value of $r < 1.0$. These results indicate that the prediction of failure mode according to flexure and shear capacity is in good agreement with the actual mode.
