THE ADANA EARTHQUAKE (TURKEY)-SEISMOTECTONIC FRAMEWORK, GEODYNAMIC PHENOMENA, IMPACT ON THE STRUCTURED ENVIRONMENT

Eythymios L LEKKAS¹ And Emmanuel M VASSILAKIS²

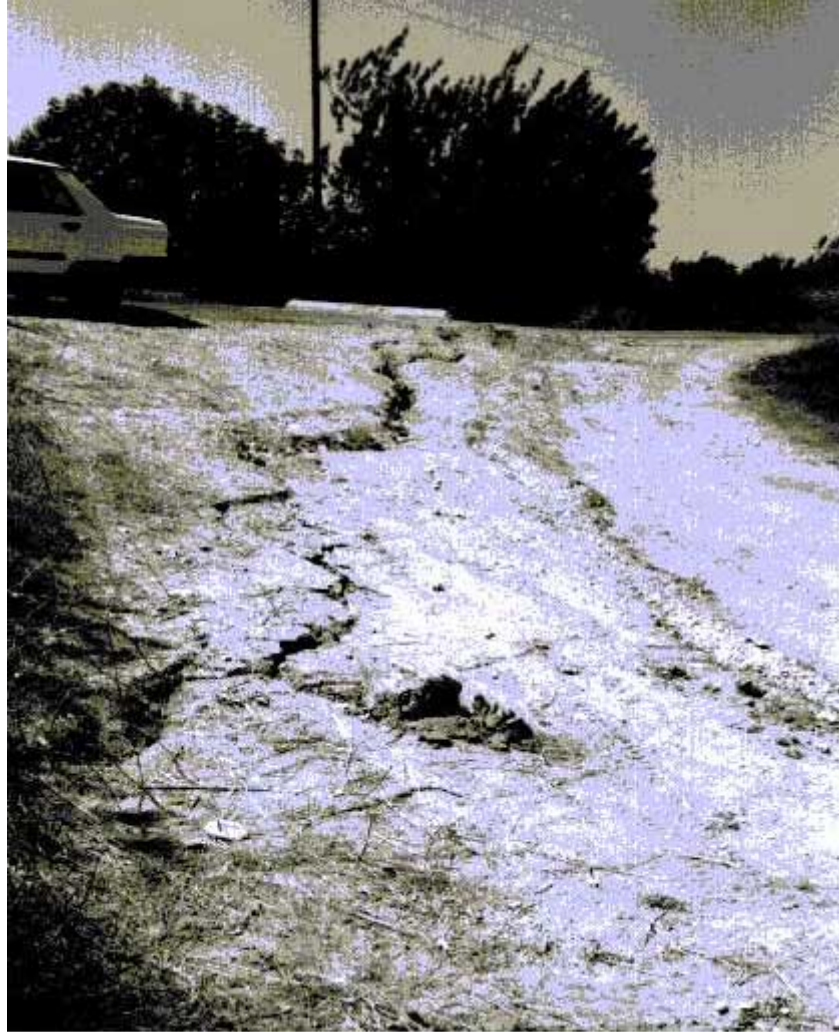
Seismic ruptures with sinistral displacement of NE-SW direction were identified after fieldwork observations. It should be noted that the general distribution of the epicentres of the recorded aftershocks displays the same arrangement with the seismic ruptures. The seismic ruptures, which extended for a length of approximately 300m between Incirlik and Yakapinar, in many locations, exhibited an en-echelon arrangement with practically no vertical displacement. This fact corroborates the sinistral displacement (Figure 3). Additionally, numerous ground ruptures were observed in the area, which are not related with the rupture caused by the fault plane but resulted from the behaviour of the ground formations during the earthquake.

Figure 3: Part of a seismic rupture caused by sinistral strike slip movement.

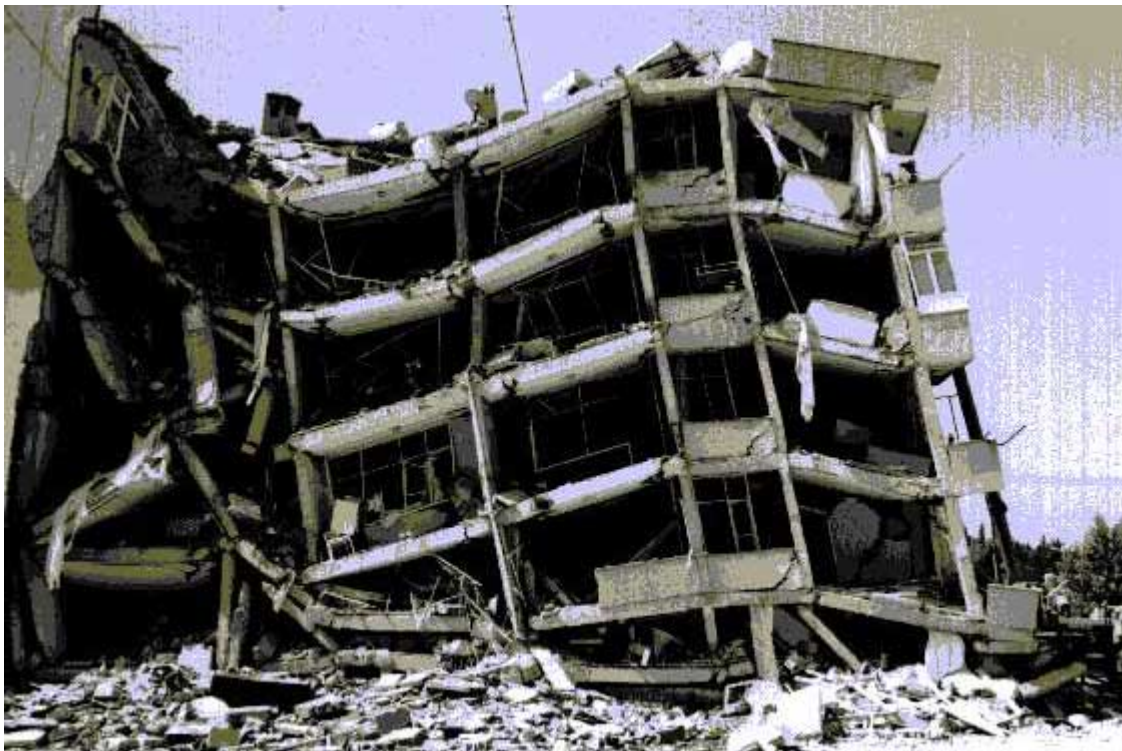
The most substantial damages occurred in buildings of the first four categories mainly in villages where at least 30%-80% of the structures suffered significant damage. Furthermore, significant damages occurred in multi-story buildings of reinforced concrete and without earthquake-design standards or with the quality of the materials significantly degraded. Such damages that led to total collapse occurred in the area of Adana and in the area of Ceyhan (Figure 4).

Figure 4: Total collapse of multi-story building at the city of Ceyhan.

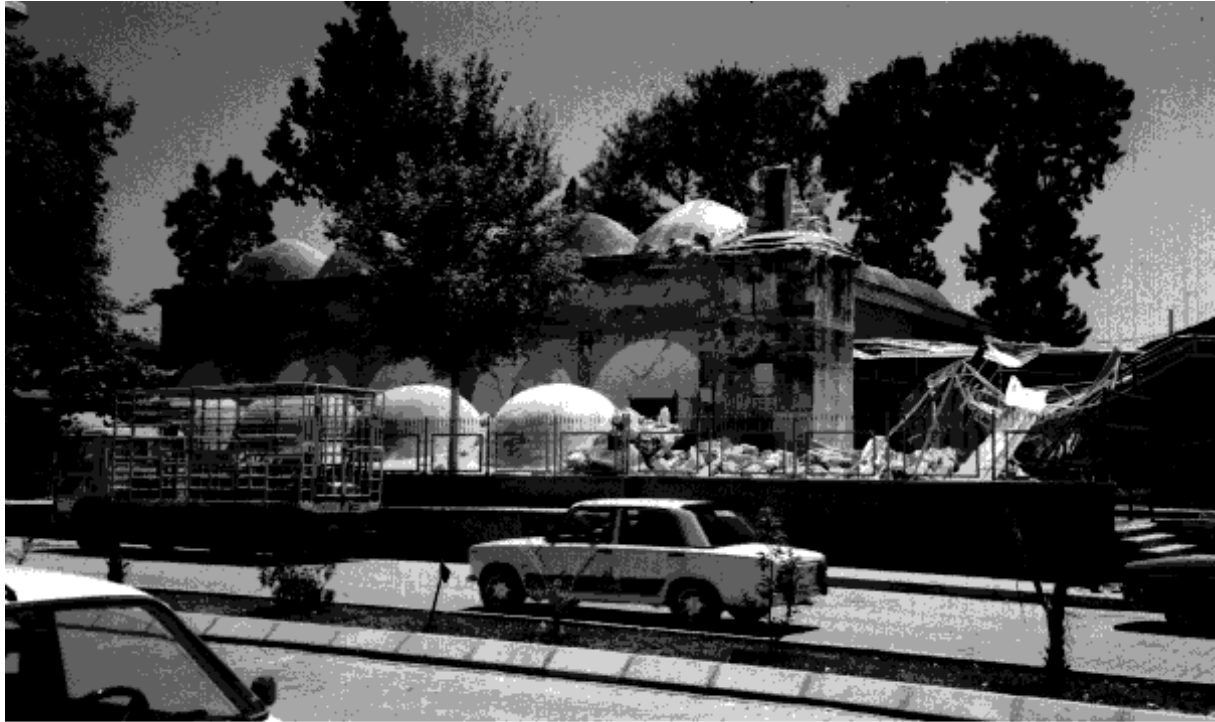
Significant damages were also observed in the historic monuments of the area and mostly in mosques and minarets (Figure 5). These damages showed a selective development in the upper parts of the minarets [Lekkas and Vassilakis, 1999]. Additionally in the vicinity of the villages Yakapinar-Abdioglu, some industrial buildings with metal framework suffered significant damages.

Figure 5: Partially collapsed mosque in the city of Ceyhan.

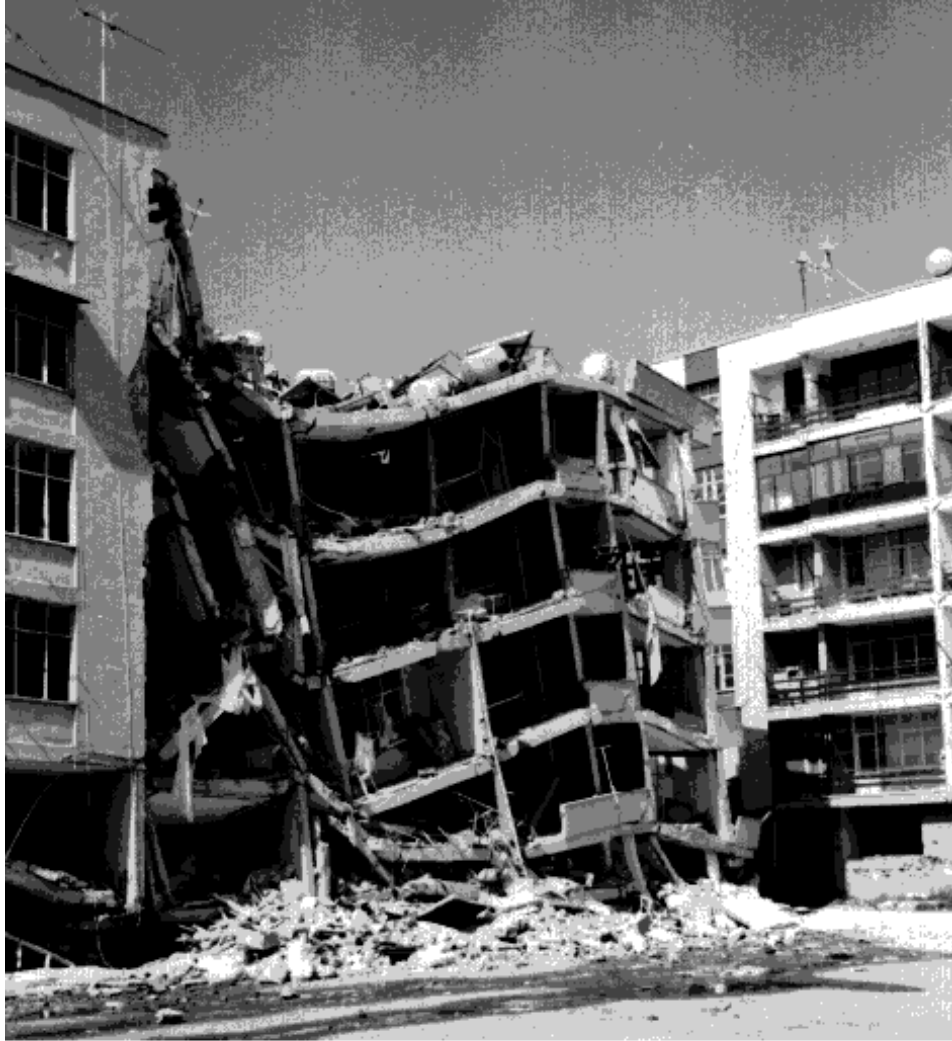
It is interesting that there is a correlation between the type of building and the type of damage suffered. The extent of the damage however, is also related to the construction quality, the quality of the materials, the age of the structure, the maintenance but also to the geographic location and the azimuth position with respect to the epicentre. Some of the reasons that caused the damages are similar to those determined in other earthquake cases in Turkey like the earthquake of Dinar [Carydis et al., 1995]. Such reasons are: (i) soft first story, (ii) inadequate detailing and reinforcements of column-beam connections and columns, (iii) design of strong beam/weak columns rather than strong column/weak beams and (iv) succession of flexible and rigid parts in big buildings (Figure 6).

Figure 6: Partially collapsed building, due to the succession of flexible and rigid structural elements.
