EARTHQUAKE DAMAGE TO HISTORIC AND OLDER ADOBE BUILDINGS DURING THE 1994 NORTHRIDGE, CALIFORNIA EARTHQUAKE

Frederick A WEBSTER¹ And E.Leroy TOLLES²

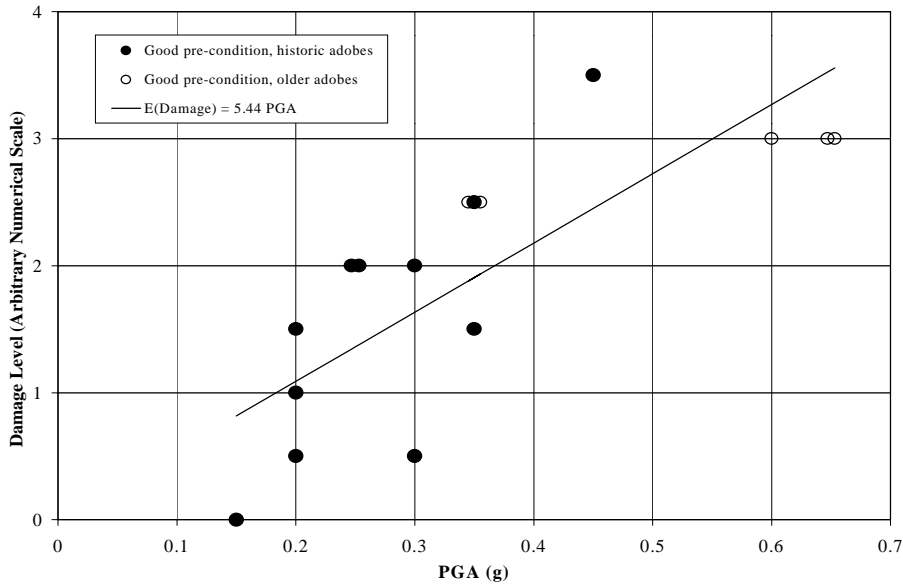
Plotting damage versus peak ground acceleration (PGA) for these 29 buildings proves to be quite informative. Figure 1 is a scattergram plot for the unreinforced, but well maintained, historic and older adobes (16 out of the 29 surveyed). These buildings had insignificant pre-existing conditions, thus excluding adobes with:

First, it appears that PGA in the range of 0.1g to 0.2g is needed to initiate damage in the well maintained, but otherwise unreinforced adobe buildings. At this level of shaking, cracks will begin to form at door and window openings and at the intersections of perpendicular walls. The damage levels increase with increases in PGA. At a PGA of about 0.4g the damage is moderate to extensive and includes more general crack damage throughout the structure.

Figure 1: Damage versus Peak Ground Acceleration for historic and older unreinforced and well-maintained adobes

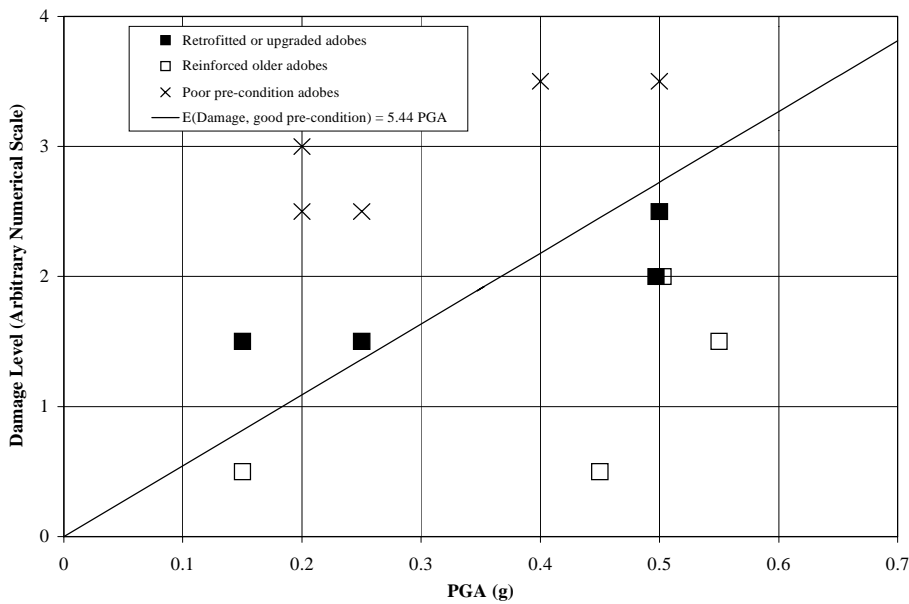
Figure 2 is a scattergram plot of damage for those adobes with the pre-existing conditions listed above (13 out of 29 surveyed). Relative to the “best estimate” damage state relationship for unreinforced, but well maintained adobes, pre-existing conditions have definite effects on the resulting damage states. Obviously, the poorly maintained adobes consistently fared worse than well-maintained adobes. Even at moderately intense ground motion (0.1g to 0.2g) poorly maintained adobes are likely to suffer substantial damage.

Not so obvious, because of the sparse data, is the effect that seismic retrofits or upgrades have on the performance of historic and older adobes. As a preliminary conclusion from Figure 2, it appears that the value of seismic retrofitting or upgrading is not realized until relatively high levels of ground shaking occur (i.e., above 0.3g). At lower levels of ground shaking, the retrofit measures appear not to affect performance. At these lower levels of ground shaking, the retrofitted buildings behave much the same as well maintained, unretrofitted

Figure 2: Damage versus Peak Ground Acceleration for adobes other than unreinforced and well maintained.

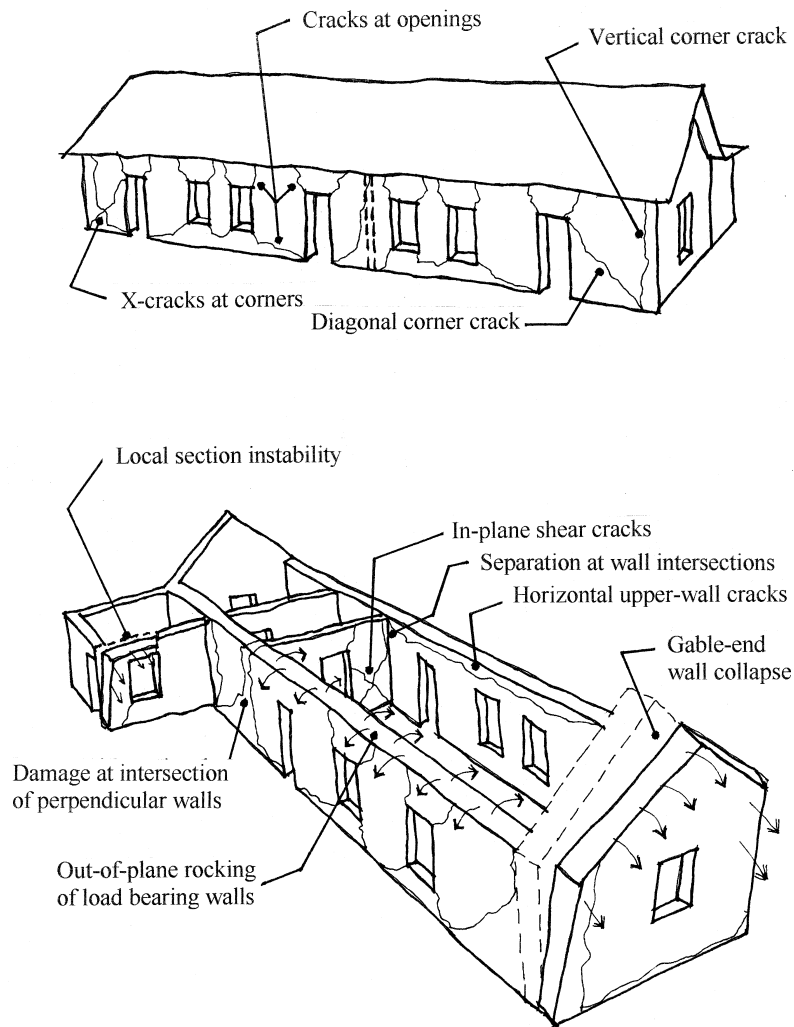
Adobe walls are quite susceptible to crack damage resulting from out-of-plane flexural stresses. Out-of-plane crack damage initiates as a vertical crack at the intersection of a perpendicular wall, extending vertically or diagonally and running horizontally along the base between transverse or intersecting walls. The wall rocks back and forth out-of-plane, rotating about the horizontal crack at the base. Although cracks from out-of-plane forces occur readily in these buildings, the extent of damage is often not severe, as long as there is adequate support provided by the floor and/or roof diaphragm.

The collapse of gable-end walls is a special case of out-of-plane flexural damage and a damage type all too often observed in historic adobe buildings as a result of strong ground motion. Gable walls are tall, slender and usually not well supported laterally. Unless anchored to the roof diaphragm, they can slip out from underneath the roof framing, as occurred at the Andres Pico and De la Osa adobes during the Northridge earthquake.

Figure 3: Typical types of damage observed in historic adobe buildings after the Northridge earthquake

Separation of longitudinal walls at their intersection with perpendicular cross walls is a common type of damage, which also results from out-of-plan movement of the walls. As the longitudinal wall rocks outward it pulls away from intersecting perpendicular walls, creating tensile stresses at these junctures that easily crack the adobe. In

many cases there is no physical connection at the intersections of walls, having been constructed simply as abutting. The discontinuity that exists at the juncture becomes larger as the longitudinal wall rocks. Examples of this type of damage were numerous in the surveyed buildings.

Damage can also occur to the upper portion of a longitudinal wall as a result of the out-of-plane movement where the roof bears on top of the wall. Included in this category are slippage of the top plate and displacement of the top course or two of adobe blocks. Slippage of the ceiling framing can also occur. This type of damage is due to the very limited friction force that is generated by the roof weight bearing down on the top of the wall and the friable nature of historic and older adobe block construction.

In-plane diagonal cracks and X-diagonal cracks result from shear forces in the plane of the walls. These cracks are not particularly serious unless the relative displacement across them becomes large. They do represent a lessening of the lateral stiffness of the building. But unless a segment of the wall on one side of the crack is in danger of losing purchase on the adjacent segment, the gravity load path remains in tact.

Diagonal cracks in exterior walls at building corners are more serious than within the main body of the wall since they form wedges that can easily move sideways and downward as the building shakes. Other corner crack patterns include vertical cracks on one or two perpendicular faces, resulting from out-of-plane movement of one or both walls. If there are two vertical cracks, one on each perpendicular face, this leaves a freestanding column of adobe at the corner, which is quite vulnerable to collapse.

The most common type of crack damage is that occurring at the corners of door and window openings. These cracks can occur at PGA levels as low as 0.1g to 0.2g and are a result of both in-plane shear forces and out-of-plane flexure of the wall. They are not particularly serious unless the relative displacement across the cracks is large, in which case instability of the section of wall above the opening becomes an issue.
