GEOTECHNICAL ISSUES OF THE JUNE 27, 1998 ADANA-CEYHAN EARTHQUAKE

Korhan ADALIER¹ And Ogun AYDINGUN²

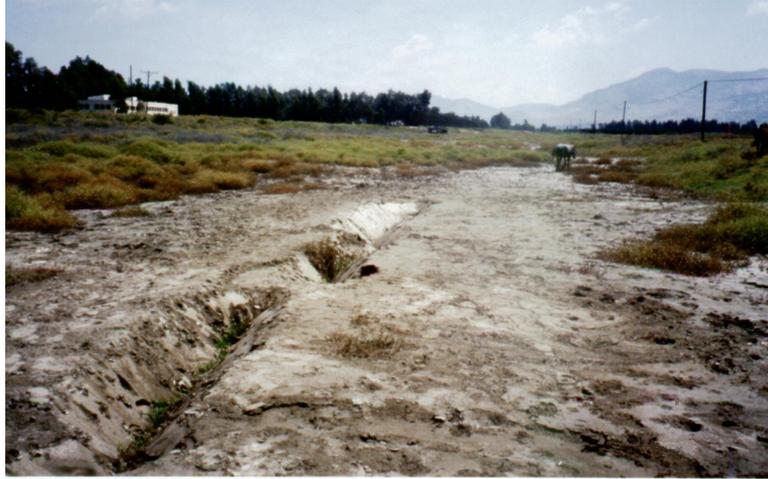
Some of the most spectacular sand boiling activities were observed in the epicentral area near the Abdioglu Village (see Figure 2), where our site investigations were most comprehensive. According to the eyewitnesses, almost all of these sand boil activities were initiated towards the end of the shaking or immediately after and continued for 10 to 60 minutes. The ejected soil was found to spread evenly by run-off, and in some cases cover a large area of ground surface (e.g., at one site few kms from the village, a single elongated fissure ejected more than 600 m³ sandy soil that covered more than 3000 m² surface area, Figure 5) around the fissure. The eyewitnesses reported water flooding reaching even much larger areas. The long duration of sand boil activity and the very large amount of fluid extruded to the ground surface suggests a high degree of liquefaction and slow pore pressure dissipation in the loose fine granular soil sublayer [Elgamal and Adalier, 1999]. At several sites, the materials brought up by the fluid were recognized to be the same as those of stratums encountered by nearby wells at depths greater than 4-5 meters (and in one extreme case 10 m, indicating the high degree of liquefaction). The ejected soil was distinctly gray in color (original ground-surface soil was brown). The grain size analysis showed that the ejected sediments were consistently fine sand with 10 to 15% fines content (mostly silt as noted by visual inspection). These fine particles appear to have remained in suspension after ejection, and were thus spread along the ground surface by the observed run-off process. The observed long duration of sand boil activity might have been influenced by the presence of this significant fine-particle content. Such fine particles were shown to reduce permeability and greatly prolong the post-liquefaction soil re-solidification phase [Adalier, 1992].

The lateral spreading appeared to have helped the occurrence of the sand boils by providing cracks of easy path in the overlying cohesive silty clay layer (acting as a capping layer) for the liquefied underlying sandy soils to escape. However, in the extreme case of large lateral spreading areas (high extensional strain usually

encountered near river channel) too much cross-sectional area of cracking led to lower hydraulic gradients in the upflowing liquefied soils which was not enough to carry these soils to surface. On the other extreme side, in the areas where no lateral spreading existed, the sand boils tended to appear more in forms of circular volcanoes (craters) and were reported to eject soils to higher levels (jets reaching 2 m or more in the air) and stayed activated for longer periods compared to the elongated fissure type sand boils that were usually encountered in areas with moderate lateral spreading (minor to moderate extensional strain).

Figure 5: A major sand boil formation in the epicentral area.

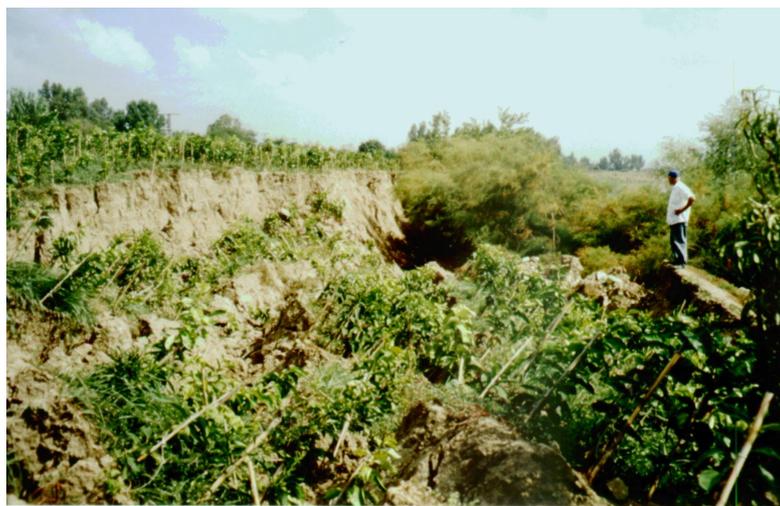
Slope failures or collapses at many locations along the Ceyhan River were observed. Large volumes of soil both settled vertically and moved laterally towards the river (Figure 6), apparently due to the flow of the liquefied silty sand sublayer (i.e., lateral spreading). In many locations, long fissures in the ground parallel to the river channel (mainly concentrated within 200-300 m inland) indicated lateral spreading of the ground toward the river. Lateral spreadings due to mildly sloping ground far from any incised channel were also observed at several isolated sites, but to a much lesser extent.

Figure 6: Lateral spreads in an orchard along Ceyhan River near Abdioglu.
