DAMAGE TO A PILE FOUNDATION DUE TO LIQUEFIED GROUND MOTION

Shin'ichiro MORI¹, Atsunori NUMATA² And Baoqi GUAN³

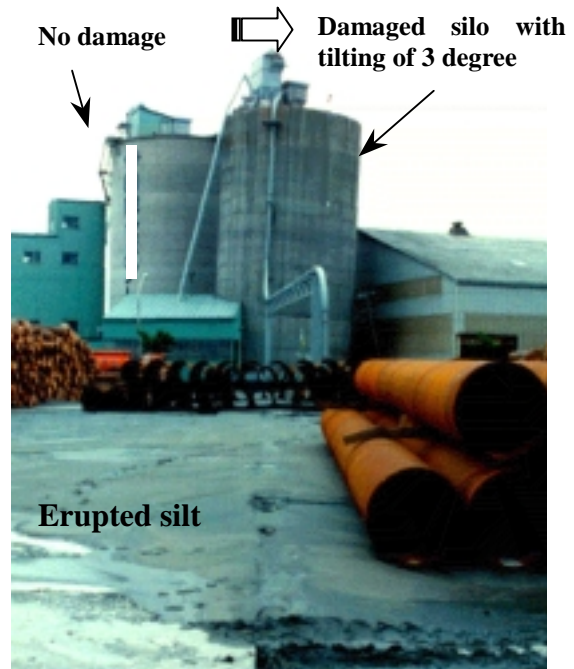
After the 1993 earthquake, the upper structure of the silo subsided by a minimum of 30 cm and a maximum of 90 cm, resulting into differential settlement of 60 cm, tilting of 1/20, and horizontal displacement of 47 cm [Mori et al, 1994]. The direction of tilt and lateral movement was southwest. On the contrary, the other silo that was constructed in 1977 being designed as per the Design Code in 1974 suffered no damage at all.

Photo. 1 Tilted silo (center) and silt eruption

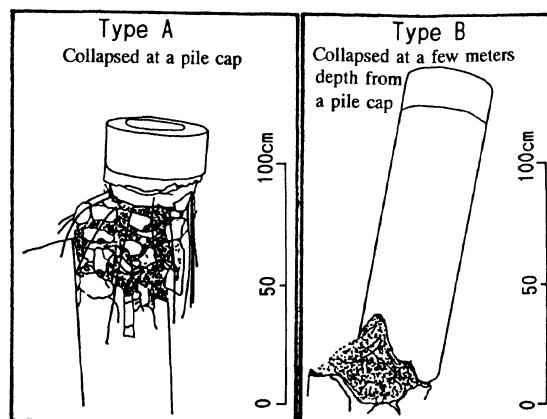
In order to clarify the damage to the pile heads and caps, an investigation by excavation during destruction of the base of the damaged silo was carried out. All the pile heads were exposed out and observed up to 1 to 3 meters below the pile tops. The investigation revealed that all the pile heads were damaged up to a depth of 3 meters, which made it easy to understand the peculiarity that enabled the failure of the pile heads to be classified into two patterns. The failure patterns of the pile heads are illustrated in Figure 2; one is shear failure or bending-shear failure at pile head (to be called Type-A) with large shear deformation and the other is bending failure at a depth of 1 to 3 meters below sound pile top (to be called Type-B) with large tilting.

Fig. 2 Failure patterns of damaged pile heads

patterns. Mori and Numata [1999] clarified the causes and mechanism of this peculiarity of the damage by the analyses of the photos taken just after piling in 1969. The two types of failure patterns of the pile heads were distinguished by the ratio of the penetration length, P to the pile diameter, D deciding sufficient connection at pile cap. The criterion of the sufficient ratio, P/D for rigid connection was 0.2. Type-A piles behaved with rigid pile-cap connection due to sufficient penetration, while Type-B piles behaved with pinned connection due to insufficient penetration.

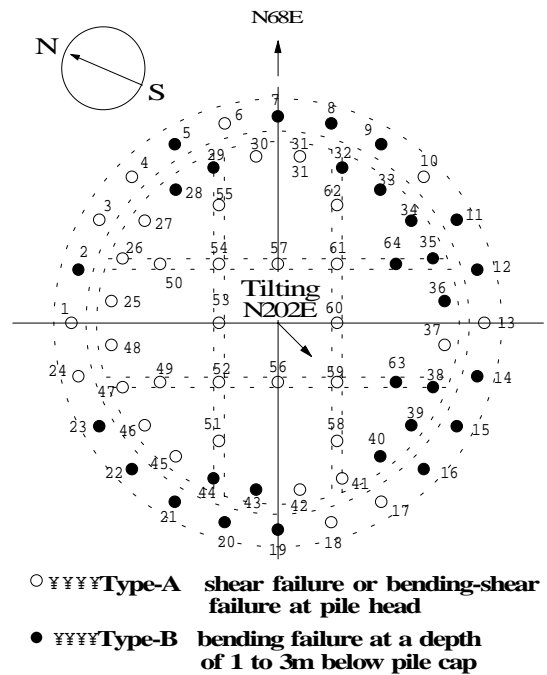
The distribution of the failure patterns is shown in Fig. 3 where numerals indicate the serial numbers of the piles. The figure makes us to basically understand the mixed and irregular distribution of the two

Fig. 3 Distribution of the failure patterns

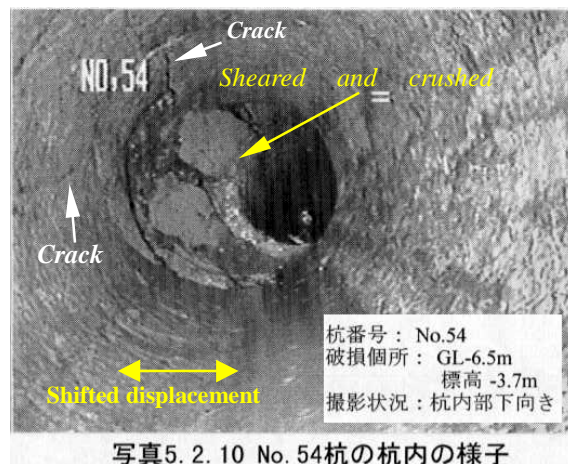
In order to directly observe the damage to the piles at a depth, the internal inspection of PC piles was carried out by inserting a CCD-TV camera into the seven piles with completely failed pile heads. Photo. 2 shows the downward internal view of No.54 pile at a depth. One-meter length of the pile at 6.5 m depth completely failed, and a large shear deformation and longitudinal cracks on the pile were clearly seen. Furthermore, the photo illustrated a lateral shift of half the pile radius at the breakage point due to the shear deformation. The failure patterns and deformations of the 5 piles that had distinct failure are shown in Fig. 4, attached with the soil profile of the site. This figure clearly shows that the piles after failure deformed largely at a depth corresponding to the bottom of reclaimed layer or the top of old sea bottom at the depth of around 7 meters.

Photo. 2 Downward inner view of the pile No.54 damaged at 6.5 m in depth

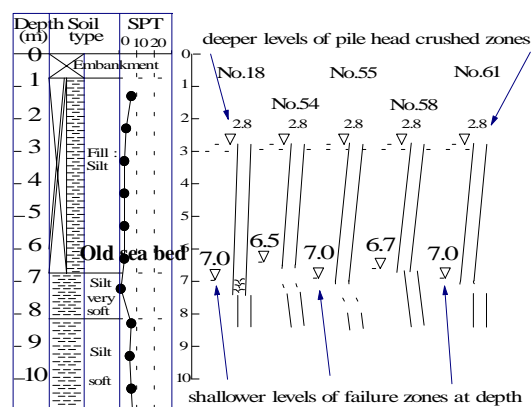
Fig. 4 Pile failures at depth of old sea bottom

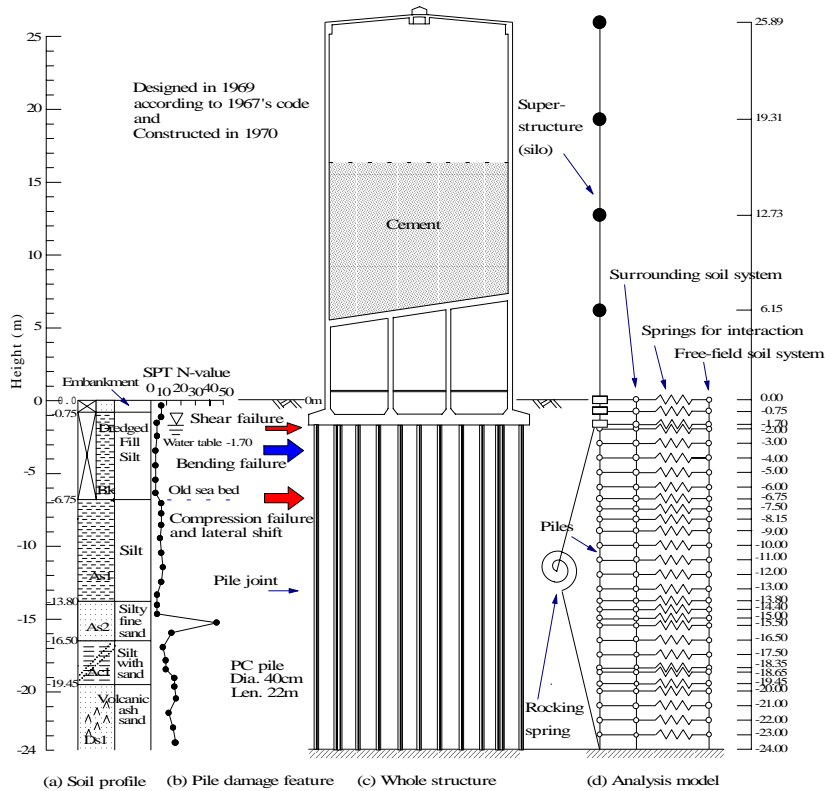
Damage to the piles along the depth is summarized in Fig. 5 (b and c). Damaged portions of the piles were at three different locations: at the pile head, a depth of 1 to 3 meters below the pile cap, and at the depth corresponding to the bottom of the reclaimed layer. The first two locations mean the breakage points of Type-A and Type-B piles as mentioned earlier.

Fig.5 Soil profile , pile damage portions, silo-pile structure and analysis model

(1) Damaged portions of the piles were at three different locations: at the pile head, at a depth of 1 to 3 meters below the pile cap, and at the depth corresponding to the bottom of the reclaimed layer. The first two locations are the breakage points of shear failure or bending-shear failure at pile head with rigid pile-cap connection (Type-A) and bending failure at a depth of 1 to 3 meters below sound pile top (Type-B), respectively.

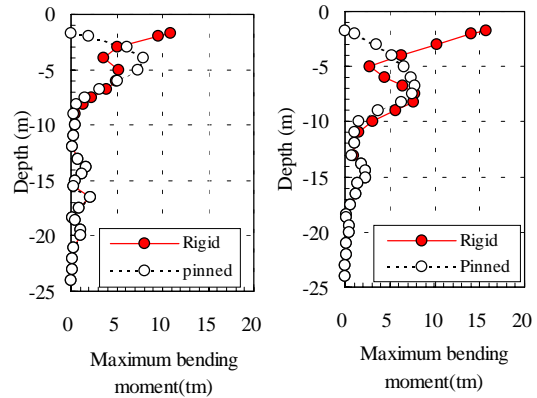
The distributions of the bending moment of pile in two cases of pile-cap connecting condition are shown in Fig. 11. This figure contains the result of TSA (a) and ESA (b). In the case of TSA, the value at pile head with rigid connection reaches the amount of cracking moment, whereas the value at a depth of 3 m with pinned connection reaches 80 % of cracking moment. The depth of maximum bending moment in the case of pinned connection depends on the interaction spring, accordingly the result of TSA can explain Type-B failure. Meanwhile, the actual input motion might be larger than that considered in the analysis. If so, the pile head with rigid connection might have failed even without the liquefaction, which means that the result of TSA can explain Type-A failure. On the other hand, in the case of ESA, the depth of maximum bending moment in the case of pinned connection is 6 to 7 m, which coincides with the depth of shear failure in the actually damaged piles. Furthermore, the value at pile head with rigid connection in case of ESA reaches 1.5 times of that of TSA and is beyond the ultimate strength. This result harmonizes the actual feature of Type-A failure. Fig. 12 shows, in the space of bending moment and axial forces, the response path at pile cap in the case of rigid connection and the yield surface. The response of TSA model exceeds the crack line only once but never reaches the yield surface, whereas that of ESA model passes beyond the line over and over again, and then reaches the yield surface. Therefore, the ESA model can preferably explain the whole feature of pile damage; so, liquefaction considerably contributes to causing damage to the pile head.

(a) Total stress analysis (b) Effective stress analysis
Fig. 11 Distributions of the bending moment of pile in two cases of pile-cap connecting condition

(2) TSA model can explain the Type-B failure, whereas Type-A failure may be explained by TSA model, however, it can be preferably explained by ESA model. Therefore, liquefaction considerably contributes to causing the damage to the pile heads.

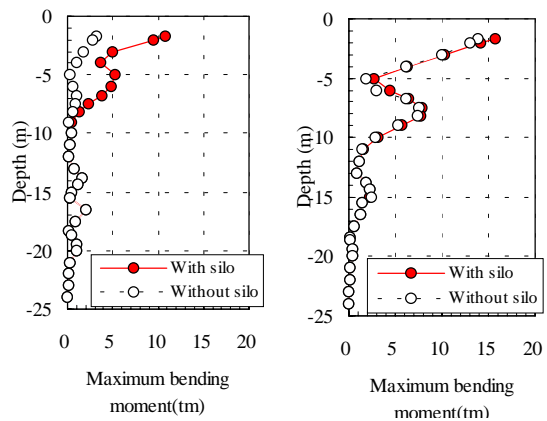
(a) Total stress analysis (b) Effective stress analysis
Fig. 13 Distributions of the bending moment of pile under the condition of rigid connection, in two cases of with silo and without silo

head in with and without, is considerable due to the inertia force of silo and its base. Accordingly, inertia force plays more important role than the ground deformation when liquefaction does not occur. On the other hand, in the case of ESA, the difference is negligible. Therefore, ground deformation is dominant in the bending moment of pile when liquefaction occurs.
