## **STRONG MOTION CHARACTERISTICS NEAR THE SOURCE REGION OF THE HYOGOKEN-NANBU EARTHQUAKE FROM ANALYSES OF THE DIRECTIONS OF STRUCTURAL FAILURES**

**Kentaro MOTOKI<sup>1</sup> And Kazuoh SEO<sup>2</sup>**

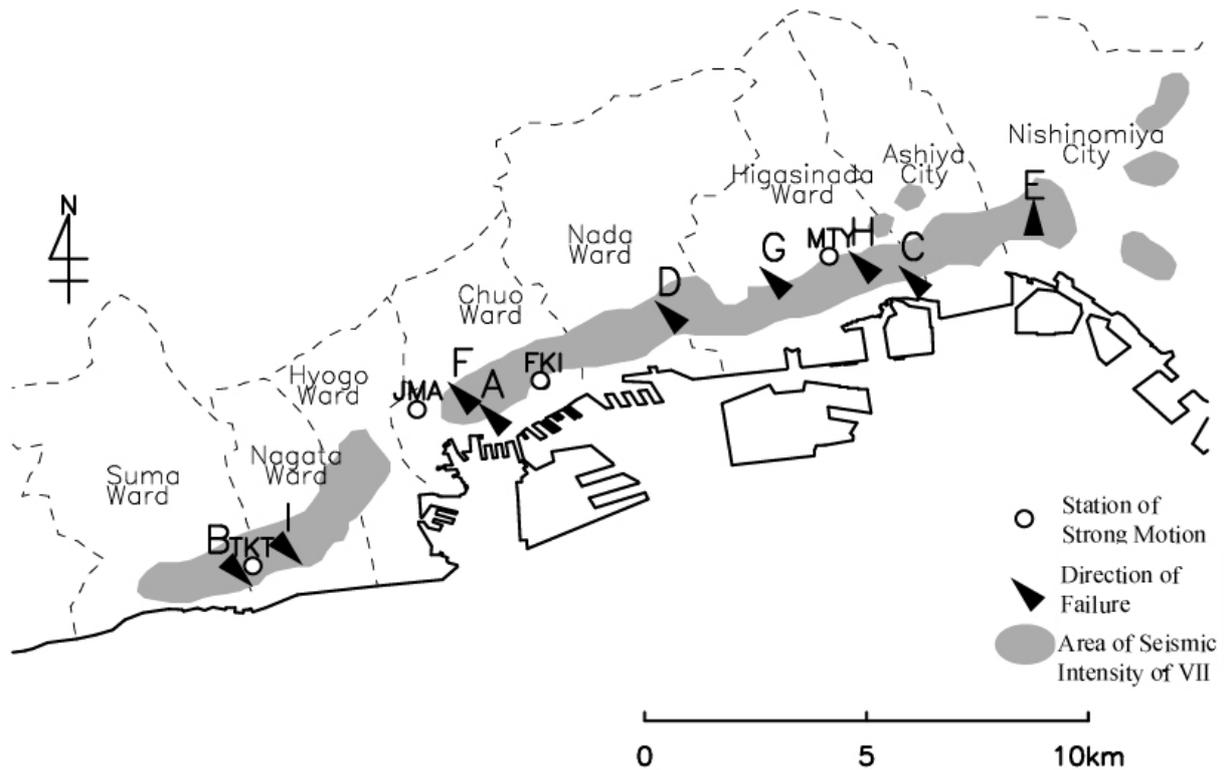
First, we found the following phenomenon: In the western part of Kobe City, structures collapsed toward the southeast direction, but in the eastern part of the city, they collapsed toward the opposite one.

- A: Kobe City Office
- B: Trains at Takatori Station
- C: Hanshin Highway
- D: Utility pole at Rokkomichi Station
- E: Shukugawa Apartment
- F: NHK (Japan Broadcasting Corporation)
- G: Coffee shop
- H: Kobe Commercial High School
- I: The 3rd Motoyama Primary School

**Figure 1 The Distribution of Observed Strong Motions and the Directions of Systematic Structural Failure**

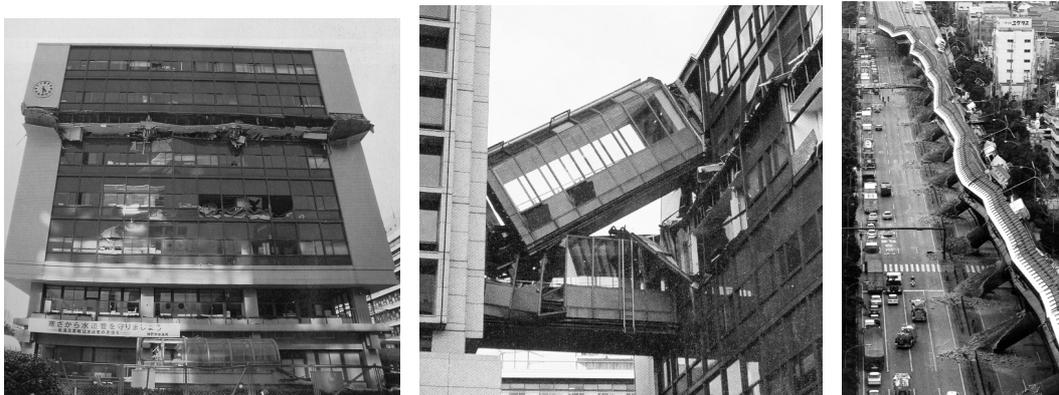
As it is well known, the municipality office No. 2 of Kobe City was collapsed in intermediate story (6th story). The upper stories displaced toward the northwest without the displacement toward the opposite direction. It is quite clear because the bridge at 8th story just fell down without crashing by compress or shear force. The Hanshin Highway fell down toward the northwest direction along 600 meters in width. Such that, the direction of structural failure is determined by the behavior of the upper stories. The direction of systematic failures shown in Fig.1 reveals remarkable regularity on respective damaged areas: structures collapsed toward the southeast direction in the western part and toward the northwest in the eastern part of Kobe City. We investigated these feature patterns for 113 wooden structures and 66 non-wooden structures and about half number of structures were collapsed toward the same direction as stated. Since school buildings are uniform in floor design, in

**Photograph 1 Kobe City Office (from northwest, left), The Bridge of Kobe City Office (middle), Hanshin Highway (from north east, right)**
