SEISMIC SAFETY OF EXISTING CONCRETE MASONRY GARDEN WALLS

SUMMARY

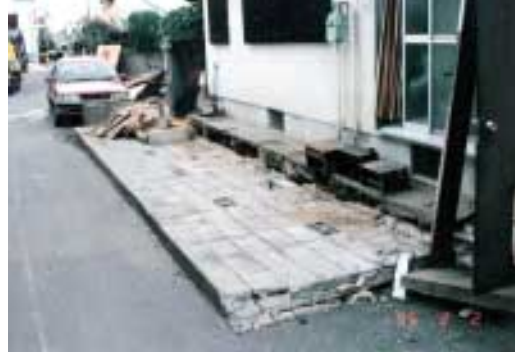
Figure 1: Structural damage to a masonry garden wall by the 1995 Hyogoken-nanbu earthquake

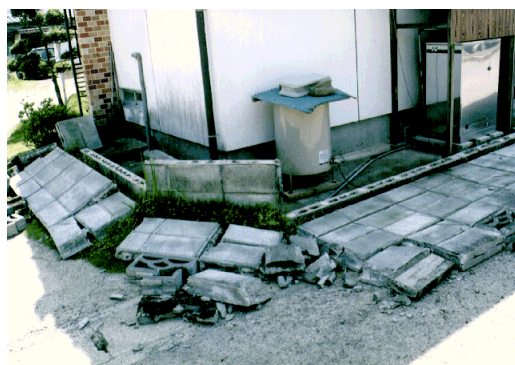
On the 26th of March and 13th of May, 1997, other severe earthquakes (the 1997 Kagoshimaken-hokuseibu earthquake) occurred on the northwestern region of Kagoshima Prefecture which is located in the southwest island of Japan. The magnitude of these earthquakes were 6.5 and 6.3 on the Richter scale, respectively. During these two earthquakes, a large number of masonry garden walls were also collapsed or severely damaged as shown in Figure 4. The authors conducted post-earthquake investigations within the damaged area just after the occurrence of each earthquake. Sixty-one masonry garden walls were investigated in a residential areas. Among those walls, 23% had collapsed [Yoshimura et al., 1998a].

Figure 4: Structural damage to masonry garden walls by the 1997 Kagoshimaken-hokuseibu earthquake

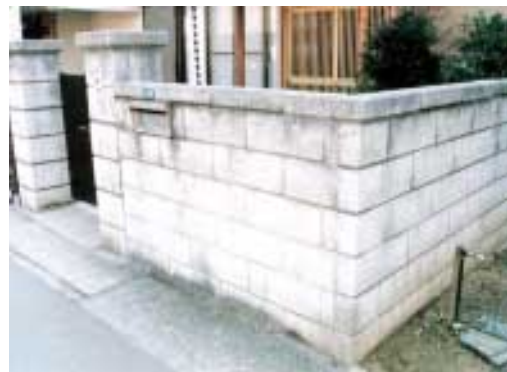
and/or joints of the buttress walls. On the contrary, 64% of the walls investigated in Kobe City and Kagoshima Prefecture have intersecting walls, where the intersecting walls are defined as the walls connected at right angles in plan to each horizontal edge of the investigated walls as shown in Figure 6.

Figure 6: A wall having intersecting wall

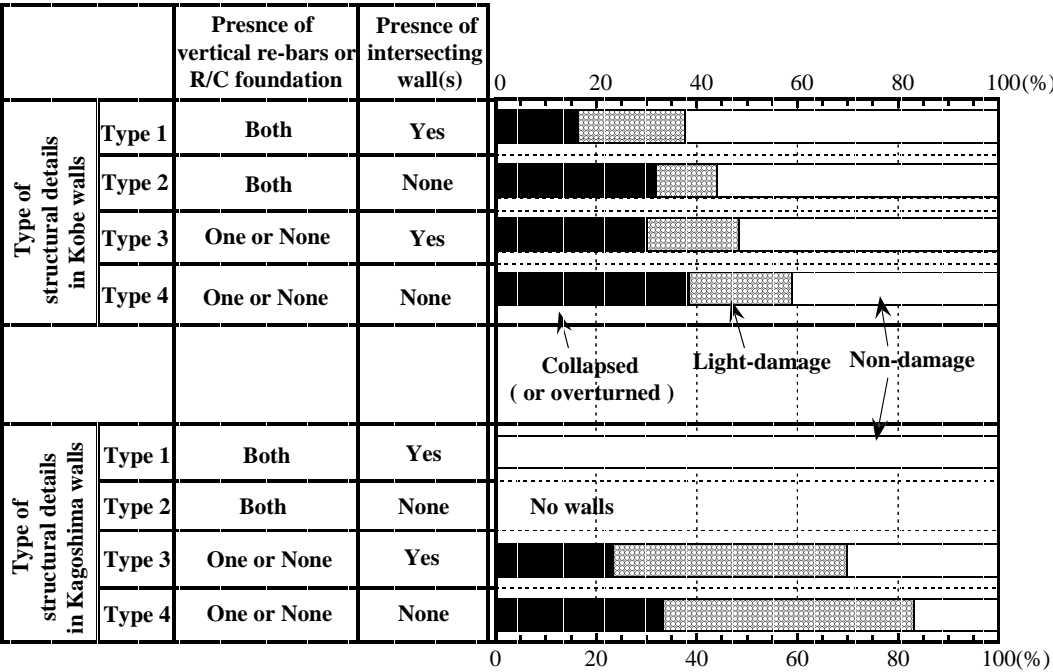
Relations between the structural details of the investigated walls and their damage levels are summarized in Figure 7, where the investigated masonry walls are classified into four types in accordance with their adopted structural details. Type 1 Walls have both of vertical wall reinforcements and R/C foundations as well as intersecting wall(s) at the wall edge(s). Type 2 Walls do not have any intersecting walls, although they have both of the vertical re-bars and R/C foundations. Types 3 and 4 Walls, have either vertical re-bars or R/C foundations are provided, or neither of them. The difference in Types 3 and 4 Walls is that the former have the intersecting walls and the latter do not have those. It is noted that all of the walls investigated in Kagoshima Prefecture did not have any R/C foundations. It can be seen from Figure 6 that, in case of the investigated walls in Kobe City, the ratio of collapsed walls to the total number of walls in Type 1 is 16 % smaller than that in Type 2 and the ratio of undamaged walls in Type 1 is 6 % larger than that in Type 2. In addition, similar tendency can be seen in comparison between results of Types 3 and 4 Walls. These facts mean that the presence of intersecting walls as

well as vertical re-bars and R/C foundations give large effects on the mitigation of earthquake damage to the masonry walls. Many of the connections between the investigated wall and its intersecting walls were observed to be inadequate during the field investigations. Therefore, by connecting more firmly the masonry wall to its intersecting wall(s), then the seismic resistance of masonry garden walls are expected to increase much more.

Figure 7: Relations between structural details and earthquake damage

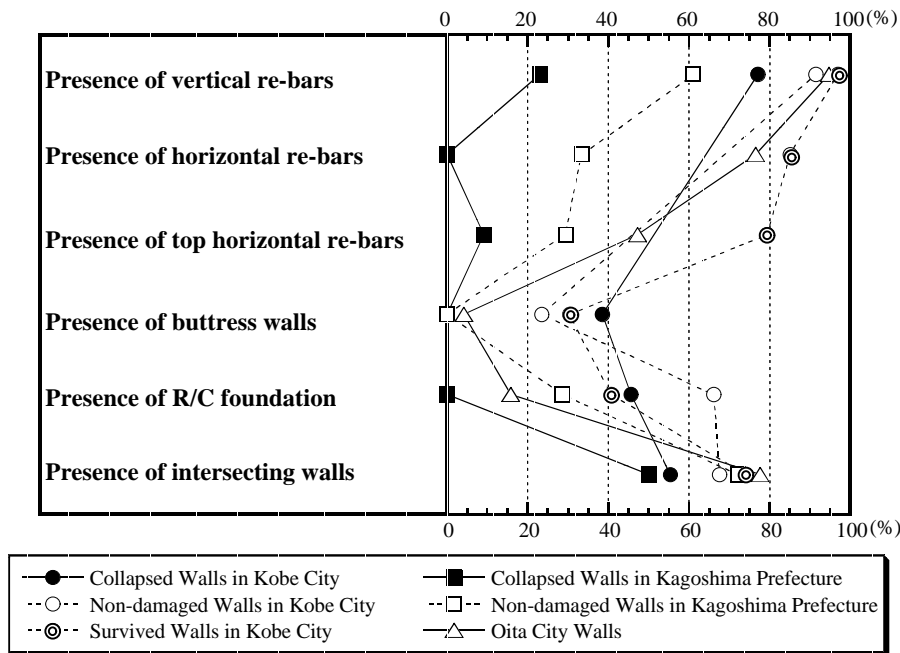
- (1) With regard to the ratio of the walls having vertical re-bars, the results from the collapsed walls in both of Kobe and Kagoshima were 14-38% lower than those from the undamaged walls or the survived walls. The ratio of the walls with vertical re-bars in Oita was as high as those of the undamaged walls and survived walls in Kobe.

- (2) None of the masonry garden walls in Kagoshima had buttresses. In Kobe on the contrary, approximately 40% of the collapsed walls and 30% of the survived walls had buttresses. It is noted that there were only a few walls with adequate foundations of these buttresses and/or joints of the buttress wall. The walls having the buttress walls in Oita were only 4%.

- (3) Collapsed walls in Kagoshima did not have any R/C foundations. On the contrary, 29% of the undamaged walls in Kagoshima had R/C foundations. In Kobe, 66% of the undamaged walls had R/C foundations, while only 46% of the collapsed walls had R/C foundations. For most of the collapsed walls with R/C foundations, shallow embedment depth of foundations and insufficient anchorage of vertical re-bars were observed. Only 16% of the walls in Oita had R/C foundations.

- (4) In both Kobe and Kagoshima, approximately 70% of the undamaged and survived walls had intersecting walls at their horizontal edges, while about 50% of the collapsed walls did not have any intersecting walls. Most of the collapsed walls with intersecting walls had inadequate joints between wall edges and intersecting walls. In Oita, 78% of the investigated walls have the intersecting walls.

It can be understood that most of the investigation results in Oita City are scattered or fall within the results obtained from investigations of collapsed and survived walls in Kobe City. As a result, severe structural damage

to the masonry garden walls is expected during next big earthquakes in Oita City, and thus the structural inspection and seismic strengthening for existing masonry garden walls are urgently required.

Figure 8: Results of four field investigations on seismic resistance of masonry walls

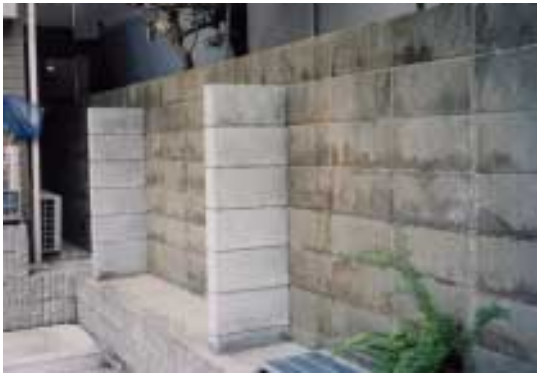
(1) Add reinforced concrete block buttresses. This type of strengthening was used on five walls among those investigated. In Figure 9 the additional buttresses are connected to the existing wall by using bolts or other connecting materials. The buttresses should have massive foundations to prevent the wall from overturning toward the opposite side to the buttress during a severe earthquake.

Figure 9: Existing wall strengthened with concrete block buttress wall

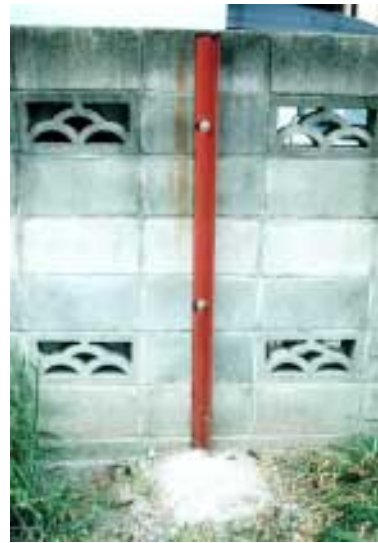
(2) Add steel pillars. As shown in Figure 10, new steel pillars are anchored into ground soil or their foundations newly constructed, and are connected to the existing wall by using bolts or other connecting materials. This type of strengthening method was used on seven existing walls.

Figure 10: Existing wall strengthened with steel pillar

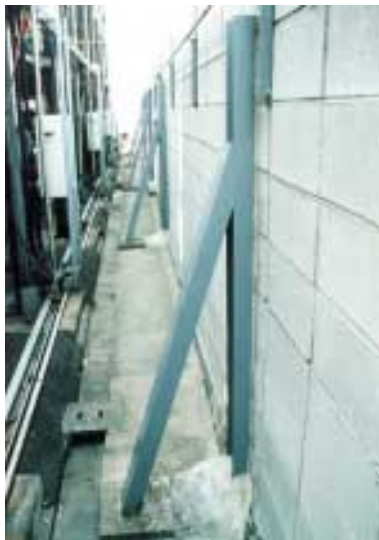
(3) Add buttresses composed of steel members. This strengthening method was composed of a steel pillar and a steel diagonal member as shown in Figure 11. A total of 11 walls were strengthened by this type of strengthening method. If these strengthening elements are anchored into massive foundations and are connected to the masonry wall firmly, then this type of strengthening seems to be effective. However, wide space is necessary between a building structure and a masonry garden wall.

Figure 11: Existing wall strengthened with steel pillar and diagonal member

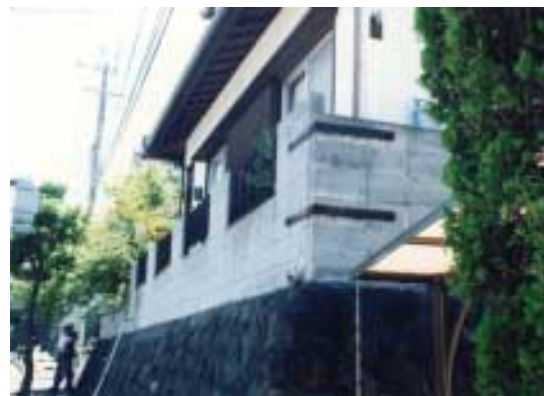
(4) Connect walls to intersecting walls. As shown in Figure 12, this strengthening method is to connect the existing wall to the intersecting walls with connecting materials such as steel plates. It was adopted on five existing walls.

Figure 12: Existing wall connected to intersecting wall with steel plates

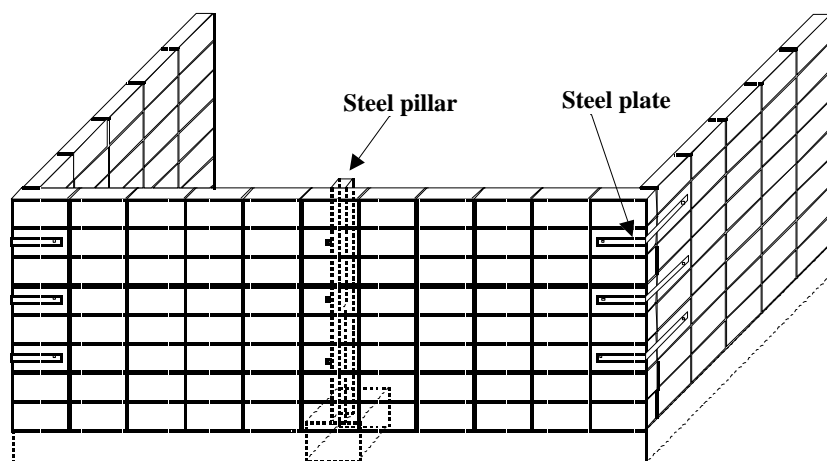
Figure 13: An example of strengthening method by connecting masonry wall to intersecting walls

The number of existing masonry walls investigated in Oita City were listed in Table 1, where the walls classified into four types in accordance with their structural details. It can be understood from Table 1 that the walls having the R/C foundations were very few. On the contrary, the intersecting walls were provided into more than three fourth of the walls in Oita City. As these results, it is noticed that the strengthening method by connecting the masonry walls to the intersecting walls can be applied to a large number of the existing masonry walls. Figure 13 shows an example of the strengthened masonry wall by connecting to the intersecting walls. In the case when the masonry wall are long, buttress walls or steel pillars would need to be installed in the center of the masonry wall as shown in Figure 13.
