# Seismic studies of the San Francisco-Oakland Bay bridge

A. Astaneh-Asl University of California at Berkeley, Calif., USA

ABSTRACT: During the October 17, 1989 Loma Prieta earthquake, the San Francisco-Oakland Bay bridge sustained some damage and was closed for a month. Following the earthquake, a comprehensive research project has been underway at the University of California at Berkeley to study seismic behavior of the bridge and formulate retrofit seismological, geotechnical and structural aspects. By developing realistic models of the bridge and subjecting the models to realistic ground motions, seismic deficiencies are being identified. This paper summarizes the progress of this study.

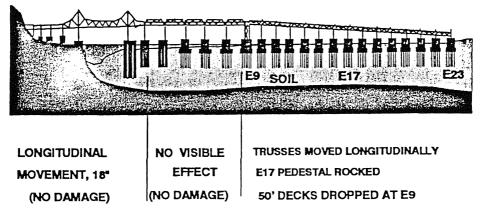
Figure 5. Summary of the damage

Following the earthquake, the damage was documented and reported (Astaneh, 1989). Figure 5 shows a summary of the damage to the East Bay Crossing of the bridge. During the October 17, 1989 earthquake, fourteen trusses at the eastern end of the bridge had moved in the longitudinal direction of the

bridge and caused structural damage and the collapse of two 17m long segments of the decks at the location of Pier E9. During the 1989 earthquake, the two 88m span trusses immediately to the east of Pier E9 appeared to have moved primarily in an east-west direction relative to Pier E9. The main damage in this area was shear failure of forty 25mm diameter bolts connecting shoes of the trusses to the top of the steel The maximum movement of shoes was towers. estimated to have been more than 18 cm. After the quake, a residual movement of about 13 cm in longitudinal direction eastward and about 4.5 cm in transverse direction northward were measured. Due to this movement, the stringers supporting the 15m long segments of the upper and lower decks over Pier E9 came off their seat supports and collapsed.

Another area of damage was the segment of the bridge between Piers Ell and El7. The structure of the bridge between Pier Ell and El7 consists of six 88m span trusses

supported on steel columns with the exception of Pier E17 which is a hollow reinforced concrete pedestal as shown in Figure 3. During the earthquake, apparently these six spans had moved together in the east-west direction about 13 cm. causing the concrete pedestals at Pier E17 to rock about their base. The rocking caused some damage to the concrete at the base of the pedestals.

The damage in the spans east of Pier E17 was failure of a number of 25mm diameter bolts connecting the truss shoes to the top of the piers. The shear failure of these bolts had resulted in release of the trusses allowing the trusses between Pier 17 and Pier 22 to move in the east-west direction along the length of the bridge.

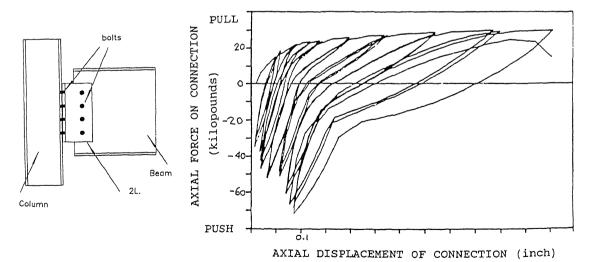
Figure 8. Behavior of angle connections subjected to cyclic axial load

As shown in Figure 4, the concrete deck of the Bridge is supported on longitudinal stringers which in turn are supported by double angle connections to the web of floor plate girders. Investigation of behavior of deck system indicated that the double angle connections can experience considerable yielding due to axial push-pull when bridge moves in longitudinal direction. To study cyclic behavior of these connections comprehensive experimental and analytical studies are underway. A total of 14 test of full scale connections have been tested under simulated cyclic loading.

Figure 8 shows a typical connection and its response to the cyclic axial load. When connections were pulled, they behaved in a very flexible manner due to bending flexibility of outstanding legs of angles. When angles were pushed against the support,

they exhibited very large stiffness due to the axial stiffness of the outstanding legs bearing against the support. After sufficient number of inelastic push-pull cycles, during which the shear was maintained at a constant level, the strength of outstanding legs had deteriorated so much that the connections failed due to gravity shear. This finding has extremely important design and retrofit implications. It means that connections that are designed to carry gravity shear, usually with a factor of safety of about 2.0, during severe and long duration earthquakes, can deteriorate sufficiently such that either during the quake or afterward, the connection fails under service load alone.

In addition, due to considerable cyclic inelasticity of these connections, it is necessary to model these connections as nonlinear elements in the computer model and conduct the dynamic analysis of the system.
