July 16, 1990 Luzon (Philippines) earthquake

R.L. Sharpe
Cupertino, Calif., USA

ABSTRACT: The purpose of this paper is to present an overview of the July 16, 1990 Luzon, Philippines earthquake, what was learned, and what can be learned. The earthquake was one of the largest in several decades. Its impact on the local populace and the country as a whole was major.

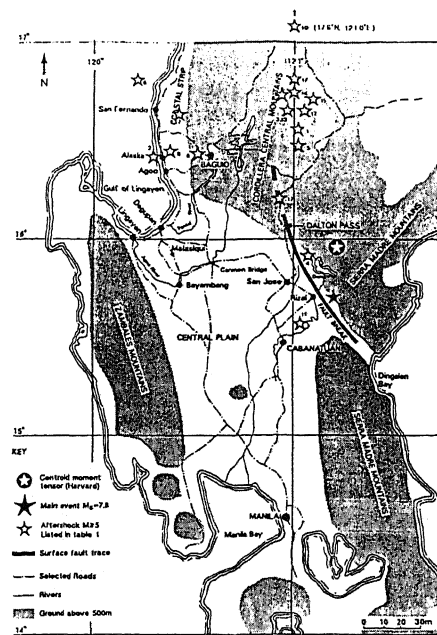
The July 16, 1990 earthquake is attributed to the Philippine Fault Zone and its major branch, the Digdig Fault. The Digdig is apparently nearly vertical and cuts under or near Baguio City. The epicenter is estimated to be located about 13 km north-northeast of Cabanatuan. The main shock was magnitude 7.8 (M_s) with a focal depth of 25 to 36 km. There were nearly 700 aftershocks, with about 80 felt and 17 greater than Richter 5, in two and one half days after the main shock (fig 1).

Fig 1. Fault break and major aftershocks (from USGS data and EEFIT, 1990)

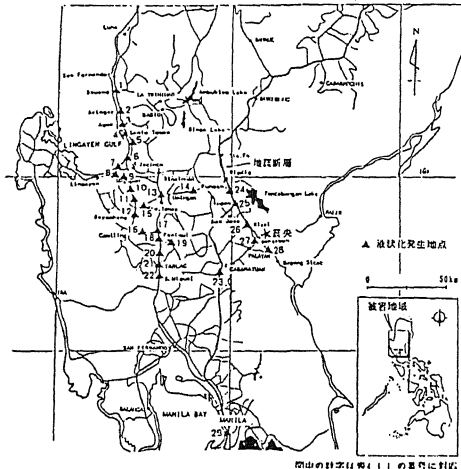
The city of Agoo on the west coast of Luzon is one of the main population centers in the region. Large areas around Agoo liquefied,

settled, and were flooded with sea water. Northwest of Agoo the Village of Alaska with some 30 houses was totally destroyed (fig 2). Although there was extensive liquefaction around Agoo, apparently there was none in the city itself.

Fig 2. Major liquefaction sites (from JICA, 1990)
