The April 22, 1991 Limón (Costa Rica) earthquake

G. Santana

Laboratorio de Ingeniería Sísmica, Universidad de Costa Rica, Costa Rica

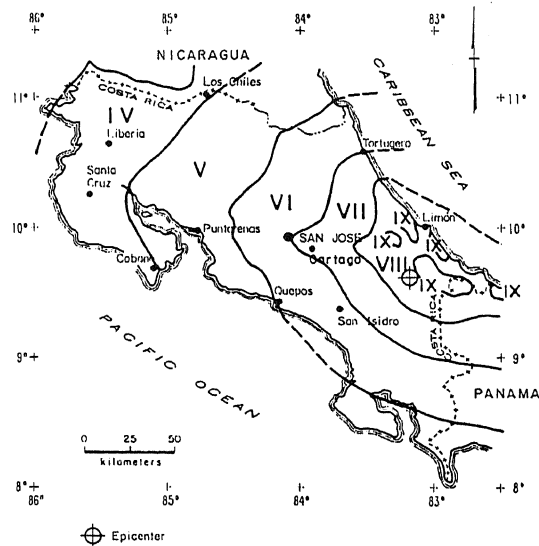
The main shock had a magnitude M_s 7.6. It occurred at 15:57 local time with epicenter 43 km SE of Port Limón at a 10 km depth. Fig 1 shows estimated MM intensities. The earthquake caused the failure of buildings, bridges and infrastructure in general and severe damage to roads and industrial facilities. The number of fatalities was less than 100. About 4000 dwellings were destroyed and 12 000 more suffered partial collapse, mainly associated with poor construction. Some 250 small schools were damaged. In Limón the water supply system developed many ruptures and required several weeks for repair. This paper deals with seismicity, design practice in the country and direct material losses caused by the earthquake.

Fig 1. MM intensities of the 1991 main shock (after Rojas, 1991).

The maximum MM intensity was IX in Matina, just north of Highway 32, along Highway 36 on the coast south of Limón and in Panama next to Costa Rica (fig 1).

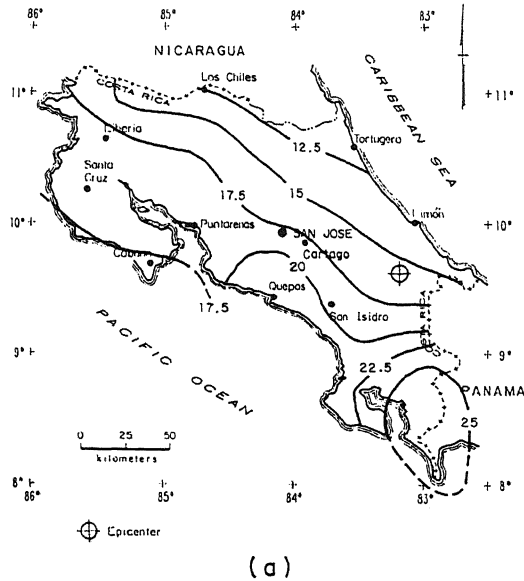
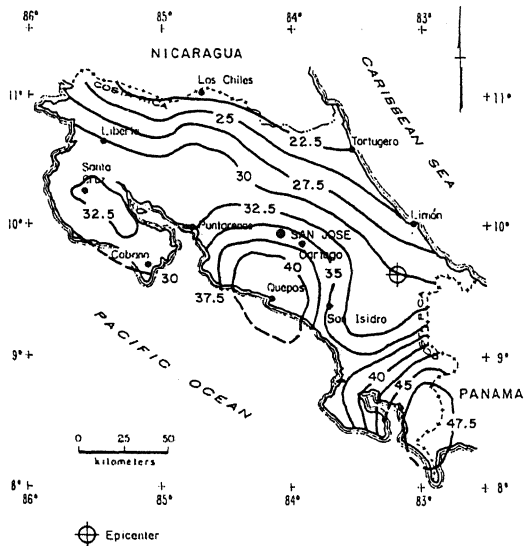
The 1986 Seismic Code (Código Sísmico de Costa Rica) uses isoacceleration maps, based on Mortgat et al (1977), for return periods of 50, 100 (fig 2a), 500 and 1000 (fig 2b) yr. The latter reflects the assumption of three source zones, all near the Pacific coast. Santana (1990) gives examples of damage from a recent earthquake with epicenter in Nicoya Gulf off the Pacific coast. Yet the April 22, 1991 event occurred near the Caribbean coast, far from the assumed source zones.

Fig 2. Code isoacceleration curves for a) 100 yr return period; b) 1000 yr return period.

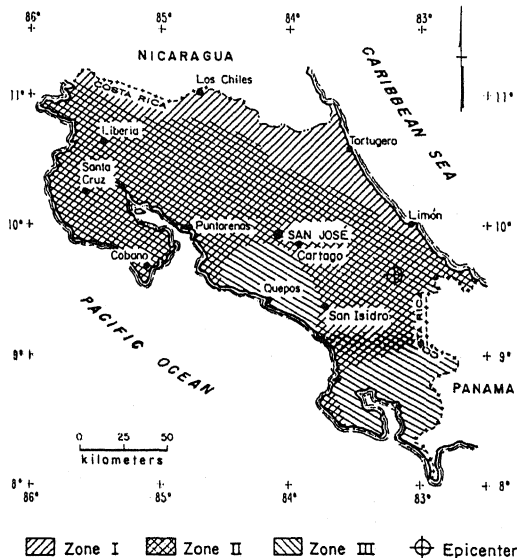
The code requires modal analysis for structures taller than 30 m and allows static analysis for lower structures. In both methods the peak acceleration is obtained from the isoacceleration maps. For 1-2 story buildings a simpler approach is permitted; the country is divided into three zones (fig 3); base shear coefficients are 0.11, 0.22 and 0.33 for zones I, II and III, respectively.

Fig 3. Code seismic zones for simplified design.

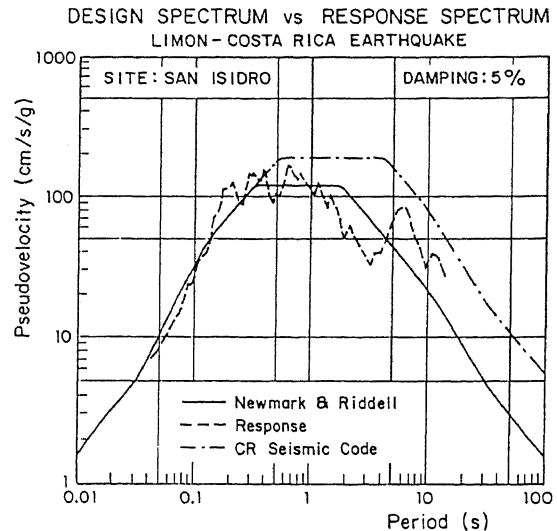
At San Isidro the strong shaking (5-95% of the Arias intensity) lasted 26.2 s, much longer than at Presidio during the 1989 Loma Prieta earthquake and in the 1986 San Salvador earthquake. Comparison of the 5%-damping response spectrum for the strongest San Isidro component with the code design spectrum and with that derived from the Newmark-Riddell criteria (fig 4) shows that the latter spectrum is in reasonable accord with the response spectrum but that the code overestimates spectral ordinates for long periods. This is more pronounced for the Cartago station, on soft ground (fig 5). As a consequence structures with long fundamental period, designed according to the code, are overdesigned, especially on soft ground. The situation is brought out in fig 6, which shows ductility demands for single-degree-of-freedom systems designed for a ductility factor of 4. Qualitatively the same holds for other design ductility factors. (The apparently excessive demand in very rigid structures is doubtless covered by their overstrength. — Note by the editor.) This helps explain the low-damage incidence to large buildings in San José's metropolitan area.

Fig 4. Response and design spectra, San Isidro Station.

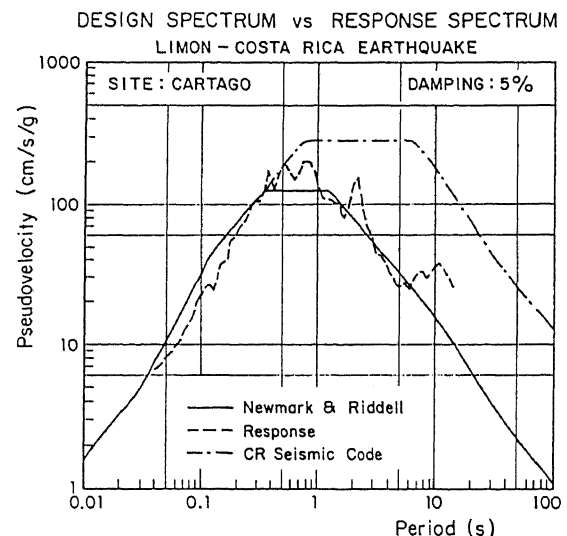
Fig 5. Response and design spectra, Cartago Station.

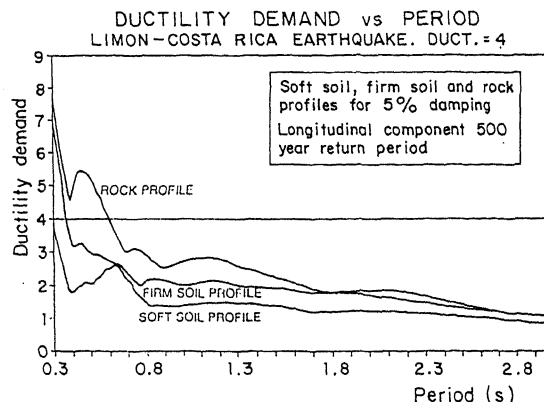
Fig 6. Ductility demands in a single-degree system designed for ductility factor of 4 according to the code.
