The Mont Chenoua (Algeria) earthquake of October 29th, 1989: Damage assessment and distribution

M. N. Farsi & M. Belazougui

National Center of Applied Research in Earthquake Engineering, Algiers, Algeria

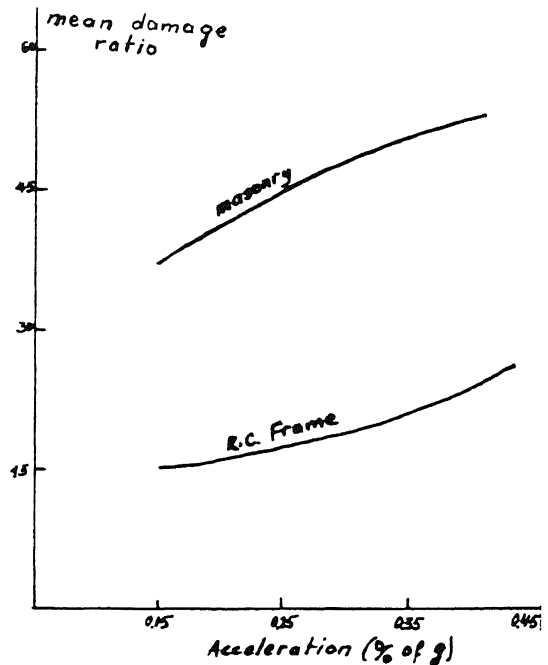
Figure 2. Vulnerability functions for Chenoua region

vulnerability functions (Fig.2), it has been necessary to eliminate the forms of "toub" constructions (construction made of reed and argileous matter) the number of which is 5547. This type of construction has almost disappeared in Algeria.

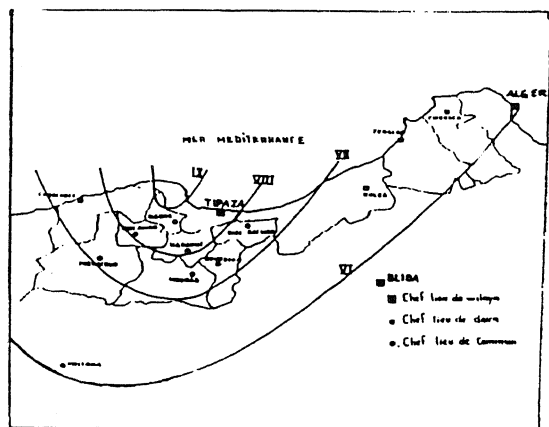
Figure 3. Isoseismal map of Chenoua region

The inspected buildings were divided in five (05) damage levels and a geographical distribution has allowed to set up an isoseismal map. More over, a precise damage analysis was undertaken and allowed to assess some vulnerability functions.
