Special structures, damage report of the Manjil earthquake on June 21, 1990

Khosrow Bargi
University of Tehran, Iran

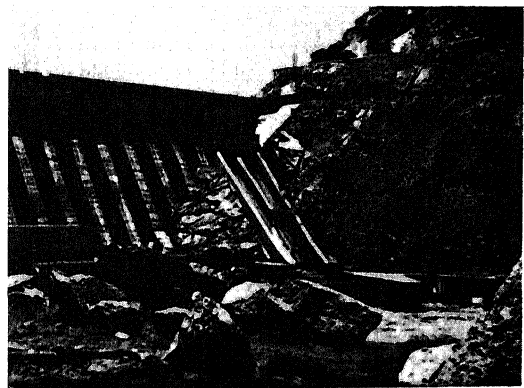
This buttress dam is located 3km northwest of Manjil, so its location coincided with the site where the earthquake had the maximum intensity. The height of the dam is 106m and at the time of the earthquake the reservoir was almost full. Generally the dam kept its structural integrity and its own global. One of the middle buttress support has been suffered a little subsidence and some horizontal and diagonal cracks developed at the top of some buttress and at the same level, some longitudinal cracks due to the poor resis-

Figure 1. Buttress Sefidrud Dam built near fault. Experienced cracking at the interface of crown and tops also longitudinal crack has occurred.

tance appeared. Non monotonous settlement of two side dam supports was the main reason for these cracks.

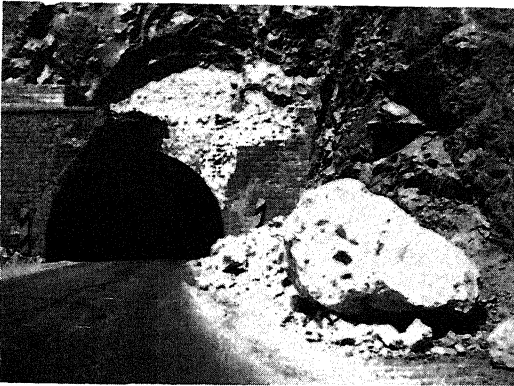
Generally, damage to most tunnels has been moderate or slight. In most cases damage is limited to the entrance due to the reflection of earthquake waves. Some tunnel entrances have been damaged due to rockfalls or soil instability. A particular example of a damaged tunnel inside lining was observed in the case of the tunnel near Manjil dam. This damage seems to be the result of relative ground movements due to the activated fault passing through the tunnel and continuing across the river canyon close to the downstream face of the Manjil dam.

Figure 2. Cracks and partial collapse of the concrete and stone masonry facing in Manjil Tunnel entrance.

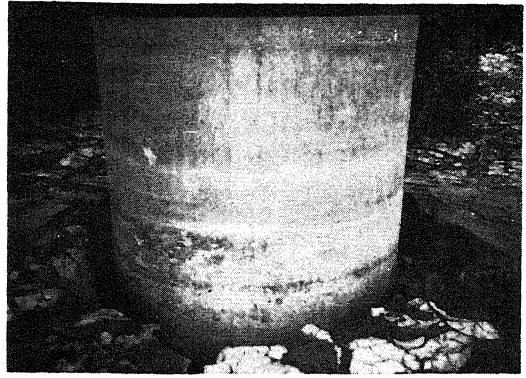
This bridge (L =780 m) with prestressed girders, between Lowshan and Manjil has experienced permanent soil deformations of 5 to 8^{cm} around almost all the piers which clearly indicate the lateral tilt of the bridge superstructure. Certain horizontal cracks of the middle piers have been also observed. Damage to bridge structures was most commonly observed near to the end pier supports (as settlements of the soil), in areas in both support concrete wings, and in the approach ground embankments. Due to the much larger superstructures mass and imposed greater inertial forces, the supports, as well as expansion joints have experienced relative movements in longitudinal , transverse or in some combined directions depending on the global orientation of the bridge relative to the imposed dominant direction of earthquake ground shaking. Steel bridges appeared to suffer much smaller relative movements of the superstructure than R.C. bridge in the area (Rudbar steel bridge).

Figure 3. visible lateral permanent deformations of Bala - Bala bridge piers due to the liquefaction phenomena.

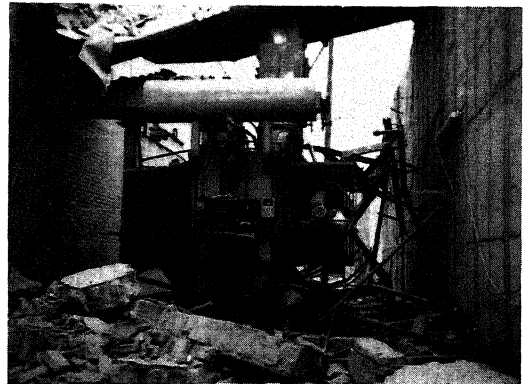
In general, the electrical power generation system and supply networks , including power plants, transformer stations, electricity distribution lines have sustained moderate damage and only in a few cases has heavy damage been recorded. One such case was the power plant in Lowshan which has been heavily damaged. One kind of damage has been produced by malfunctioning of the transformers rail supports caused by ground motion.

Torsion and settlement of one of the columns which had supported power plant generator produced severe damage and caused the suspension of electricity production.

Most shock absorbers on the transformer rails were broken and the transformer resting on such support, have experienced strong seismic shocks and sustained heavy internal damage.

Figure 4. Lowshan power plant transformer damage due to the partial collapses of last storey walls

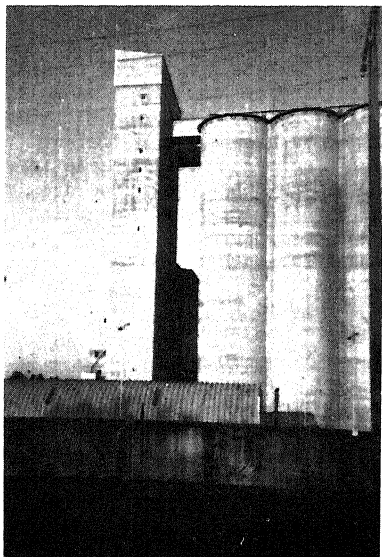
Some slightly damages have been observed in the cells - Tower corridor due to the different rigidity (rigid cells groups and flexible Tower).

Figure 5. RC 120 000 tons silo damages in the cells - Tower corridor due to the different rigidity.

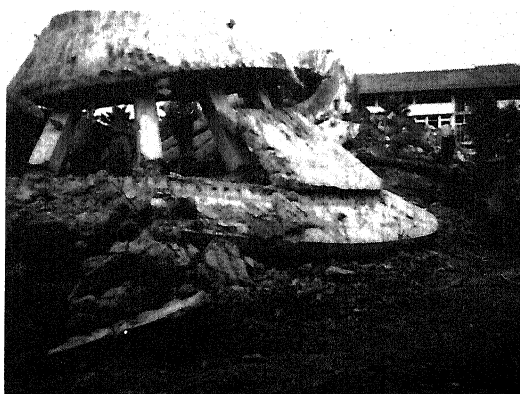
However, the water tanks constructed of R.C. behaved slightly differently. A specific example is the collapsed R.C. elevated water tank in Rasht which was built some 20 years ago. The capacity of this water tower was approximately 1500 m³, and it consisted of a R.C. shaft, 6m in diameter and 30cm thick, and a prestressed concrete tank 10.3 m high, with its top 46.5 m from the ground. At the time of the earthquake it contained about 1000 m³ of water.

Since the collapsed R.C. water tower was in use and contained significant amount of water in the time of the earthquake, its behaviour can be regarded as dynamic response of long period structure and oscillation and impact mode effects. Relatively long epicentral distance of about 50 km, high response amplification is probable inherent with a resonant effect resulting consequently in the total collapse of this structure.

Figure 6. Total collapse of elevated water tank 1500 m³ in Rasht

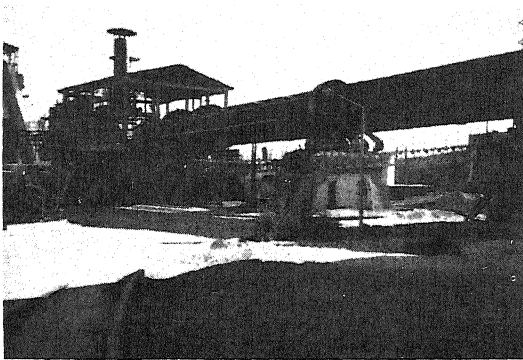
This new cement factory (2000 ton) which had been completed several months prior to the earthquake, generally has sustained moderate damage but in some parts has heavy damage been recorded. One of these part was the Knapping - hammer building (R.C. frame with masonry infill) where its control room roof has been completely collapsed due to the very poor connections. A large number of the separation of the wall brick infill and severe cracks in the walls have been observed. Vertical displacement (5-10 cm) in a large part of this factory has been recorded.

Figure 7. Settlement of the Lowshan cement factory kiln's foundation

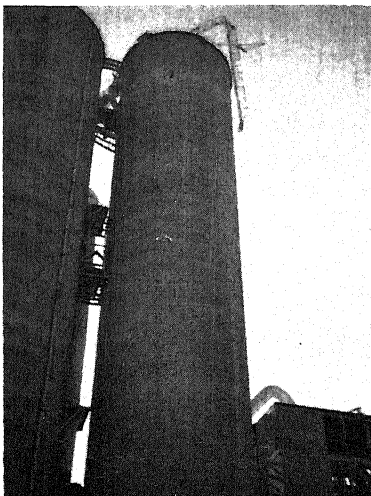
Comparing with the other parts of this factory, the behaviour of its silo has been relatively satisfactory. Although one crane which had been used for construction of this silo, has completely overturned.

Figure 8. Overturned crane in Lowshan cement factory

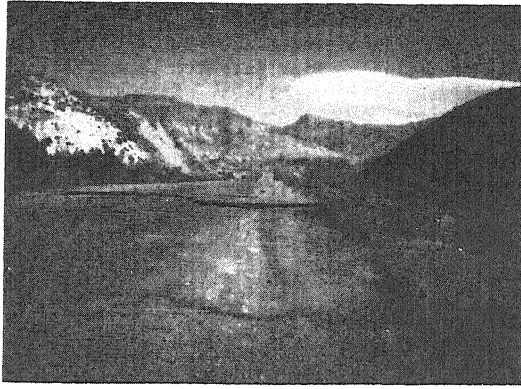
The extent and types of damage to roads and highway Structures largely dependent on the position of the road section. Road sections passing through wide and flat areas mainly have been damaged due to the ground settlements as a result of liquefaction or other types of dynamic soil instability. Contrary, the road sections passing through steep hilly and mountainous regions have been much severely damaged due to the local and global instability of the slopes as well as due to the other relative movements producing transversal areas with different wideness. Very frequent damages of roads in mountainous regions have been produced due to the ground and rock slope failures which resulted in complete closure of the roadways and severe transportation difficulties during the most urgent rescue operations immediately after the earthquake.

Figure 9. Road's Pavement transversal displacement

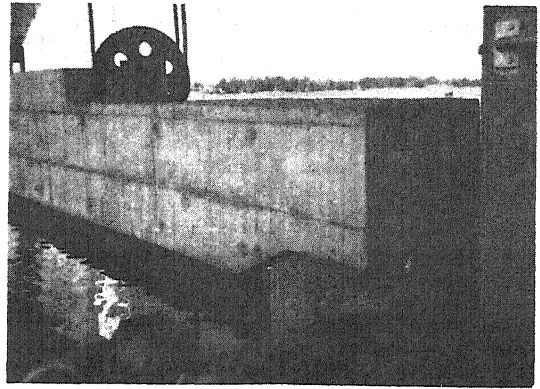
The mechanical equipments of some traps such as retaining cables of equilibrium weight beams for open and closing of traps have been heavily damaged, caused by settlement of the supports due to the liquefaction phenomena. Non ductile connections between the equipments and their supports have been aggravated this kind of damage

Figure 10. Collapse of the equilibrium Trap's beam due to the defects of mechanical and installed equipments in Sangar Control Dam.

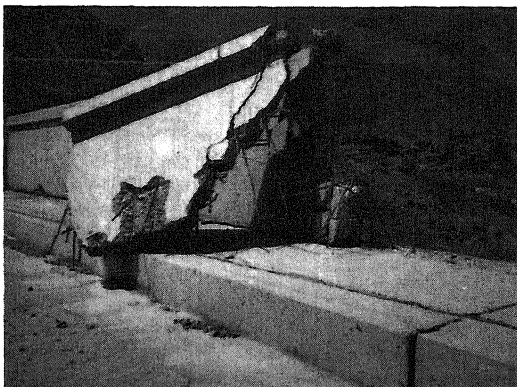
Figure 11. Damage of the parapet walls on the Sefidrud dam's crown.
