Analysis of the collapsed Armenian precast concrete frame buildings

Loring A. Wyllie, Jr

H.J. Degenkolb Associates, Engineers, San Francisco, Calif., USA

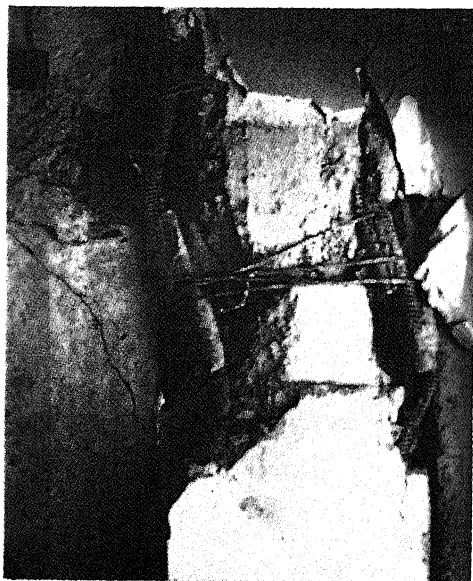
A review of the analysis and the damage suggests that the most probable cause of damage leading to collapse was the failure of the column splices with the eccentrically welded column reinforcement. Assuming some creep in the columns had transferred axial gravity loads to the column reinforcement, the eccentricity of the column reinforcement overstressed the column ties by factors of 3 to 16 times, depending on the actual configuration. These bars must have been on the verge

Figure 3 Column splice with buckled reinforcement at eccentric bar splice.

of buckling prior to the earthquake. Figure 3 shows one of these splices in a damaged but still standing building.

2. The weakest link of the Series 111 buildings as constructed was the column splices with eccentricities between the weld spliced column vertical reinforcing. The eccentricities in these bars, combined with weak concrete in the splice region, led to bar buckling and a failure of the columns, leading to collapse.

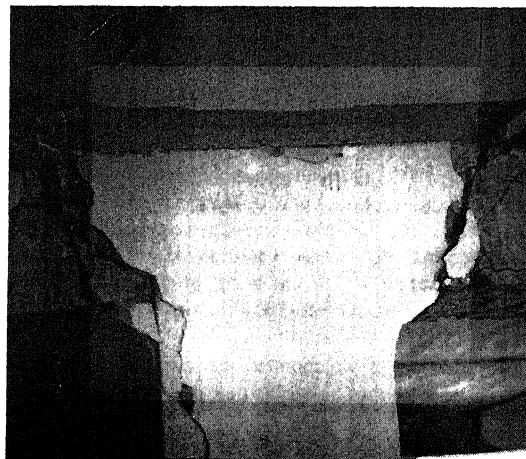
The next issue is that of the moment resisting frames. Beyond the column splices, the frames were analyzed to find the weak link under seismic loads. The analysis revealed the weak link was the beam shear capacity. The beams were not strong enough in shear to develop the reverse plastic hinge capacity of the beam at its ends. This was confirmed in field observations where columns in the vicinity of the beams and the beam-column joint were always uncracked, whereas shear cracks were often evident in the beams. Most dramatic were conditions like Figure 4 with wide shear cracking at the end of the angle embedded in the column. In a few cases observed, the only thing holding up the beam was the bottom reinforcement welded to the embedded angle. Many modern codes have detailing requirements for seismic frames to prevent these shear failures.

Figure 4 Beam column connection showing severe shear cracking in beams beyond embedded steel angle.

4. An analysis of the moment resisting frames of the Series 111 buildings revealed that the weakest link in these frames was the beams in shear. This is consistent with the field observations of damaged buildings where extensive shear cracking was observed in the beams at the end of the steel angle embedded in the column.

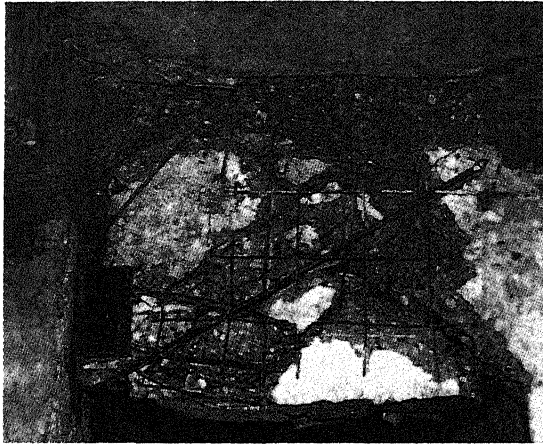
The shear walls were analyzed and their weak link was the spandrel or coupling beams between the stacked doorways. This was consistent with observed damage, as in Figure 5, where these beams were completely shattered. This was consistent where these openings were observed in shear walls. In the building plan with solid walls, working of the connection to the precast column and cracking along the floor joint were also observed.

Figure 5 Shear wall coupling beam between wall at right and precast column at left between door openings.

3. Shear walls consisting of precast panels welded to columns had stacked door openings. The spandrel beams above or between these openings were lightly reinforced and they sustained substantial damage. Links like these beams which are weak in shear should be substantially reinforced to allow the rest of the wall to work in resisting seismic forces.
