# Correlation between recorded building data and non-structural damage during the Loma Prieta earthquake of October 17, 1989 – Selected case studies

S.S.Rihal

California Polytechnic State University, San Luis Obispo, Calif., USA

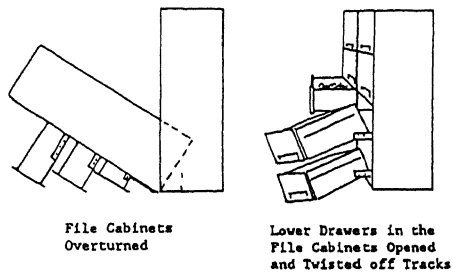
It appears that non-structural components such as lateral file cabinets were subjected to rocking action due to the floor motions produced by the earthquake. One major factor that contributed to the overturning failure of lateral file cabinet systems was the sudden opening of upper drawers which caused these components to overturn due to the adverse P- $\Delta$  effects.

Typical and representative non-structural component damage at 7th and 11th floor level is graphically presented in Figure 2.

Significant non-structural damage was observed to have occurred particularly at the 7th floor level especially during the 1989 Loma Prieta earthquake. At this floor the recorded peak accelerations and displacements during the 1989 Loma Prieta earthquake were approximately 2-3 times those recorded during the 1986 Mt. Lewis and 1984 Morgan Hill earthquakes.

Figure 2 Representative Non-Structural Component Damage 7th Floor (left) and 11th Floor (right)
