A study on structures of grounds liable to induce earthquake damage

Makoto Nasu

Railway Technical Research Institute, Tokyo, Japan

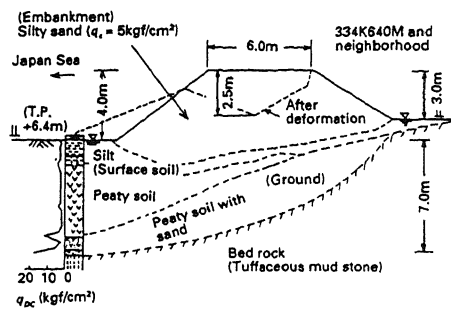
Fig. 2 Railway embankment in Koikawa¹⁾

(3) In the Nipponkai-Chubu earthquake of 1983, the embankment between Koikawa and Kado on the Ou line failed on the ground in which the bottom of the soft soil stratum including a thick peaty layer greatly tilted in both the longitudinal and transversal directions of the embankment, as shown in Fig. 2. Still, it is noted that the right end of this embankment failure zone agrees with the right end of the zone of a very soft peaty soil.

A neighboring embankment underlaid with a very soft and almost horizontal soil stratum did not subside nor was deformed. Furthermore, the embankment strength around this site is fairly low, that is $q_c = 5 \text{ kgf/cm}^2$ ($\approx 0.5 \text{ MPa}$), regardless of failed or

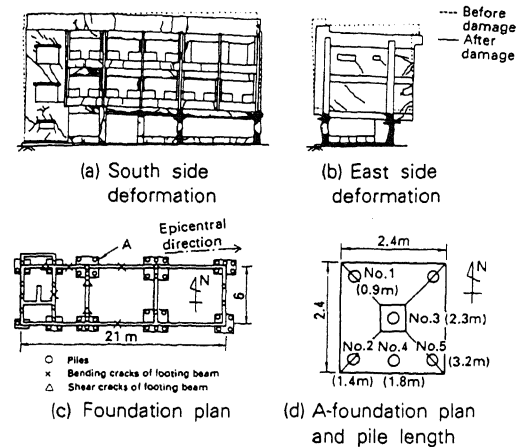
Fig. 3 The Maruyoshi building²⁾

(4) In the Miyagiken-Oki earthquake of 1978, the collapsed building of the Maruyoshi industrial Co. Ltd. had piles of various lengths even in one foundation as shown in Fig. 3, and the ratio of the max. length of them to the min. one was about 3.5. At this site the depth of the bedrock varied suddenly. Especially the inclination of the building was larger in the span direction than in the ridge direction. The span direction was inclined in the direction in which piles became shorter and the soft soil layer thinner. The ridge direction is inclined in the direction in which the soft soil layer became thicker.

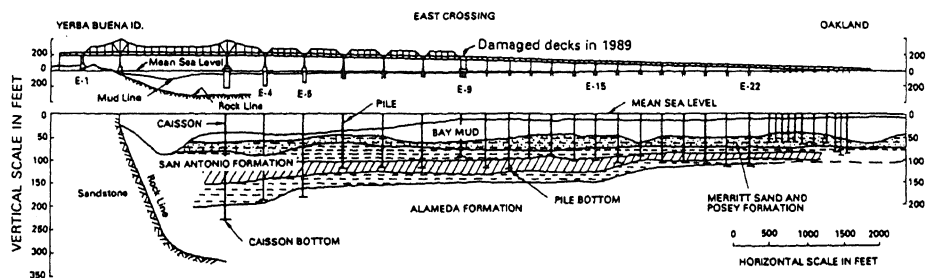
Fig.4 The San Francisco-Oakland bay bridge (revised original figure)³⁾

Because the damaged Bay Bridge had been constructed straddling both thick and thin parts of the soft Bay Mud in the bridge axis direction as shown in Fig. 4 and a seismic differential displacement occurred largely in its direction, the bridge decks on the pier E-9 are considered to have fallen down. The soft Bay Mud thickness changes at the site of this pier. Moreover, the Bay Bridge moved largely at right angles to the bridge axis, namely in the radial direction of the equi-depth lines of the Bay

Mud. This can be expected from the equip-depth line map of the Bay Mud base.

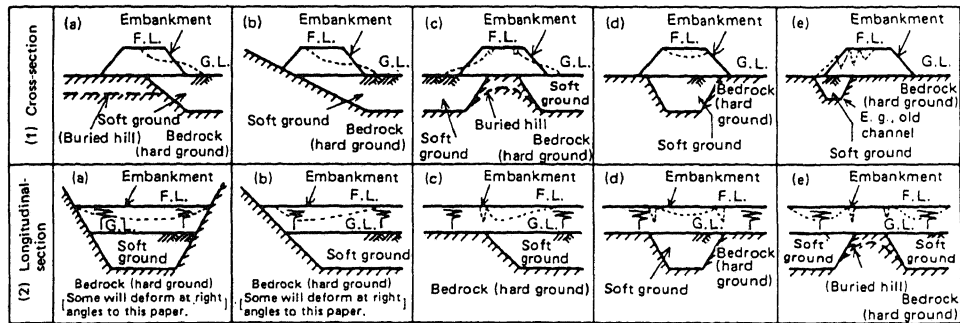
(1) Embankments (possibly including buried hill and valley)

deformed by earthquakes on grounds where the surface of hard soil layer underlying soft soil layer is inclined, and when these objects straddle both soft ground and hard ground, as shown in Fig. 5. In the latter case, they are liable to be deformed remarkably by earthquakes.
