Experimental study of the church 'Sveta Sofia' in Sofia

L.Tz.Tzenov & S.L.Dimova

Central Laboratory for Seismic Mechanics and Earthquake Engineering, BAS, Sofia, Bulgaria

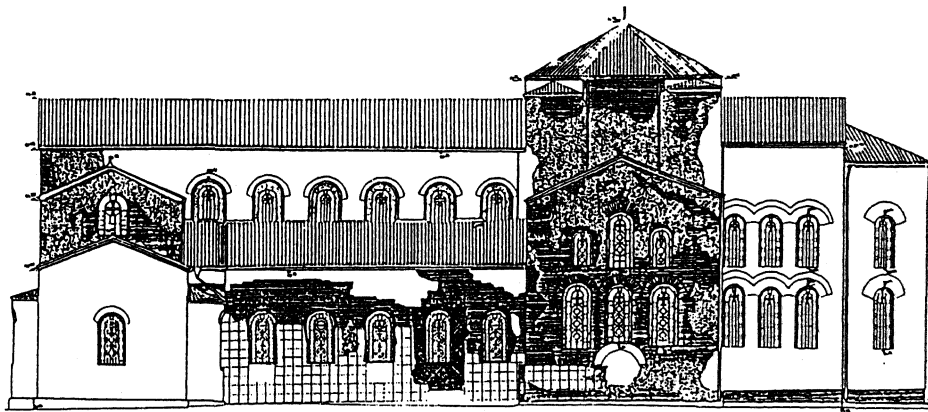
Figure 1. South facade of the church.

The building represents a three-nave basilica with a transept (see Figure 1). The length with the apse is 46.40 m, the width of the transept is 23.00 m, the height of the central nave is 16.10 m and the height of the dome is 19.75 m. Bearing elements are the walls and the columns. The church as a whole is constructed of brick masonry and is

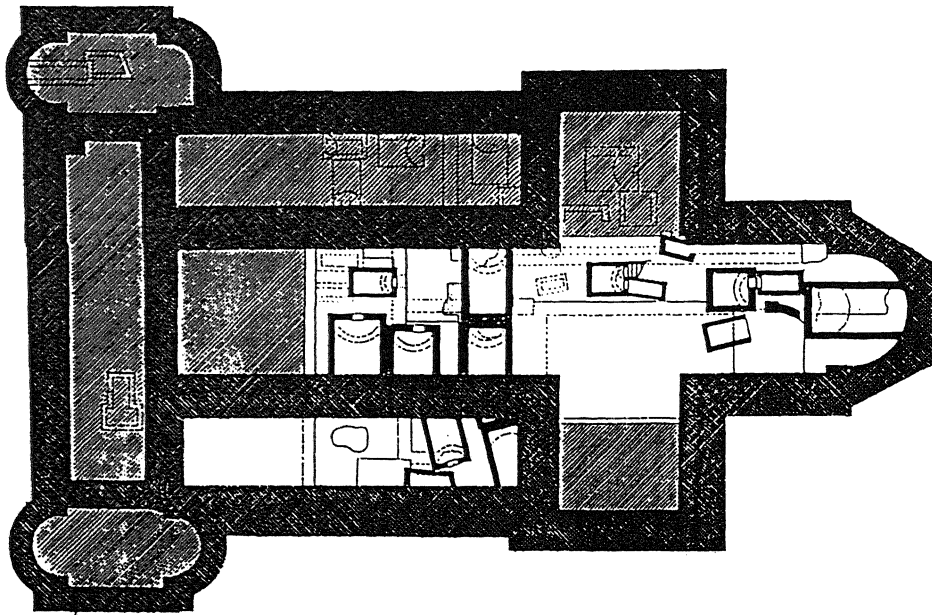
Figure 2. Plan at the archaeological level, elevation -2.50 m.

founded on strip stone work foundations. Some of the foundations lay on the cracked antique tombs (see Figure 2). The ground is represented by a layer of alluvial sands 3.40 m thick. Some of the foundations are in contact with quaternary gravel 1.60 m thick and embankments 1.6 m thick (Geological survey 1990).

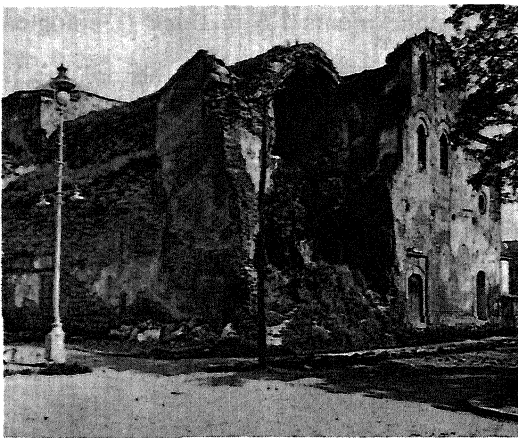
Figure 3. The church in the beginning of 20 century.

During its 15 centuries-old history the building has suffered a lot of interventions - till the 14 century it acted as a church, in the 14 century it is reconstructed in a mosque, the earthquakes in 1818 and in 1858 caused severe damages of the structure (see Figure 3). The building is abandoned till 1910. After serious investigations from 1910 till 1912 the structure is fully restored and since then it is acting as a church. The above mentioned reconstructions and excitations have influenced the structural

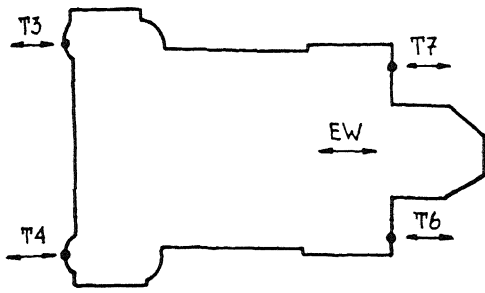
Figure 4. Transducers disposition according scheme 3.

1. The separate structural elements of the building should not be treated as parts of a monolithic continuity. By way of illustration the results from the registrations according schemes 3 and 6 can be cited. According the scheme 3 transducers T3, T4, T6 and T7 are situated "in one horizontal plane" on the first row of windows at the corners of the building (see Figure 4). Transducers T1, T2 and T5 are located "in a vertical line" on the windows of the weste facade (see Figure 5). All transducers register vibrations into direction EW. For predominant period of free vibrations $T_{ew}=0.107$ s a "mode" of vibrations in a horizontal plane is obtained (see Figure 6). Its shape gives reasons to consider the connection between the bearing walls as insufficient good one.

registrations of transducers T3, T4, T6 and T7 are shown. As far as the excitation is applied nearby the west facade wall, a delay of the order of 0.08 s is registered by the transducers T6 and T7 located in the eastern facade wall (see Figure 4). This fact could be explained as by the available cracks in the walls, as by the non-identical characteristics of the foundation base under the different parts of the structure. In other words, the registered vibrations could be treated as vibrations of a complicate system of interacting fragments, which is located on a base, consisting of interacting fragments, too.

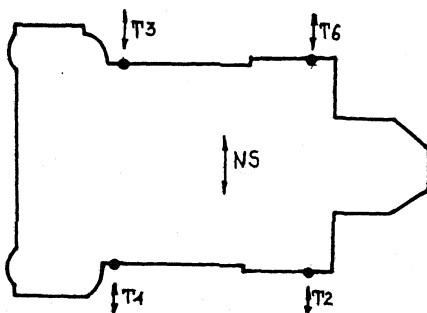
Figure 7. Transducers disposition according scheme 6.

According the scheme 6 transducers T2, T3, T4 and T6 are situated "in one horizontal plane" on the first row of windows in the north and the south facades of the building (see Figure 7) and register vibrations into direction NS. Data analysis shows the predominant period of free vibrations $T_{ns}=0.095$ s. In Figure 8 is shown a "mode" of vibrations in a horizontal plane, corresponding to this period. Its shape is a

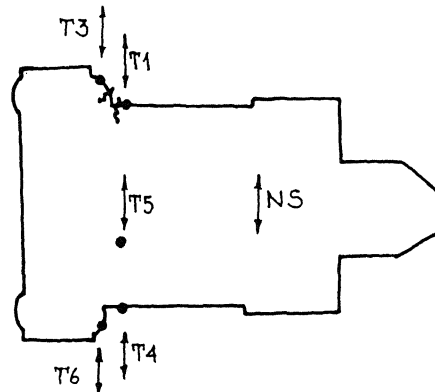
Figure 9. Transducers disposition according scheme 7.

According the scheme 7 transducers T1, T3, T4 and T6 are situated "in one horizontal plane" on the first row of windows on the north and the south facades of the building and transducer T5 - on the window opening of the lantern basilica light, over a column of the south colonnade (see Figure 9). The transducers register vibrations into direction NS. Transducers T1 and T3 are placed on adjacent windows in the north facade, between which there are visible cracks, as it is marked in Figure 9. Transducers T4 and T6 are located on the adjacent windows in the south facade. The displacements time histories obtained by the transducers registrations are shown in Figure 10. The comparison of the "adjacent" transducers registrations shows the interaction between the respective elements is "partial" because of the available cracks. Data analysis shows the predominant period of the facade walls free vibrations $T_{ns}=0.100$ s. and for the south colonnade $T_k=0.139$ s. (or more precisely of the column under the transducer T5, as far as there was not possibility for more than one transducer disposition on the windows of the lantern light and for this reason - for more detailed analysis of the dynamic behavior of the colonnade as a whole). The difference between the obtained T_{ns} and T_k is hardly likely to be caused by cracks in the south vault arch, which could be extended profoundly in the masonry. For this reason a new, more precise survey of the structure was made and cracks located longitudinally in the vault arches over the south and north naves were found out.

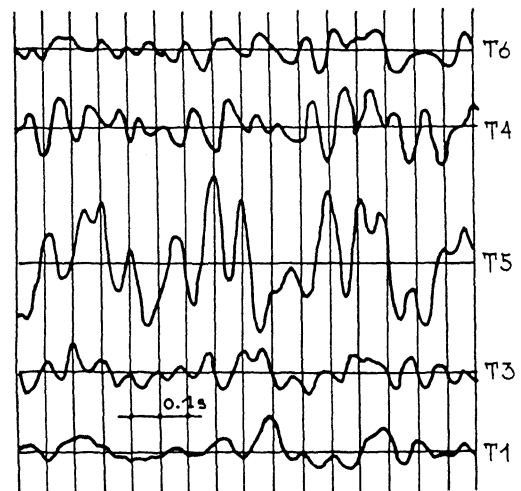
Figure 10. Displacements time histories according scheme 7.

From the other hand, the non-synchronous vibrations registered by the two adjacent transducers T1 and T3 (see Figure 10) as well as their dissimilar amplitudes of vibration give reasons to consider the visible cracks as penetrating deeply in the masonry. The vibrations registered by the situated on the opposite wall transducers T4 and T6 give another reason to consider the monolithicity of the wall between them to be decreased. On the other hand, the non-synchronism of these vibrations in comparison with those, registered on the opposite wall, confirms the insufficient good connection between the bearing walls of

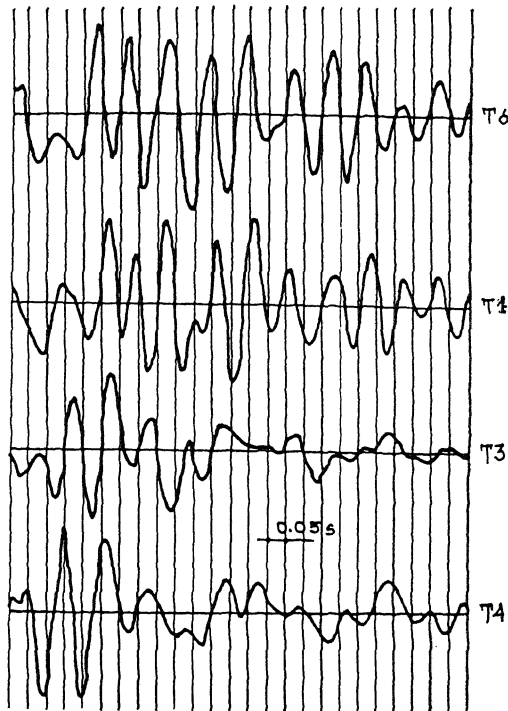
Figure 12. Displacements time histories according scheme 3.

3. The characteristics of the foundation base are not identical under the different parts of the structure. The horizontal vibrations registrations according the scheme 3 show some "delay" of the vibrations along the structure. In Figure 12 the displacements time histories obtained by the
