Behaviour of Gilan dams during Iran earthquake of June 1990

M.R. Maheri
Shiraz University, Iran

ABSTRACT: In this paper the behaviour of 3 dams, situated within a 50km radius of the epicentre of the Iranian earthquake of 20 June 1990 is discussed. The largest and most important of these dams is the 106m high aseismic-designed Sefid-rud buttressed dam. Situated in the epicentral area of the quake, it survived the 0.65+g ground accelerations with some cracking in the main body and buttresses and in particular in the intersection of the crown and the main body. Two other dams in the area, Sangar and Tarik, both diversion dams also survived the earthquake. Failure in six of the thirteen steel gates of the Sangar dam and spalling of concrete due to pounding of the bridge deck against the piers in the Tarik dam were the main damage in these two dams. Two important seismic design considerations absent in these dams include; appropriate seismic joints and the safety of secondary systems and equipments.

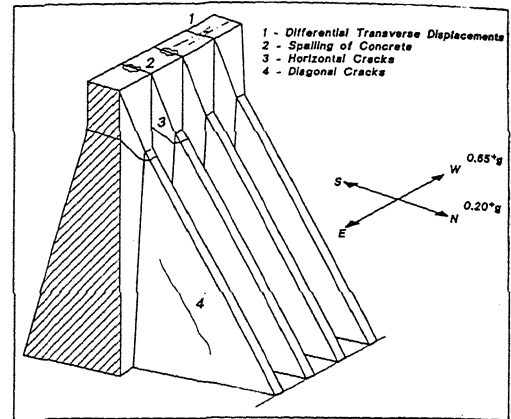
i) **Horizontal Cracks:** The main structural failure in the dam consists of a long, horizontal crack in the upper parts of the monoliths. This crack, running almost the whole length of the dam about 1.6m below the crown, was less evident in the end monoliths but could easily be seen in the middle monoliths where the oozing of water out of the crack had left some clear marks on the downstream face. In this section the crack had evidently crossed the whole thickness of the dam but appearing at two different levels on the upstream and downstream faces, roughly 4m apart (Fig. 1). The crack appears to have been of the out-

Fig. 1 Sefid-rud dam. Upstream view.

of-plane bending type caused by the N-S component of the quake. The effects of compressive and tensile failures at the cracked section could be seen in the form of spalling of concrete. Also after the formation of the crack in the middle monoliths, the periodic compressive loading around the crack on the downstream had actually driven a 4m high wedge of concrete, some few millimeters out of position; results of analysis carried out by Ahmadi [3] later confirmed this mode of failure and the location of the crack. These analyses indicated that the initial failure was of tensile type on the downstream face of the dam. Based on the analytical findings, this section of the dam has since been repaired using pre-tensioned cables (Ahmadi 1991).

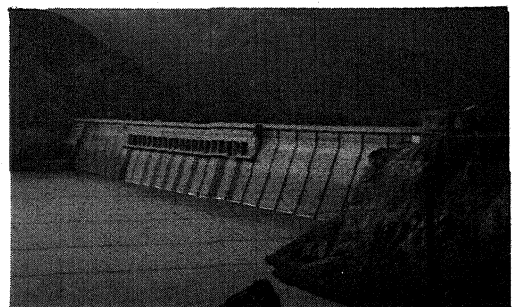
Fig. 2 Structural failures of Sefid-rud dam.

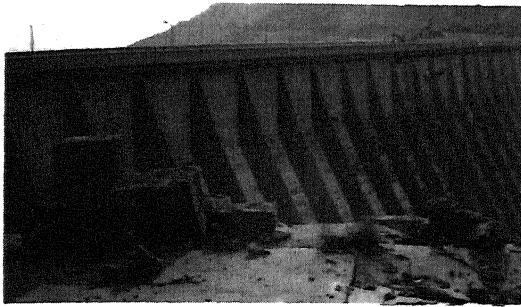
Fig. 3 Sefid-rud dam. Partial view of downstream.

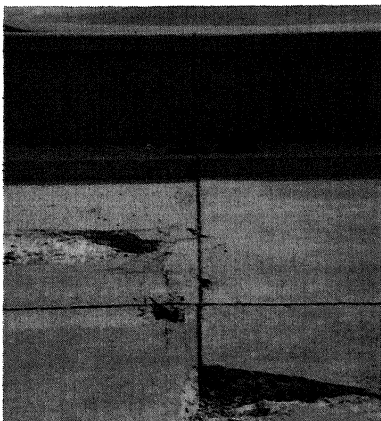
Evidence of pounding of the monoliths against each other could be seen on the crest in the form of spalling of concrete at

the interfaces (Fig. 4). The pounding was caused by the high-acceleration, longitudinal (E-W) component of the earthquake. The extent of damage due to pounding at the interface of the monoliths could not be investigated. The type and size of seismic joints, if they were at all a consideration in design of the dam, were inappropriate to mitigate the damaging effects of pounding.

Fig. 4 Sefid-rud dam. Pounding failure

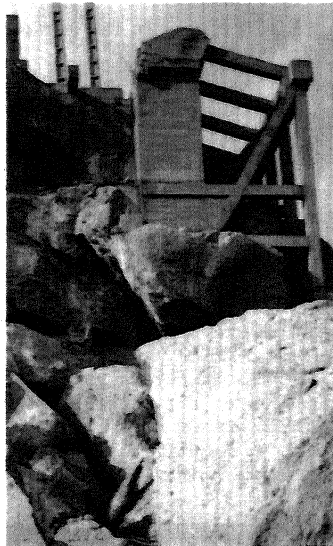
- i) Destruction of the guard post at the east side and the guard house in the west side (Fig. 5) of the dam under the impact of the falling rocks. The reinforced concrete guard house was completely destroyed causing at least one fatality.
- ii) Flexural failure and collapse of the central sections of the reinforced concrete parapet wall of the north side (Fig. 6). The failure of this long, unsupported wall was in the form of vertical cracks together with horizontal cracks at the base due to bending effects.
- iii) Subsidence of the fill adjacent to the concrete section of the dam, particularly on the west side, caused by the compaction of the loose fill under ground vibration.
- iv) Overturning failure of the majority of concrete and stone masonry guard blocks, most of which were thrown off their footing

Fig. 5 Destruction of the guard house under falling rocks.

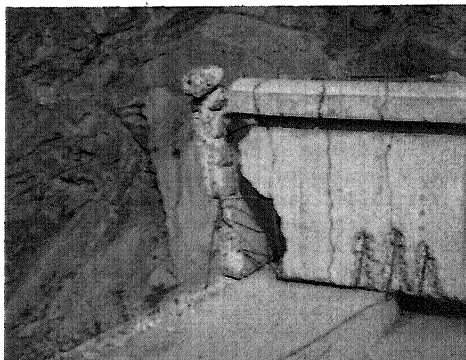
Fig. 6 Sefid-rud dam. Failure in the parapet wall of the north side.

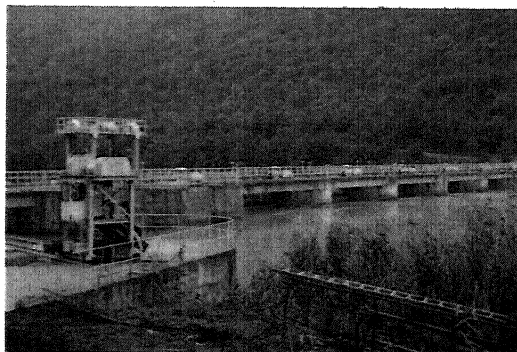
Fig. 7 Tarik diversion dam. Upstream view.

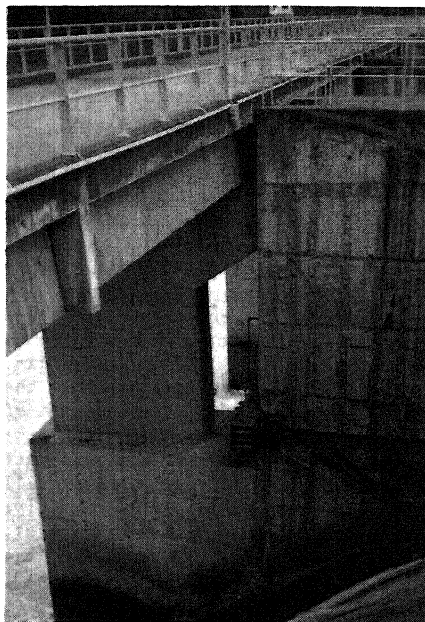
flow of water through the dam is controlled by semi-cylindrical steel gates each 15m long and about 8m high. The movement of these gates is controlled individually by an automatic pulley system. The bridge deck of the dam runs on the north side and level with top of the piers. The deck rests on columns supported by the piers (Fig. 8).

Fig. 8 Tarik dam. Details of the piers and the bridge deck.

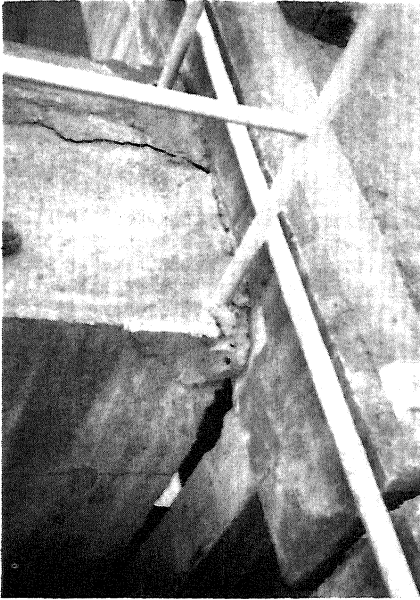
There were no visible damage to the concrete section of the dam under direct earthquake loading. However there were local cracking and spalling of concrete at the top of almost all the piers in close contact with the bridge deck (Fig. 9). The failures were evidently caused by pounding action of the relatively flexible bridge deck against the rigid piers under the N-S component of the earthquake. The distance between the bridge deck and the concrete piers was not sufficient to accommodate the relative flexible responses of the two

Fig. 9 Tarik dam. Pounding failure in the concrete piers.
