targeted completion date. This paper sets out the structural investigations, analysis and design for the seismic strengthening of the Auckland Town Hall.

BUILDING DESCRIPTION

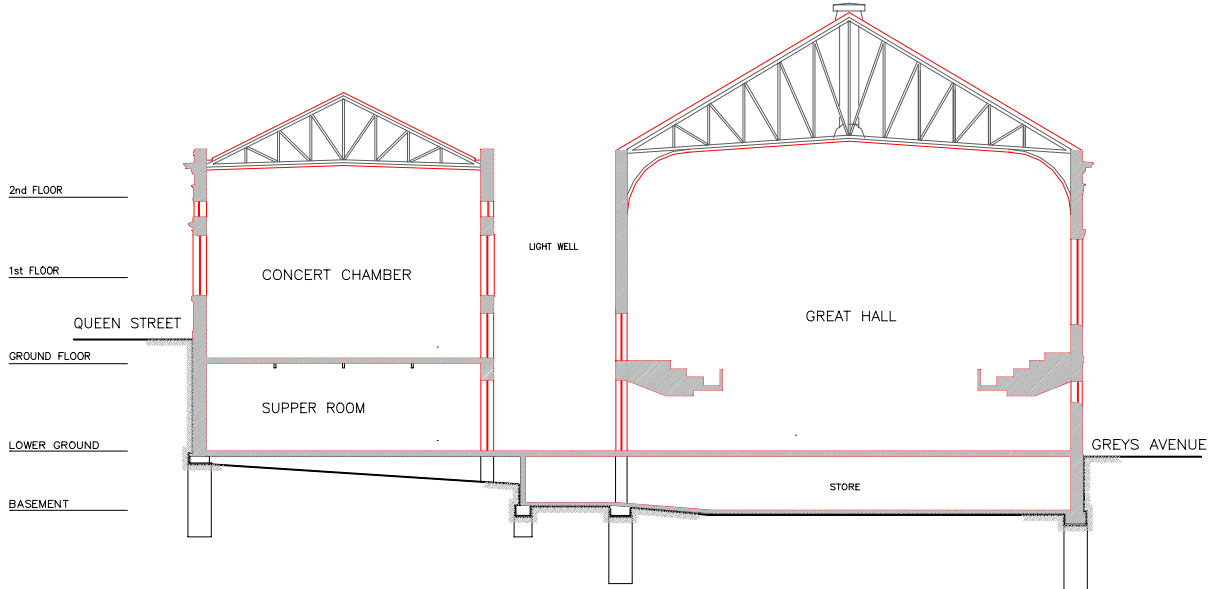
Figure 3: Cross Section Through Great Hall and Concert Chamber

The Great Hall, however, is a single volume space over all four levels, but also with a partial basement to the south. The Concert Chamber is significantly smaller with its auditorium floor one storey up, level with Queen Street. The Apex is well compartmented by internal walls but the cross walls have a slender aspect ratio due to the presence of two longitudinal corridors on each level.

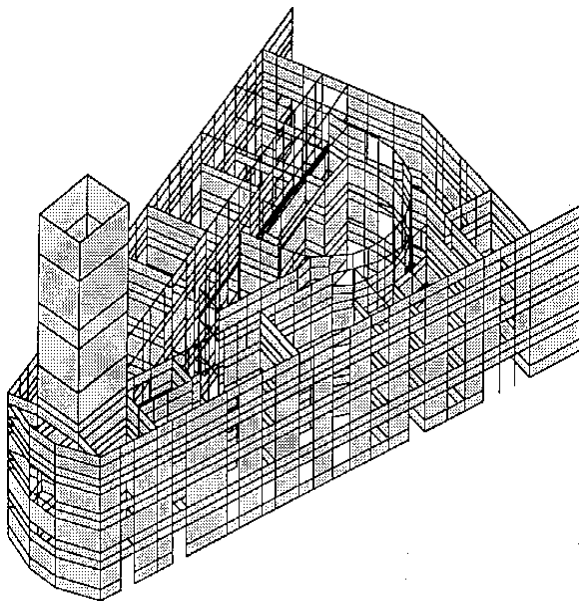
Figure 5: Apex ETABS Model

The northern Apex analysis model included the Tower, in order to model the distribution of its seismic reactions below roofline. The eccentricity of the Tower meant that modelling the flexibility of the diaphragms was particularly important otherwise, with stiff diaphragms, the Tower reactions would be analysed as distributed over a far wider distance than reality. All significant openings such as windows and doors were included in the model, as was the double storey height Council Chamber. Figure 5 shows the Apex model. (Floors and diaphragms not shown).

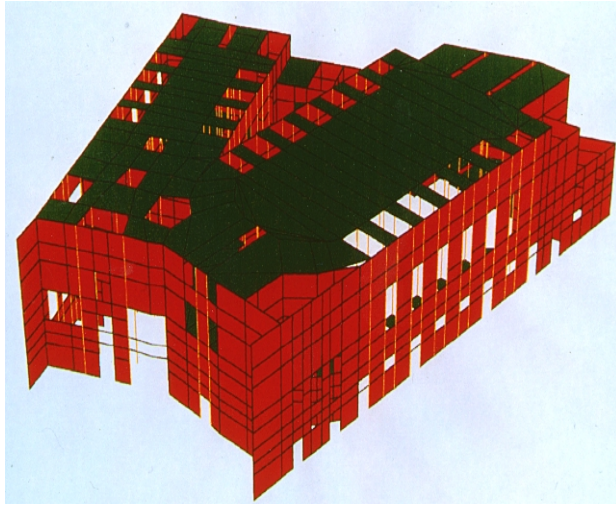
Figure 6: Halls ETABS Model, showing flexible “floor” panels with cut outs for mass locating diaphragms

Quite significant interaction between the halls was expected at their common wall and this was confirmed by the analysis. Figure 6 shows the ETABS model for the halls, showing also the flexible floor layout at ceiling level. The diaphragm "patches" are not shown but fill the spaces between the floors.
