## EFFECTIVENESS OF THE GROUND IMPROVEMENT ON LIQUEFACTION OBSERVED DURING THE HYOGOKEN- NAMBU EARTHQUAKE

S. Yasuda<sup>1)</sup>, K. Ishihara<sup>2)</sup>, K. Harada<sup>3)</sup> and N. Shinkawa<sup>3)</sup>

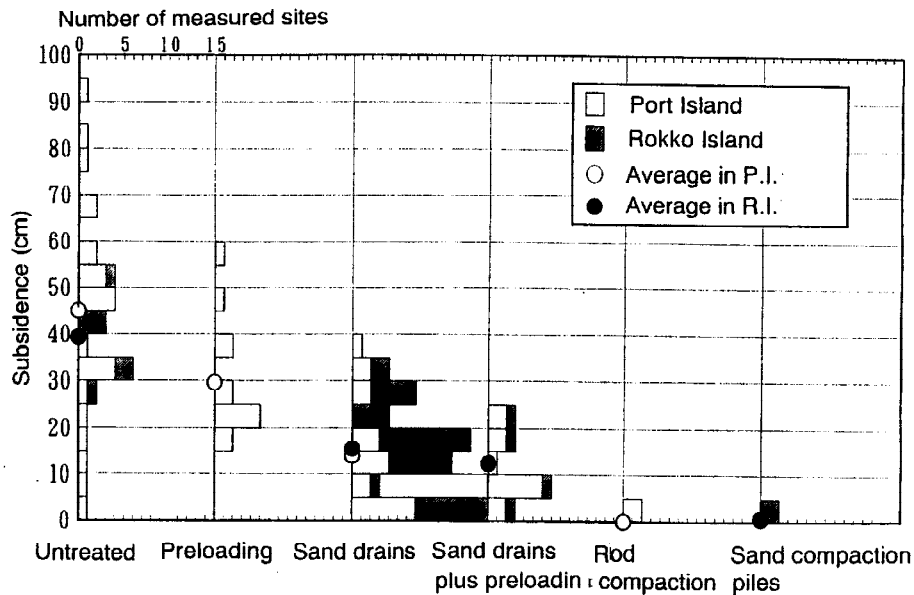
Fig.14 Comparison of ground subsidence in zones treated with different methods

Large ground subsidence, of up to several tens of centimeters, was observed in the zones where sand and water were ejected. No subsidence and no damage to structures were observed however in the zones densified with sand compaction piles and rod (vibro) compaction, and only slight subsidence was observed in the zones treated by other methods. The authors measured the ground subsidence at many sites. Figures 12 and 13 show the contours of the ground subsidence thus measured. Figure 14 compares the measured ground subsidence in each zone treated by different methods. The average subsidence in the untreated zones was almost 40cm to 45cm. Subsidence decreased with the degree of compaction. The average subsidence in zones treated by preloading, sand drains, sand drains plus preloading, rod (vibro) compaction and sand compaction piles was about 30cm, 15cm, 12cm, 0cm and 0cm, respectively. The order of decreasing subsidence is the same as the order of increase in N-values in SPT, mentioned before.

Usually the volume of liquefied soil decreases by several percent due to ejection of pore water, according to laboratory tests (Ishihara et.al., 1992). As the reclaimed Masa was loose and ground shaking during the earthquake was very strong, it can be estimated that liquefaction occurred from the ground water level to the bottom of the reclaimed layer in untreated zones. Assuming the thickness of the liquefied layer was 10m to 15m and the subsidence was 45cm, the volume change can therefore be estimated to be 3 to 5%. This value coincides fairly well with the values obtained from the laboratory tests mentioned above. The reclaimed soils in the zones compacted by sand compaction or rod (vibro) compaction were not liquefied, because no evidence of subsidence, ejection of water or damage to structures was observed. The reclaimed soils in the zones treated by other methods might have liquefied at some depths. It must be stressed that the compacted subsoils did not liquefy even though very strong shaking, of 600gal or more, hit the site. Data on the unliquefied soil is important for the development of methods to predict liquefaction.
